Pancake Creek Moorings Program

Benthic Assessment, June 2018

Report to Queensland Parks and Wildlife and Gladstone Ports Corporation

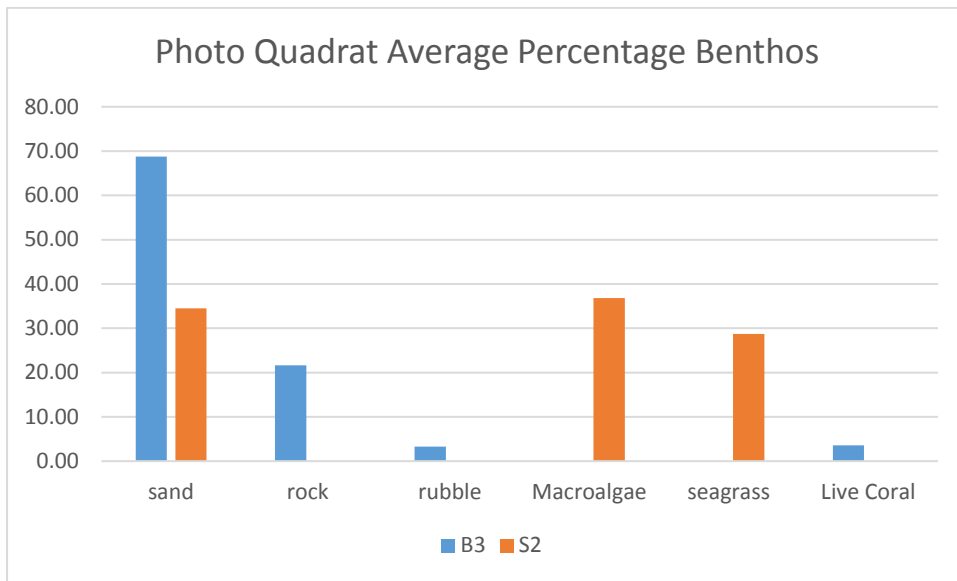
Figure 2 Graph showing the average percentage benthos cover at the two survey sites.

Mooring sites B3 and S2 are considerably different habitats. The B3 site is predominately a sand dominated environment (Figure 5). The live coral cover is quite low with only a low percentage cover detected (Figure 2 and 3). The rock detected at the site is suitable substrate where coral can settle and grow. However there was evidence that anchors have been scouring the rock of coral cover (Figure 4).

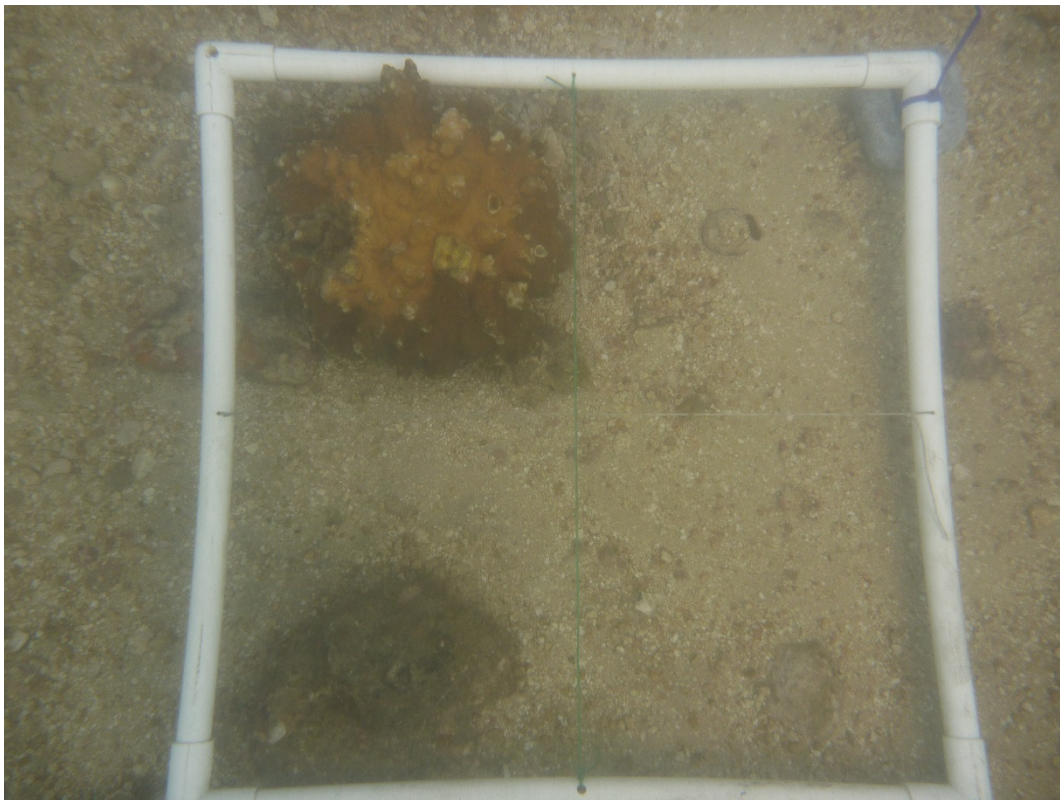
Figure 3 Image showing benthos cover (live coral) at Site B3.

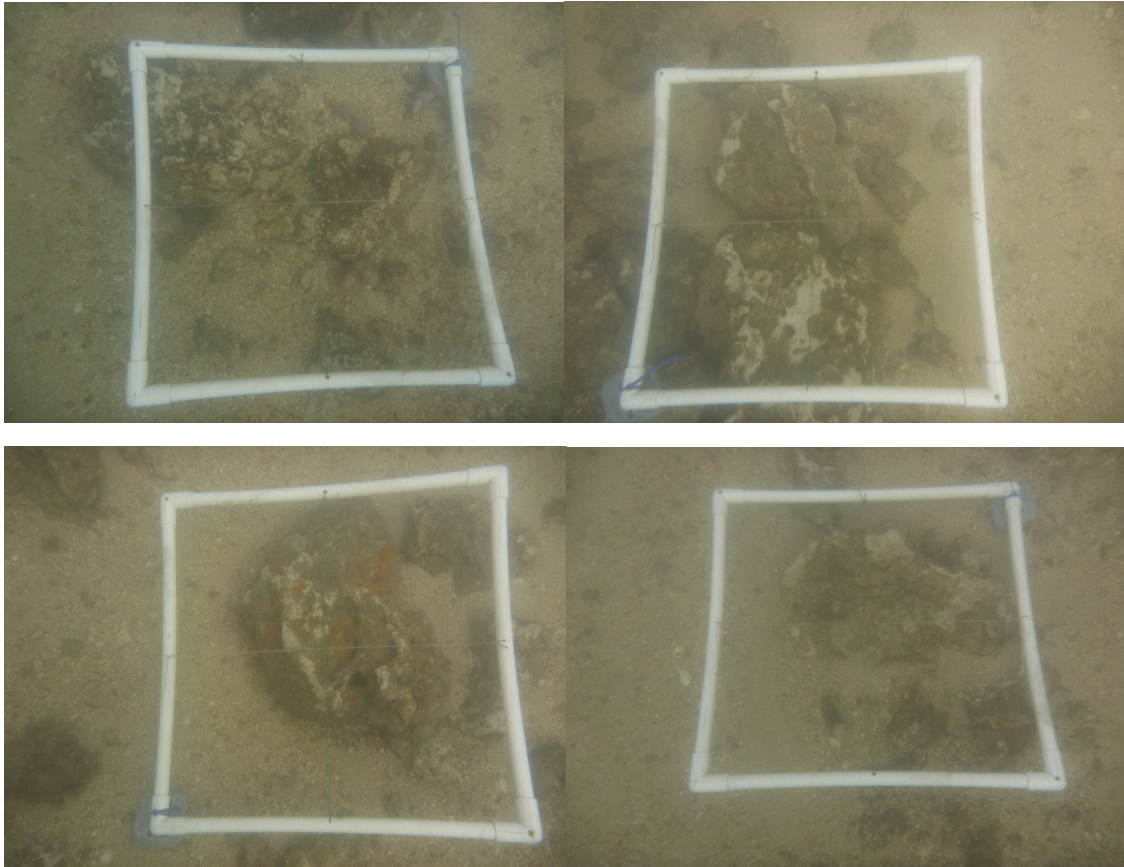
Figure 4 Images showing rock damaged by anchor at Site B3.

With the environmentally friendly moorings in place this damage should be greatly reduced and the existing live coral cover has the potential to increase. Seagrass was not detected during the survey of B3, however optimum conditions for seagrass growth are generally later in the year.

Due to the presence of hard basalt rock less than 1m below the substrate surface at both mooring sites pin moorings will not be placed as mooring anchors. Deadweight anchors will be used with all mooring tackle suspended by riser buoys to achieve environmentally friendly effect.

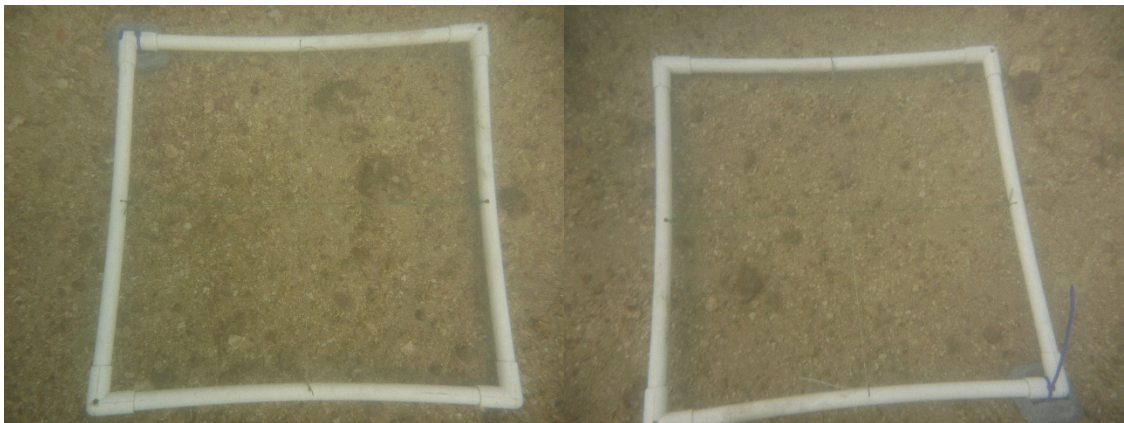
Figure 5 Images showing sand at Site B3

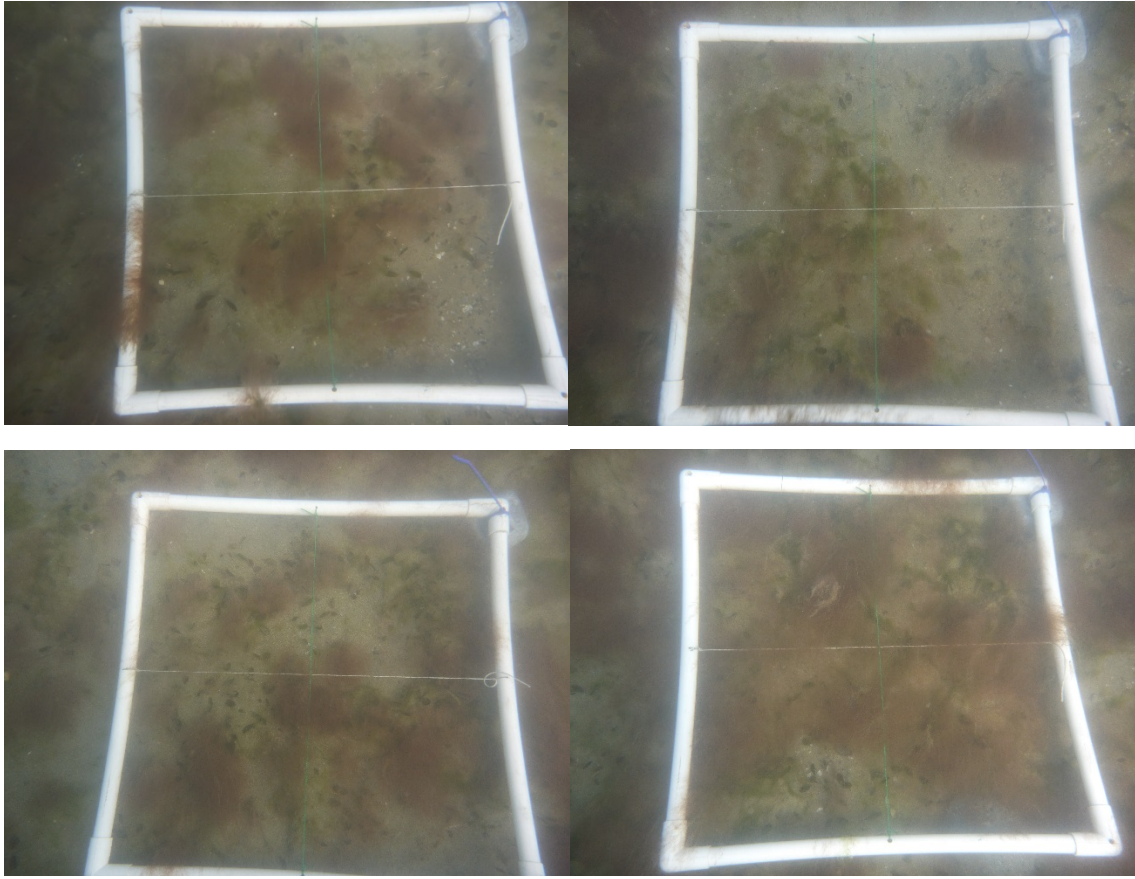
Figure 6 Images showing seagrass and macro algae cover at Site S2.

Site S2 was dominated by seagrass and macro algae (Figure 6). The coverage was consistent across most quadrats. The seagrass present was *Halophila spp.* and found in similar density to other locations within the region. There were some areas of disturbance detected. It was unclear whether this disturbance was a result of anchors or marine animals (i.e. stingray, turtle). A large male green turtle was observed feeding during the survey.

No coral was detected at this site and there is no suitable substrate present that would indicate potential for any coral recruitment.
