Pancake Creek Moorings Program

Benthic Assessment, September 2019

Pancake Creek Moorings Program Benthic Assessment September 2019

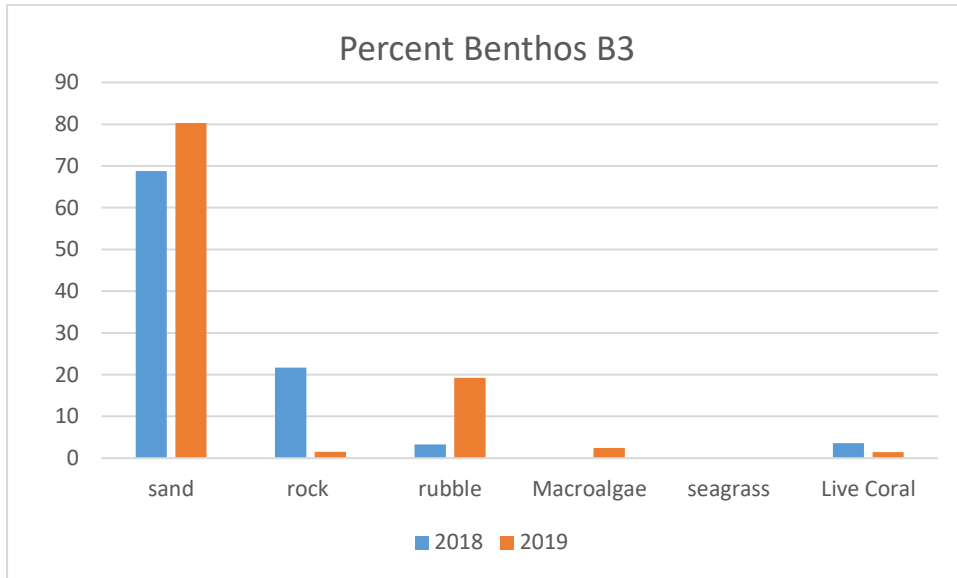
Mooring site B3 is located approximately 3 km upstream from the main entrance mouth of Pancake Creek. This site is a popular anchorage for yachts and powered vessels. In 2018 anchor damage to coral was observed along with rock that had been scoured of surface benthos. During the 2019 survey the substrate was dominated by sediment containing decaying bivalve shells. This sediment covered most of the previously exposed rock and sand sediments.

Figure 2 Graph showing the average percentage benthos cover at survey site B3, June 2018 and September 2019.

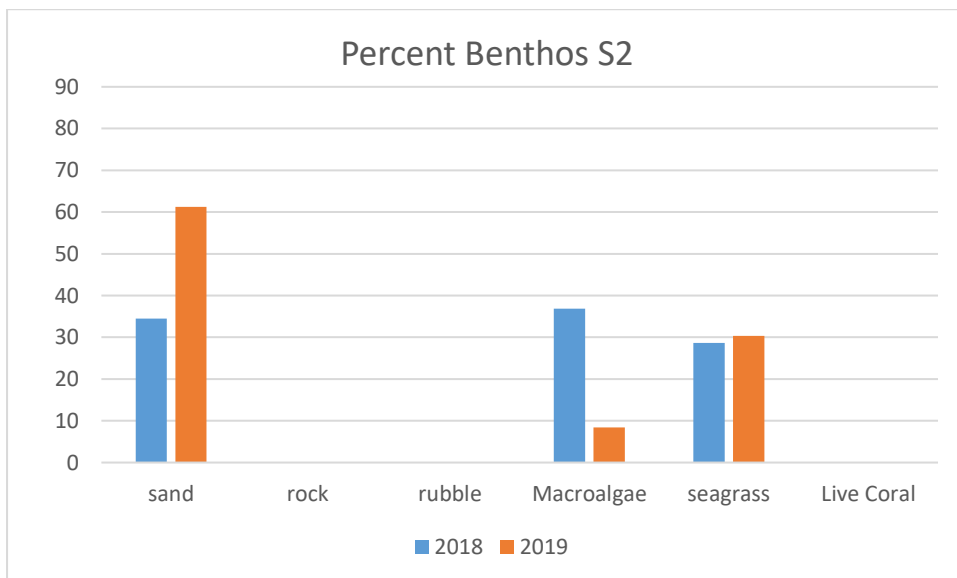
Figure 3 Graph showing the average percentage benthos cover at survey site S2, June 2018 and September 2019

Substrate conditions remain relatively similar to the previous year at S2. No anchor damage or disturbance to the seagrass beds were observed at the site. The most notable change was the reduction in macroalgae at the site (Figure 3). This reduction is likely due to the later survey period falling outside of the optimal growing period for the algae (post wet season). The increase in the sand cover is directly as a result of reduced macroalgae cover. There was an increase in the seagrass cover with 2 species of seagrass observed, *halophila decipiens* and *halophila ovalis* (Figure 8 & 9). Dense seagrass beds extend to the North and West of the site.

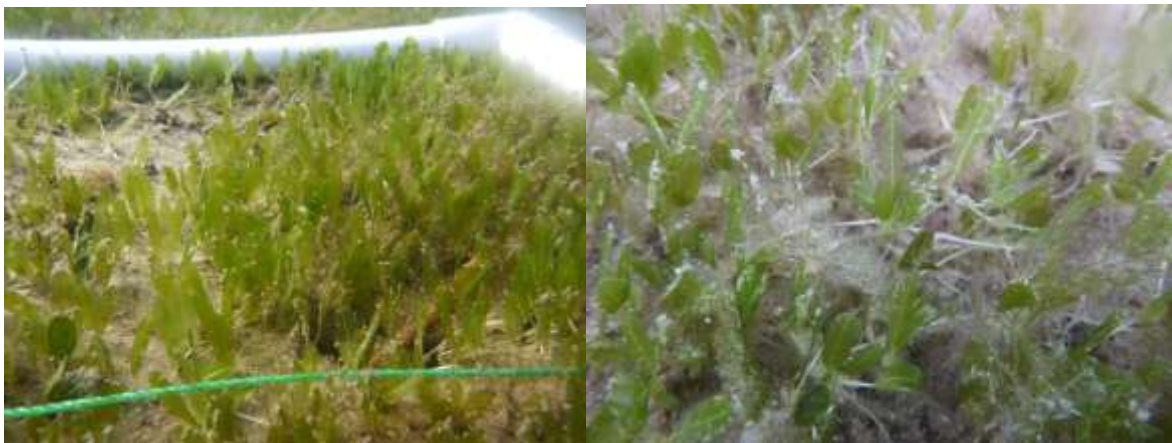
Figure 9 Image showing 2 species of seagrass near S2.
