Pancake Creek Moorings Program

Benthic Assessment, September 2019

Pancake Creek Moorings Program Benthic Assessment September 2019

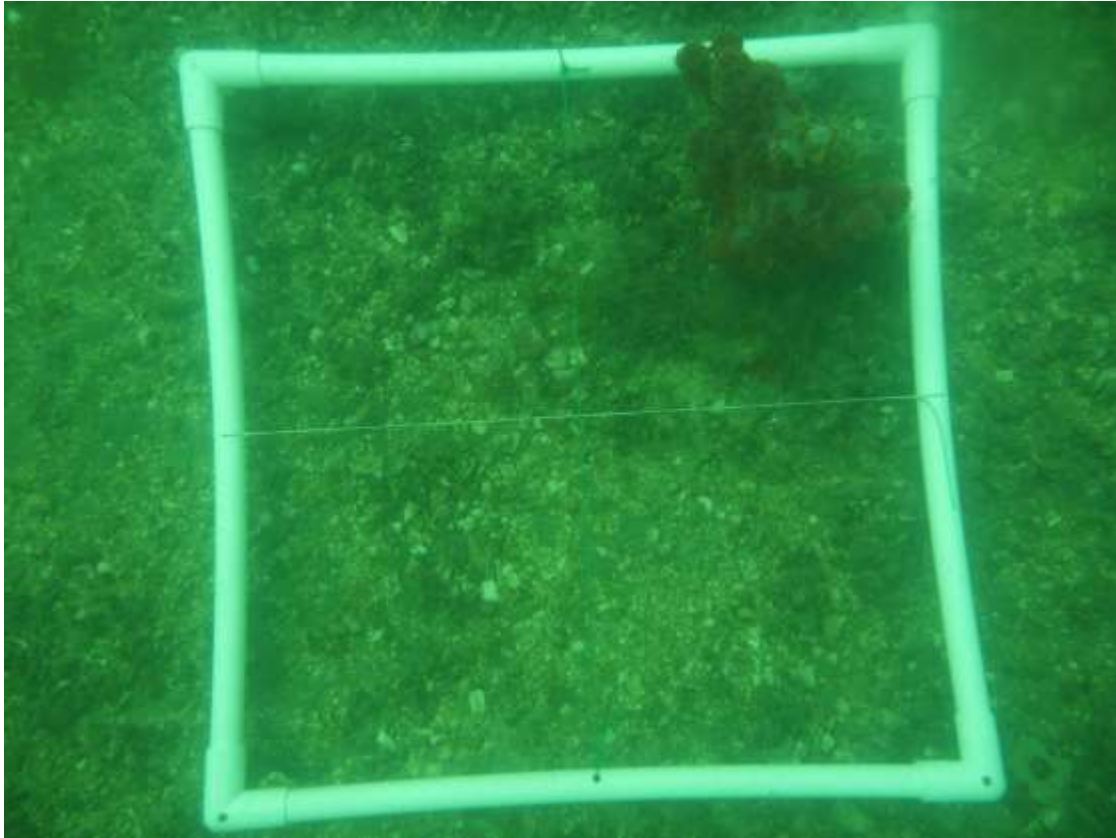
Figure 4 Image showing benthos cover (live coral) at Site B3.

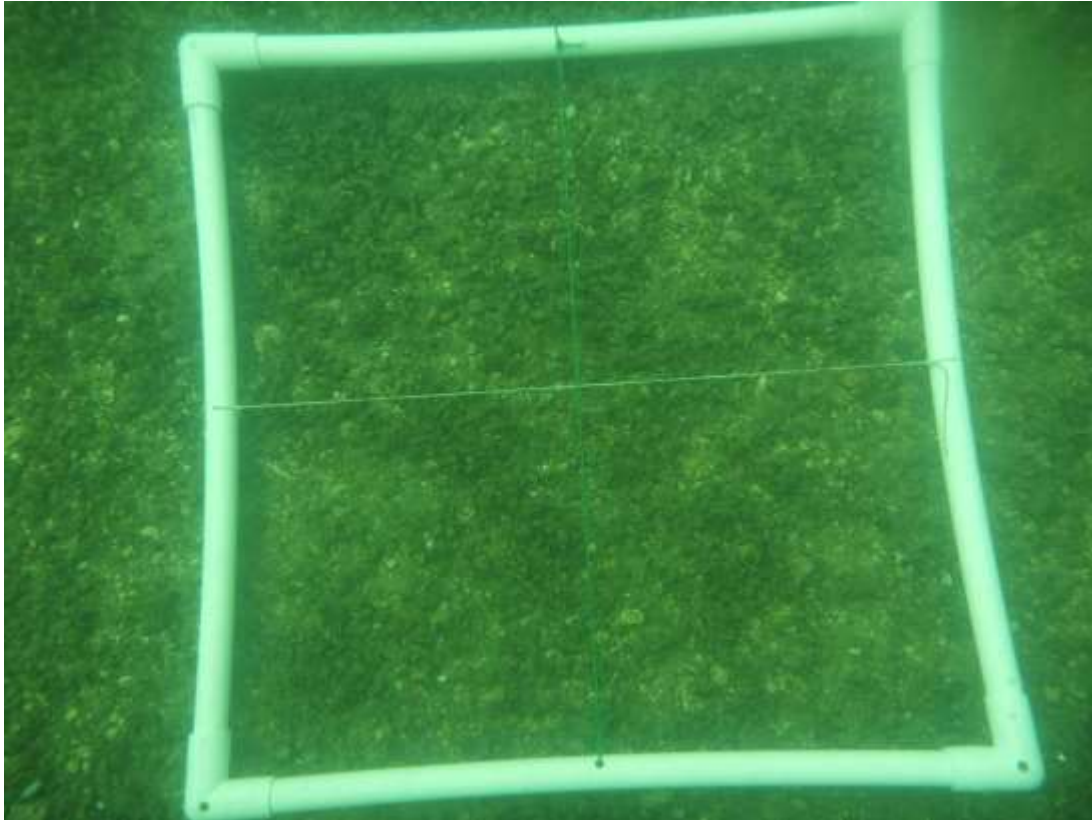
Figure 6 Images showing bivalve dominated substrate at Site B3.

The 2019 survey was conducted later in the year in September to allow for better visibility and the optimal timing for seagrass growth. There was no evidence of anchor damage or chain drag at site B3. During the survey it was noted that there had been a significant change in the substrate at site B3. The new substrate consisted of masses of deteriorating bivalve shells (Figure 6). The substrate observed in the previous survey was dominated by coarse sand (Figure 7). To fit the benthos classification the new substrate type was included under the sand category. The introduction of the new substrate is likely due to the dynamic nature of the creek system and has been shifted by tidal currents. Due to a smothering effect of the new substrate the benthos percentages (Figure 2) have changed with a reduction in rock substrate and to a lesser extent live coral cover. The lack of hard rock surface does reduce the potential for recruitment of coral. There were soft corals at the site (Figure 4) and observed in adjacent area outside the immediate survey area.

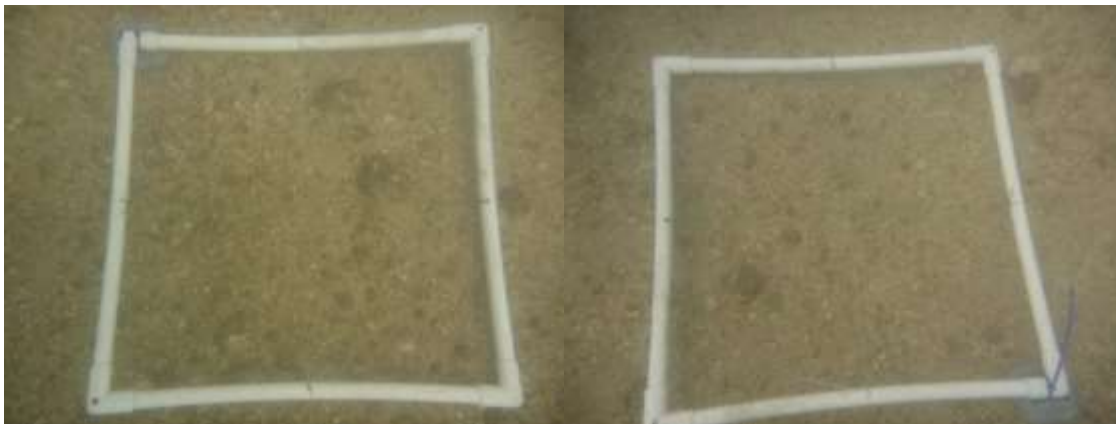
Figure 7 Images showing typical substrate from 2018 survey and at Site B3

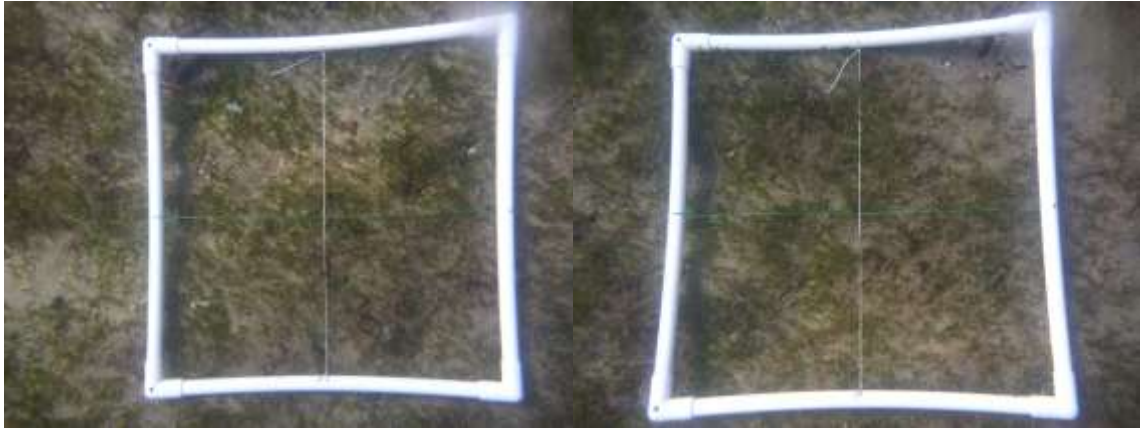
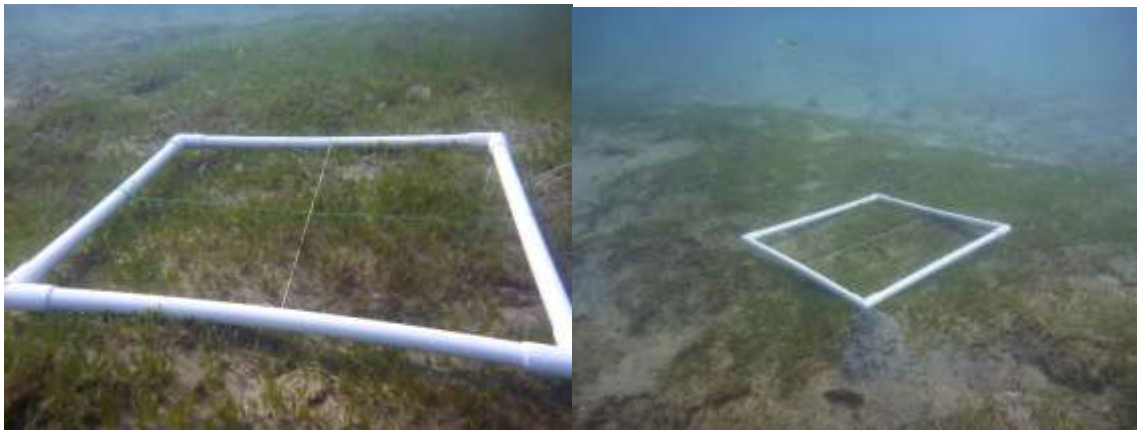
Figure 8 Images showing seagrass coverage at Site S2.

Substrate conditions remain relatively similar to the previous year at S2. No anchor damage or disturbance to the seagrass beds were observed at the site. The most notable change was the reduction in macroalgae at the site (Figure 3). This reduction is likely due to the later survey period falling outside of the optimal growing period for the algae (post wet season). The increase in the sand cover is directly as a result of reduced macroalgae cover. There was an increase in the seagrass cover with 2 species of seagrass observed, *halophila decipiens* and *halophila ovalis* (Figure 8 & 9). Dense seagrass beds extend to the North and West of the site.

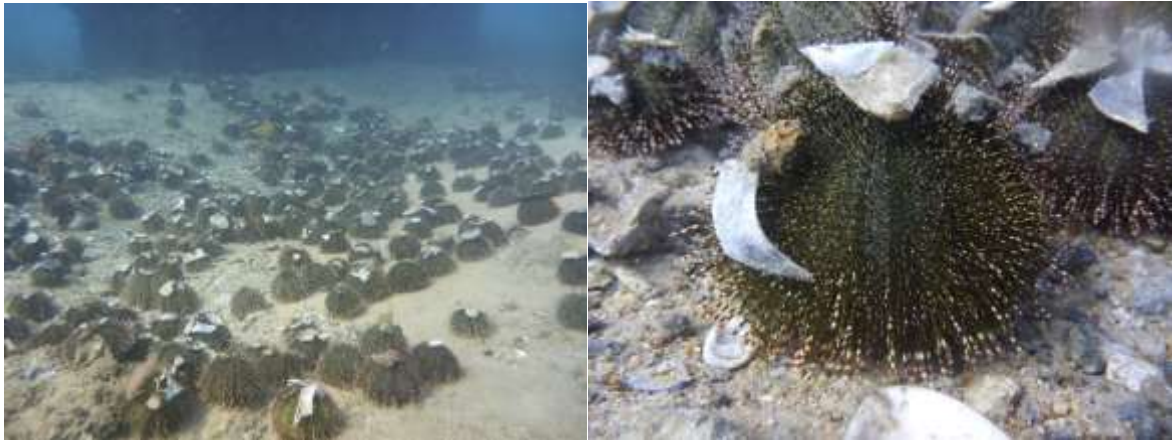
Figure 10 Image showing spawning aggregation of sea urchins near S2 Mooring.

A large spawning aggregation of sea urchins was observed around the mooring block at S2 (Figure 10). The proximity of the urchins to the block would indicate a preference for the habitat it provides. Other invertebrate species were also observed at the site including sponges, starfish and ascidians (Figure 11).
