Pancake Creek Moorings Program

Benthic Assessment, October 2020

Pancake Creek Moorings Program Benthic Assessment October 2020

Report to Queensland Parks and Wildlife and Gladstone Ports Corporation

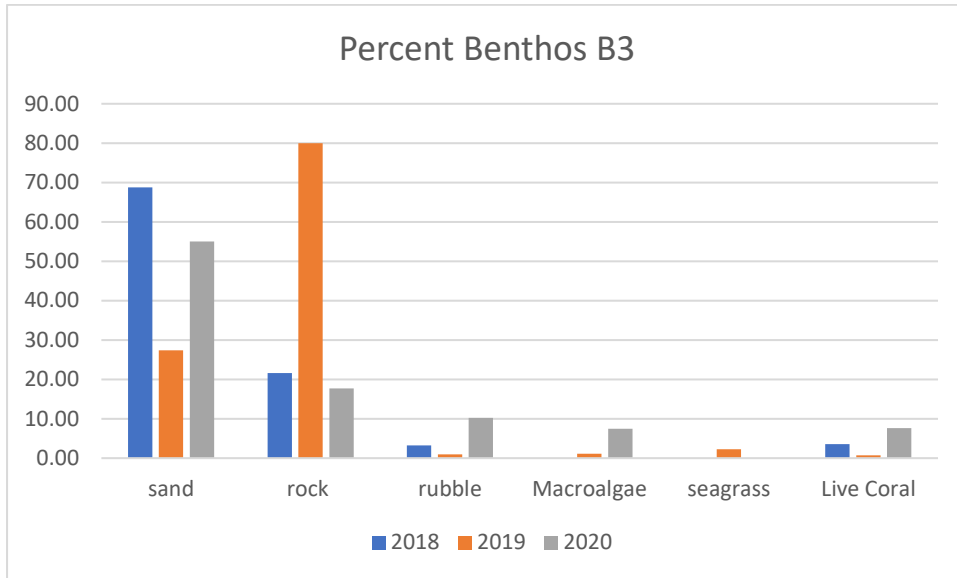
Figure 2 Graph showing the average percentage benthos cover at survey site B3, June 2018, September 2019 and October 2020.

An increase in sand at site B3 is likely indicative of the dynamic nature of the creek (figure 2). With large tidal currents moving substrate around the creek bed. Coral cover has increased at site B3. There is evidence of recruitment with small colonies of hard corals observed. This possibly indicates a recovery of the site however longer-term monitoring of the site would need to be undertaken to confirm this.

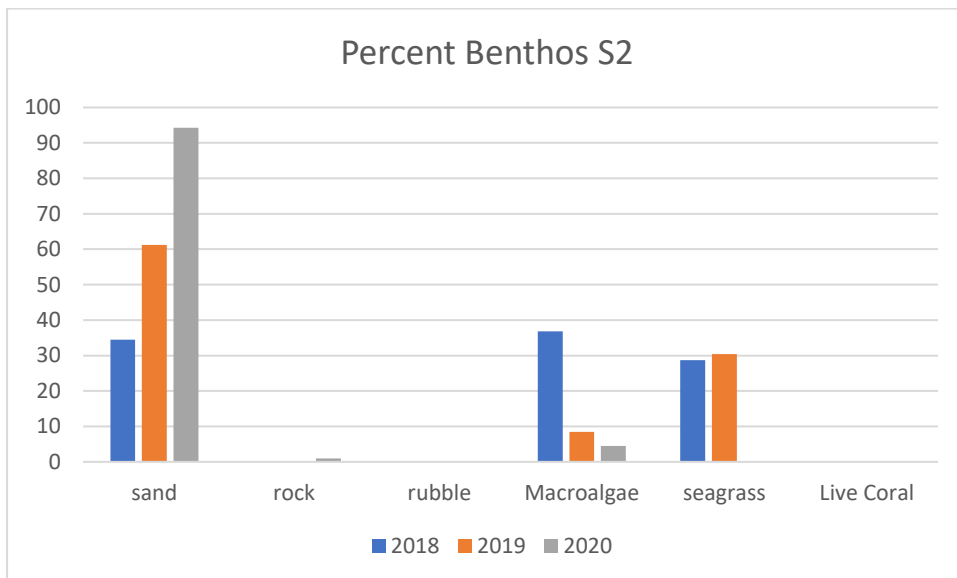
Figure 3 Graph showing the average percentage benthos cover at survey site S2, June 2018, September 2019 and October 2020.

There was a substantial decline in the seagrass coverage at site S2 (figure 3). Seagrass is seasonal and is driven largely by environmental driver like nutrients and turbidity. There was no seagrass and macroalgae observed adjacent to the site, indicating that it is likely a seasonal reduction in coverage. Seasonal monitoring would provide a great knowledge of seagrass health at the site. There were no obvious signs of anchor impacts at the site.

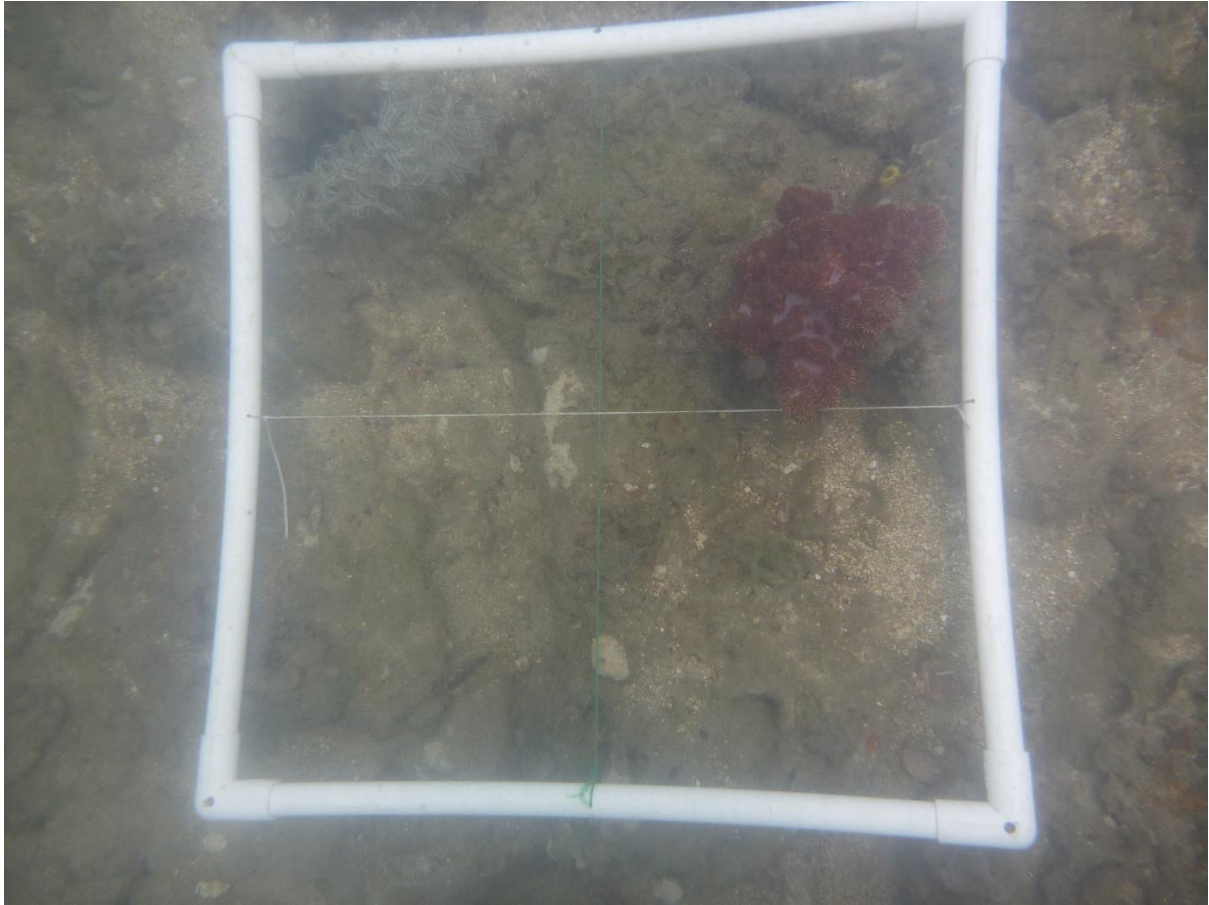
Figure 4 Image showing benthos cover (live coral) at Site B3 in October 2020.

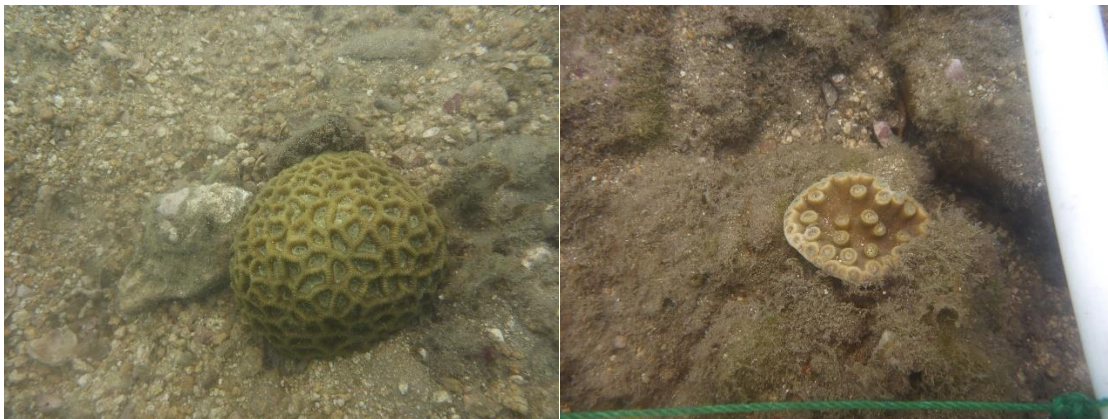
Figure 5 Images of coral species at site B3 in October 2020.

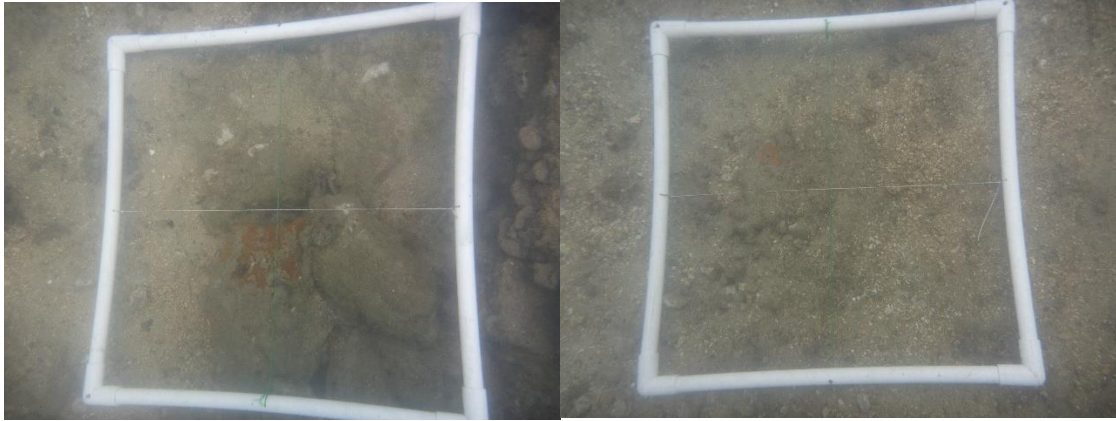
Figure 6 Images showing examples of substrate at site B3 in October 2020.

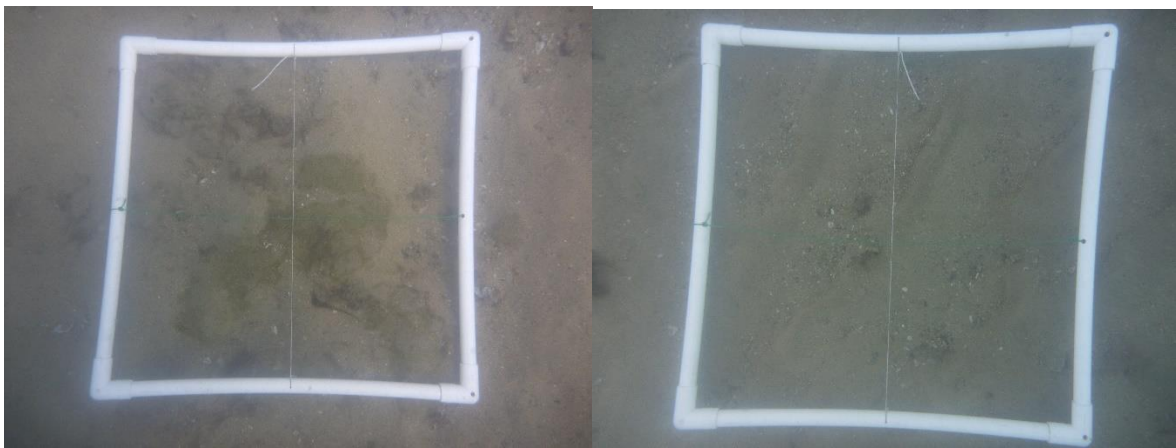
Figure 7 Images showing examples of substrate at site S2 in October 2020.

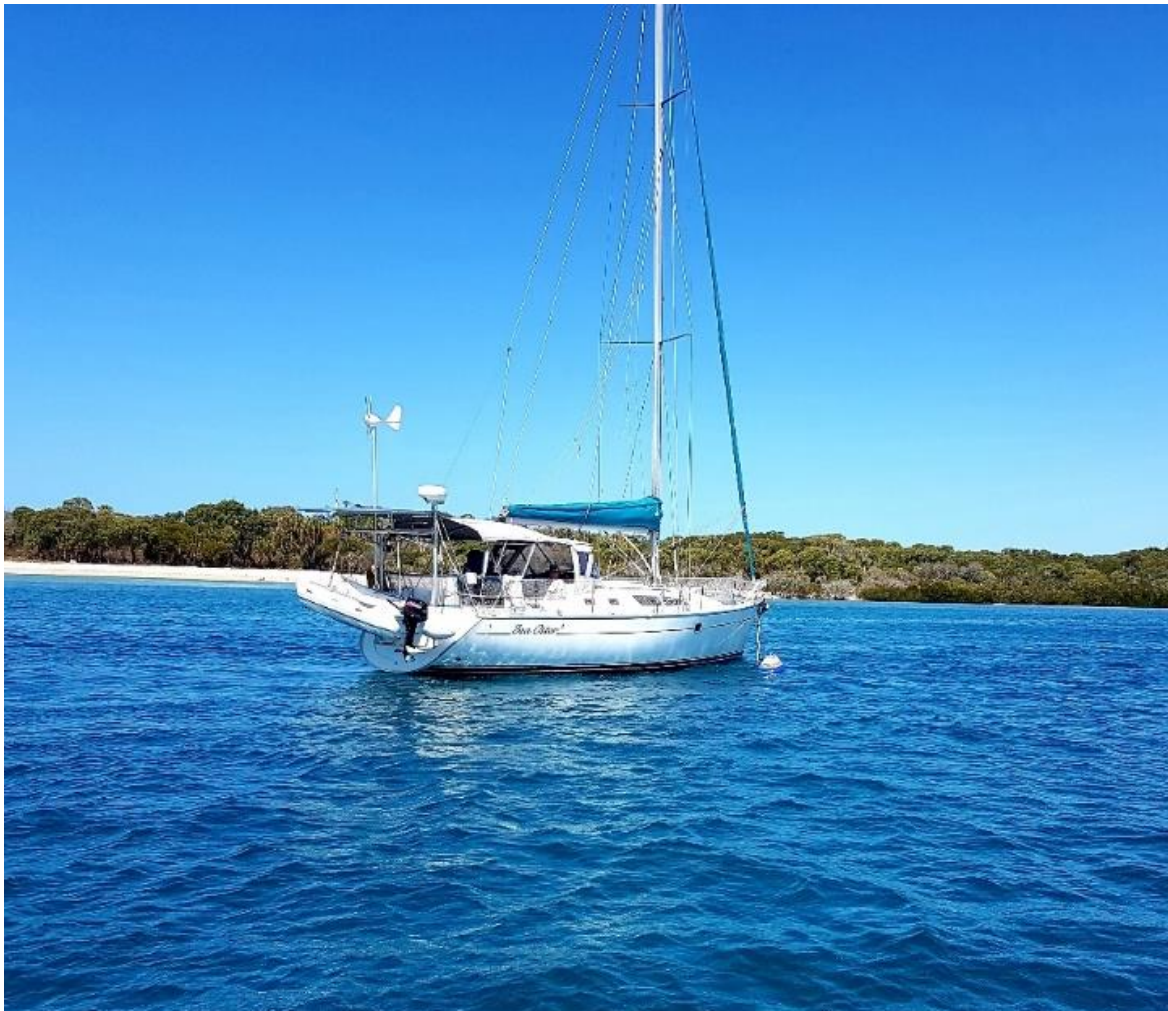
Figure 8 Image of vessel on mooring B2 in Pancake Creek 8 October 2020
