Prioritisation of Reef Restoration and Enhancement Site Selection – Phase 2 and 3 Report

Reference: R.B20731.002.05.Phase 2 & 3.docx
Date: December 2015

This report has been produced for Gladstone Ports Corporation's Biodiversity Offset Strategy. The study was undertaken through a Consultancy Agreement (CA140017) between Gladstone Ports Corporation and BMT WBM to assess and prioritise sites for coral restoration and enhancement.

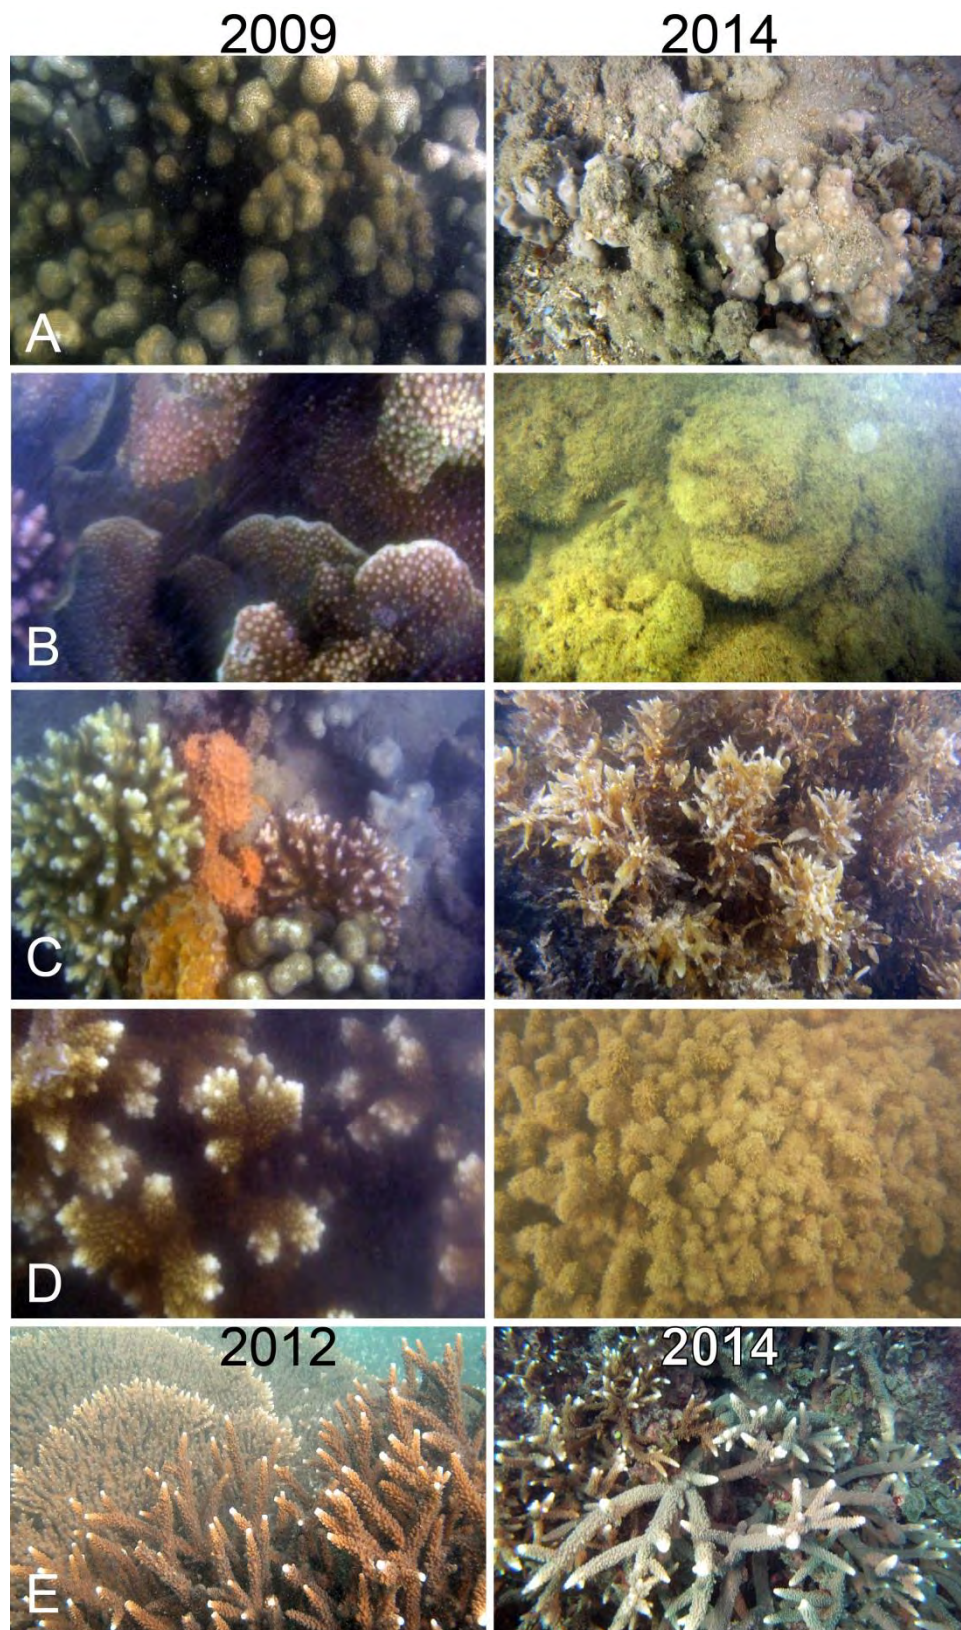
Figure 3-3 Photographic examples of changes in condition between 2009 and 2014: (A) Oaks Reef a.k.a. Facing Island #2; (B) Bushy Island; (C) Rat Island South; (D) Manning Reef; (E) Sable Chief Rocks Reef

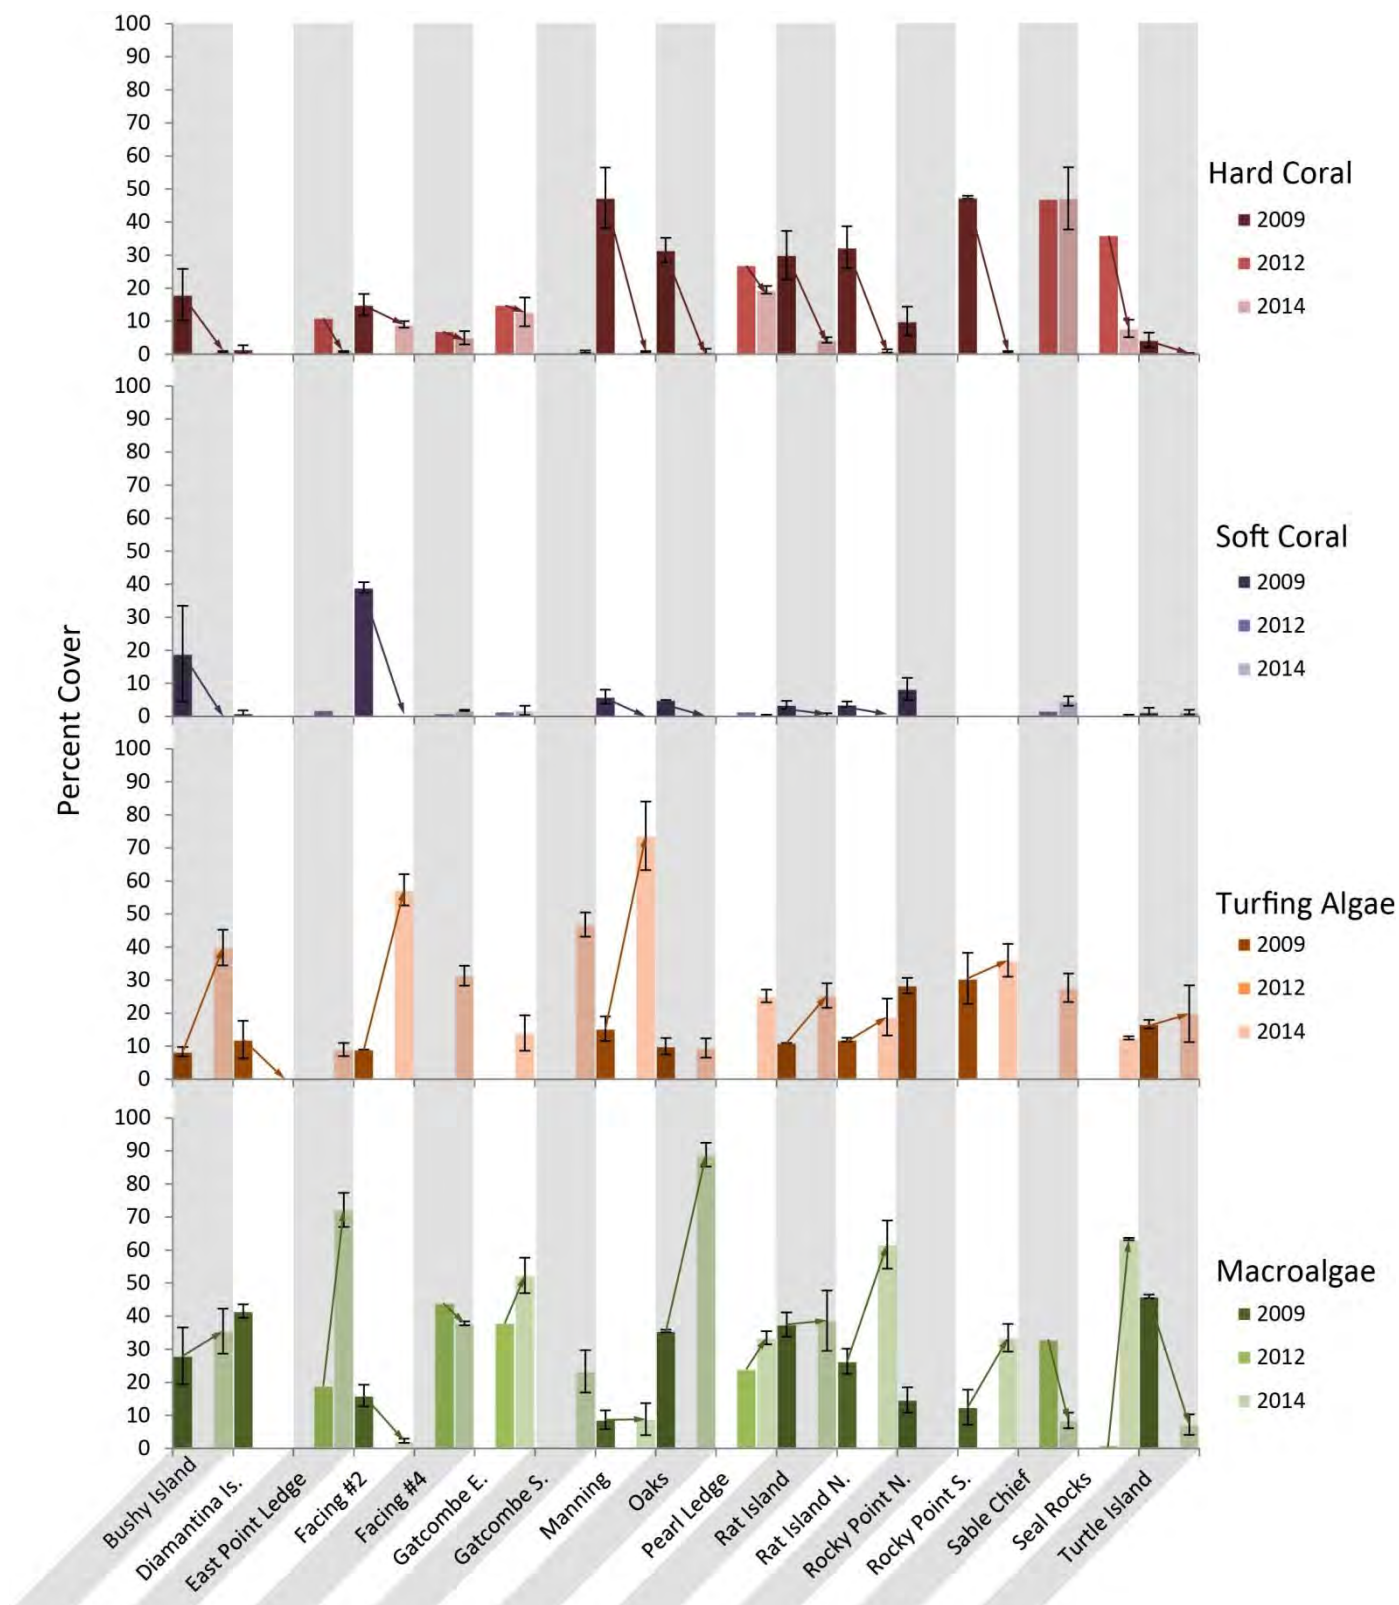
Figure 3-4 Changes in mean (\pm SE) percent cover for hard coral, soft coral, turfing algae and macroalgae. Means without error bars for Facing Island sites in 2012 have been estimated from Sea Research (2012), and Seal Rocks 2012 data is from GBRMPA (2013)

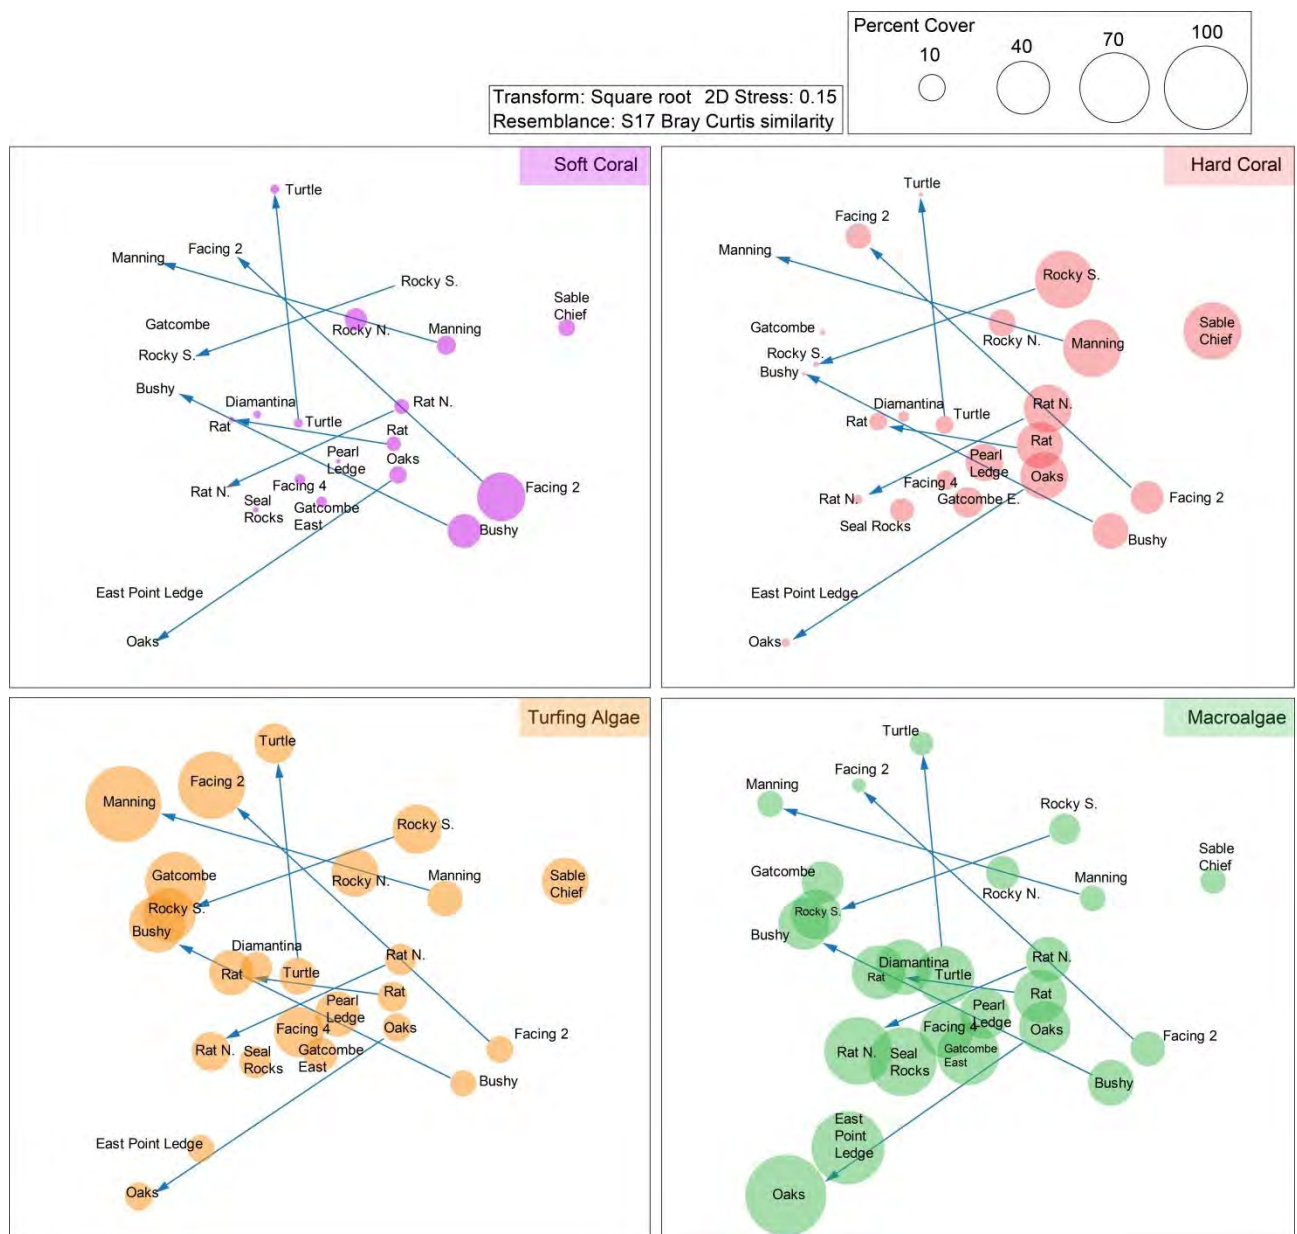
Note: Bubble size indicates relative percent cover for soft coral, hard coral, turfing algae, and macroalgae. Arrows indicate the direction of change between 2009 and 2012, sites without arrows were sampled in 2014 only

Figure 3-5 nMDS ordination of site-averaged benthic community data, based on square root transformed Bray-Curtis similarities

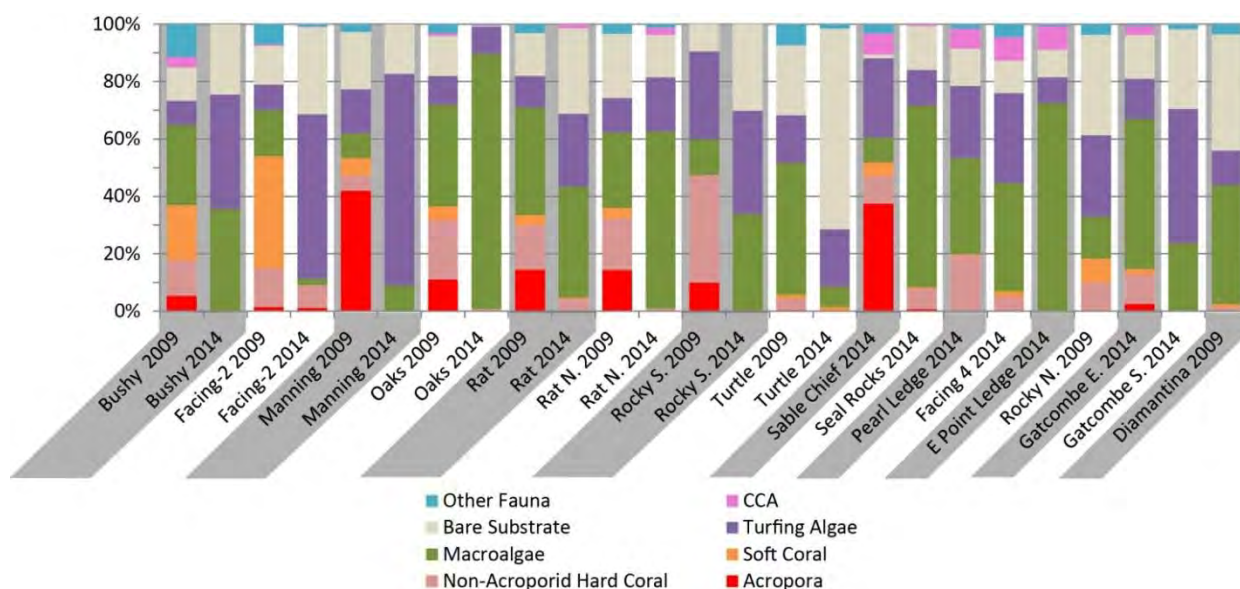
Figure 3-6 Percent cover of all major cover types

Changes in all major cover types are shown in Figure 3-6. Acroporid corals were lost completely between 2009 and 2014 at Bushy Island, Manning Reef, Rat Reef and Rocky Point South. Hard coral communities at Bushy Island, Manning and Oaks reefs consisted only of *Porites*; other genera such as *Turbinaria*, *Pocillopora*, *Goniopora*, and *Favites* which were common in 2009 were not observed in 2014.

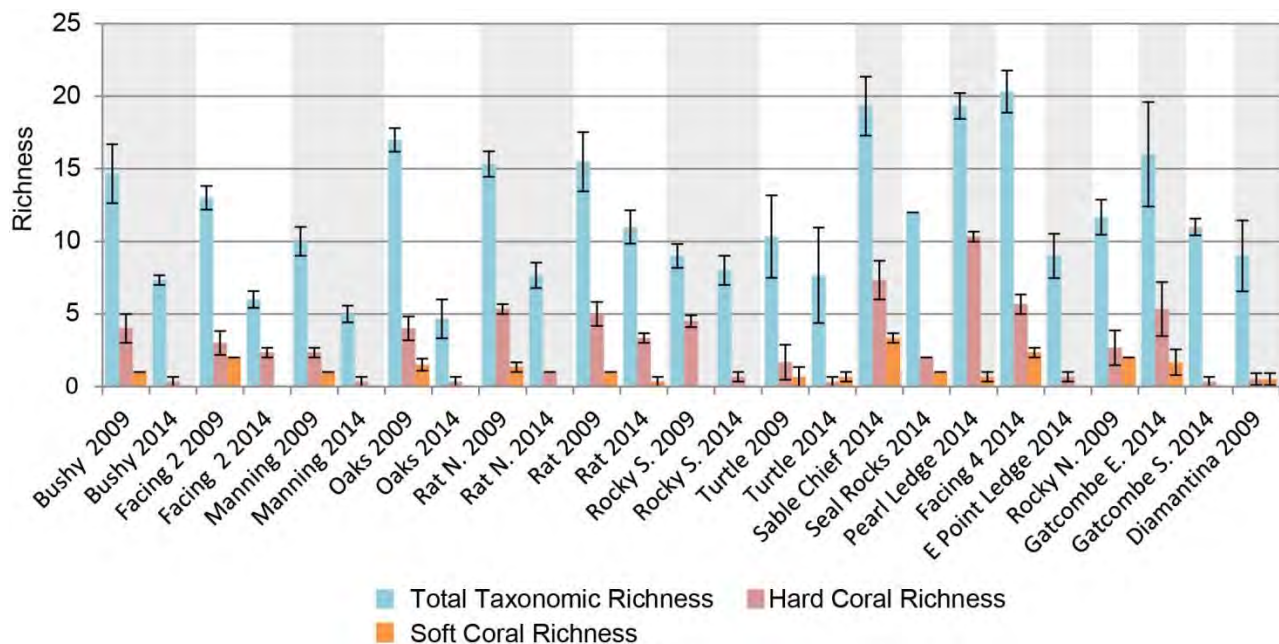
Figure 3-7 Changes in mean (\pm SE) total, hard coral, and soft coral richness between sites visited in 2009 and 2014.

Reductions in cover and species richness between 2009 and 2014 were not restricted to hard corals; total richness and the richness of soft corals also declined over this period (Figure 3-7). No soft coral taxa were recorded at Bushy Island, Manning, Oaks and Rat reefs in 2014, despite 1-2 taxa consistently recorded at those locations in 2009.

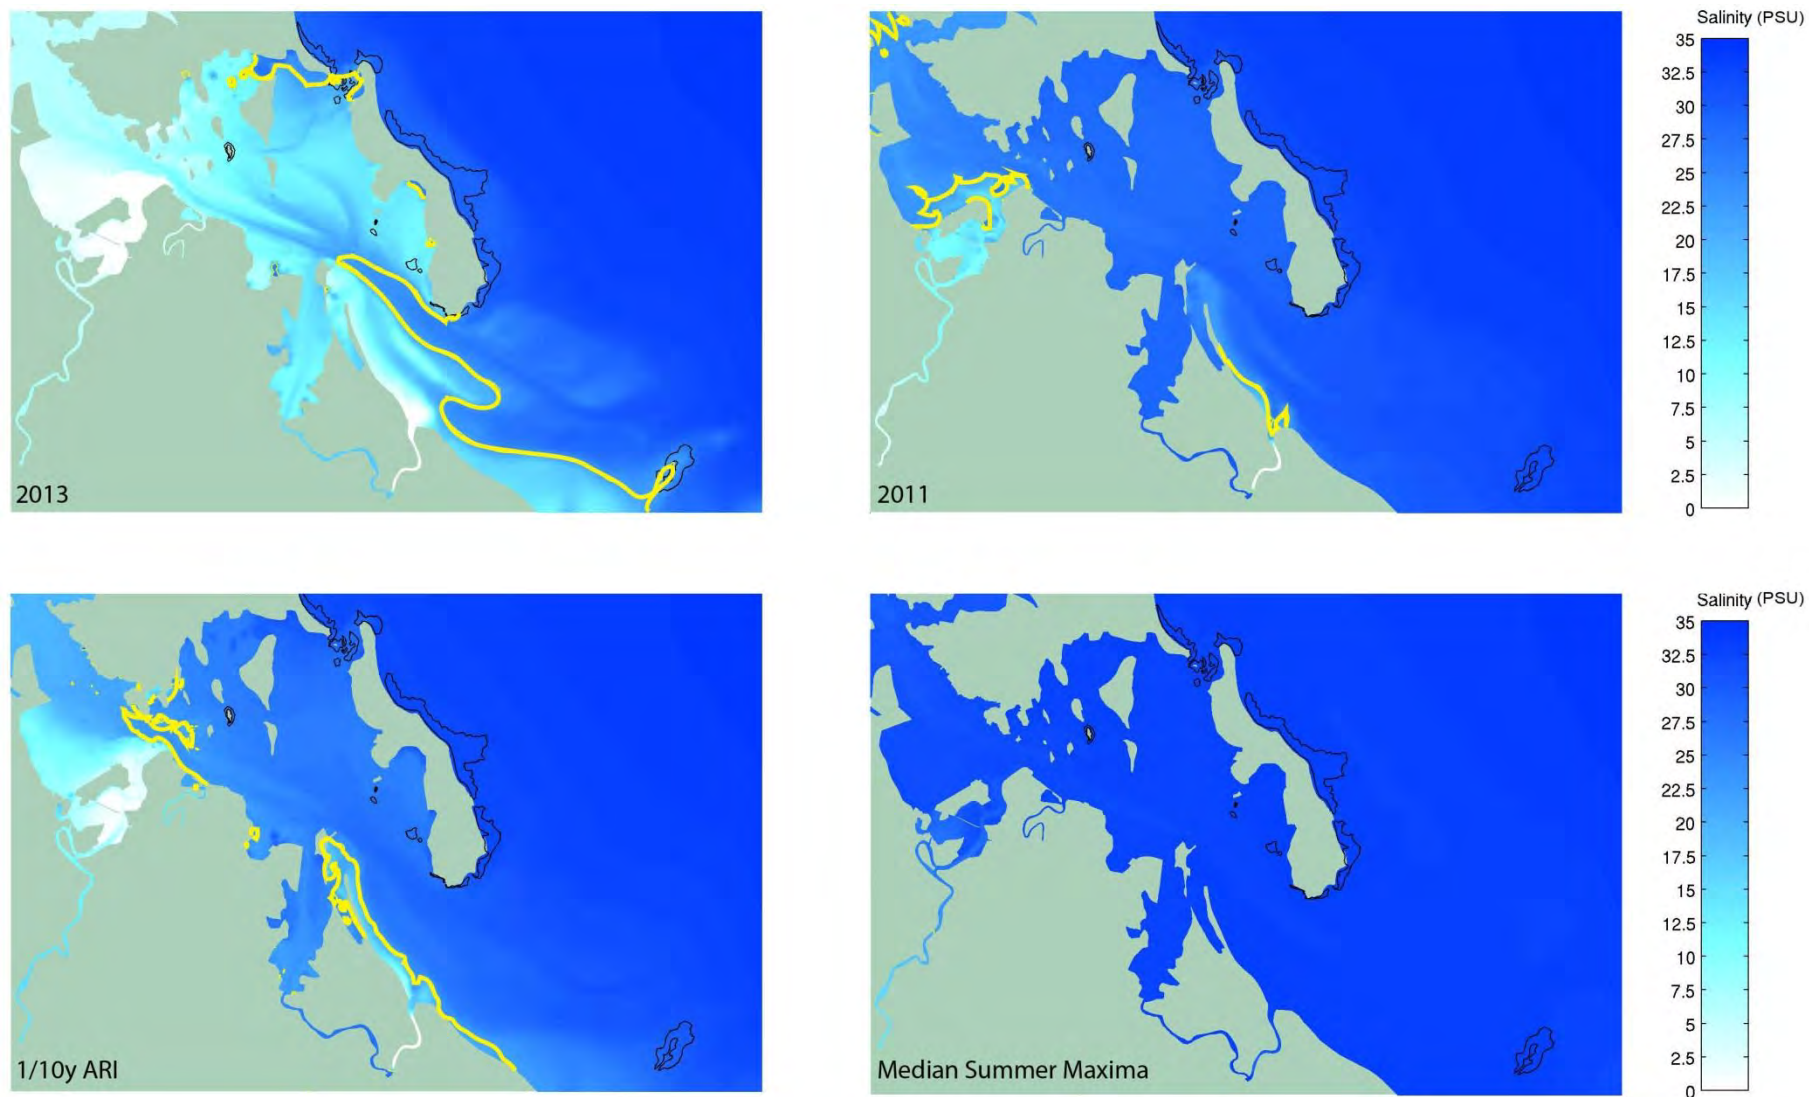
Figure 4-1 5th percentile salinity under various rainfall scenarios; a yellow line shows where salinity was < 22 PSU for 1.5 days

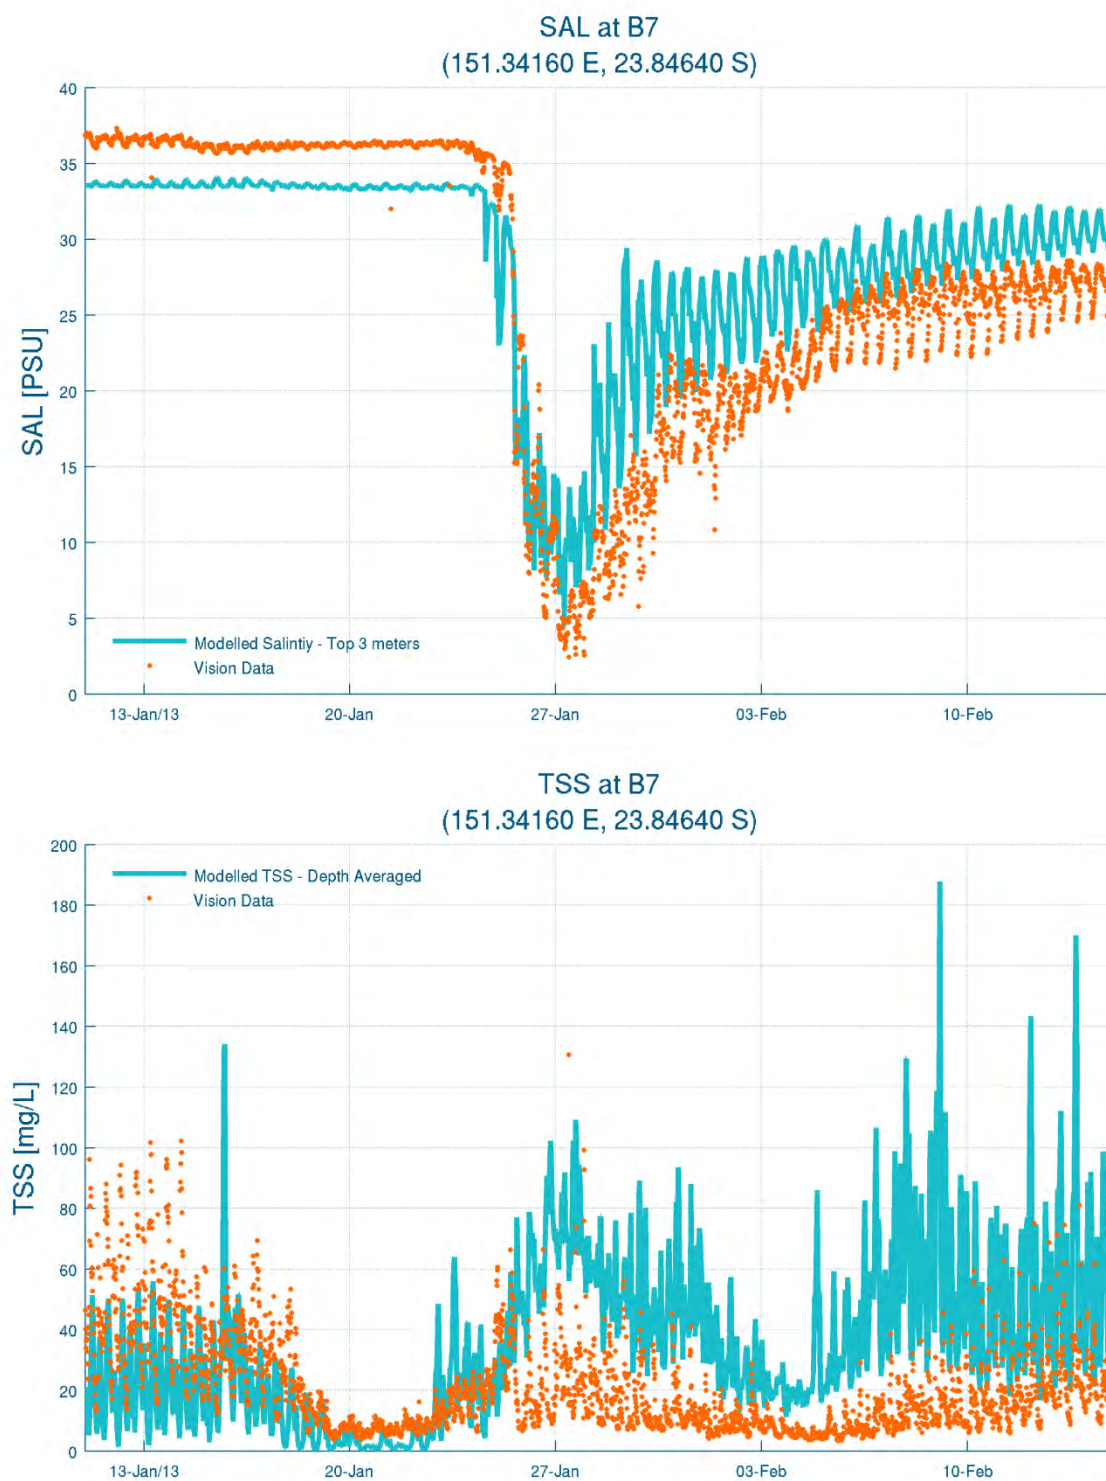
Figure 4-2 TSS and Salinity Calibration at Site B7

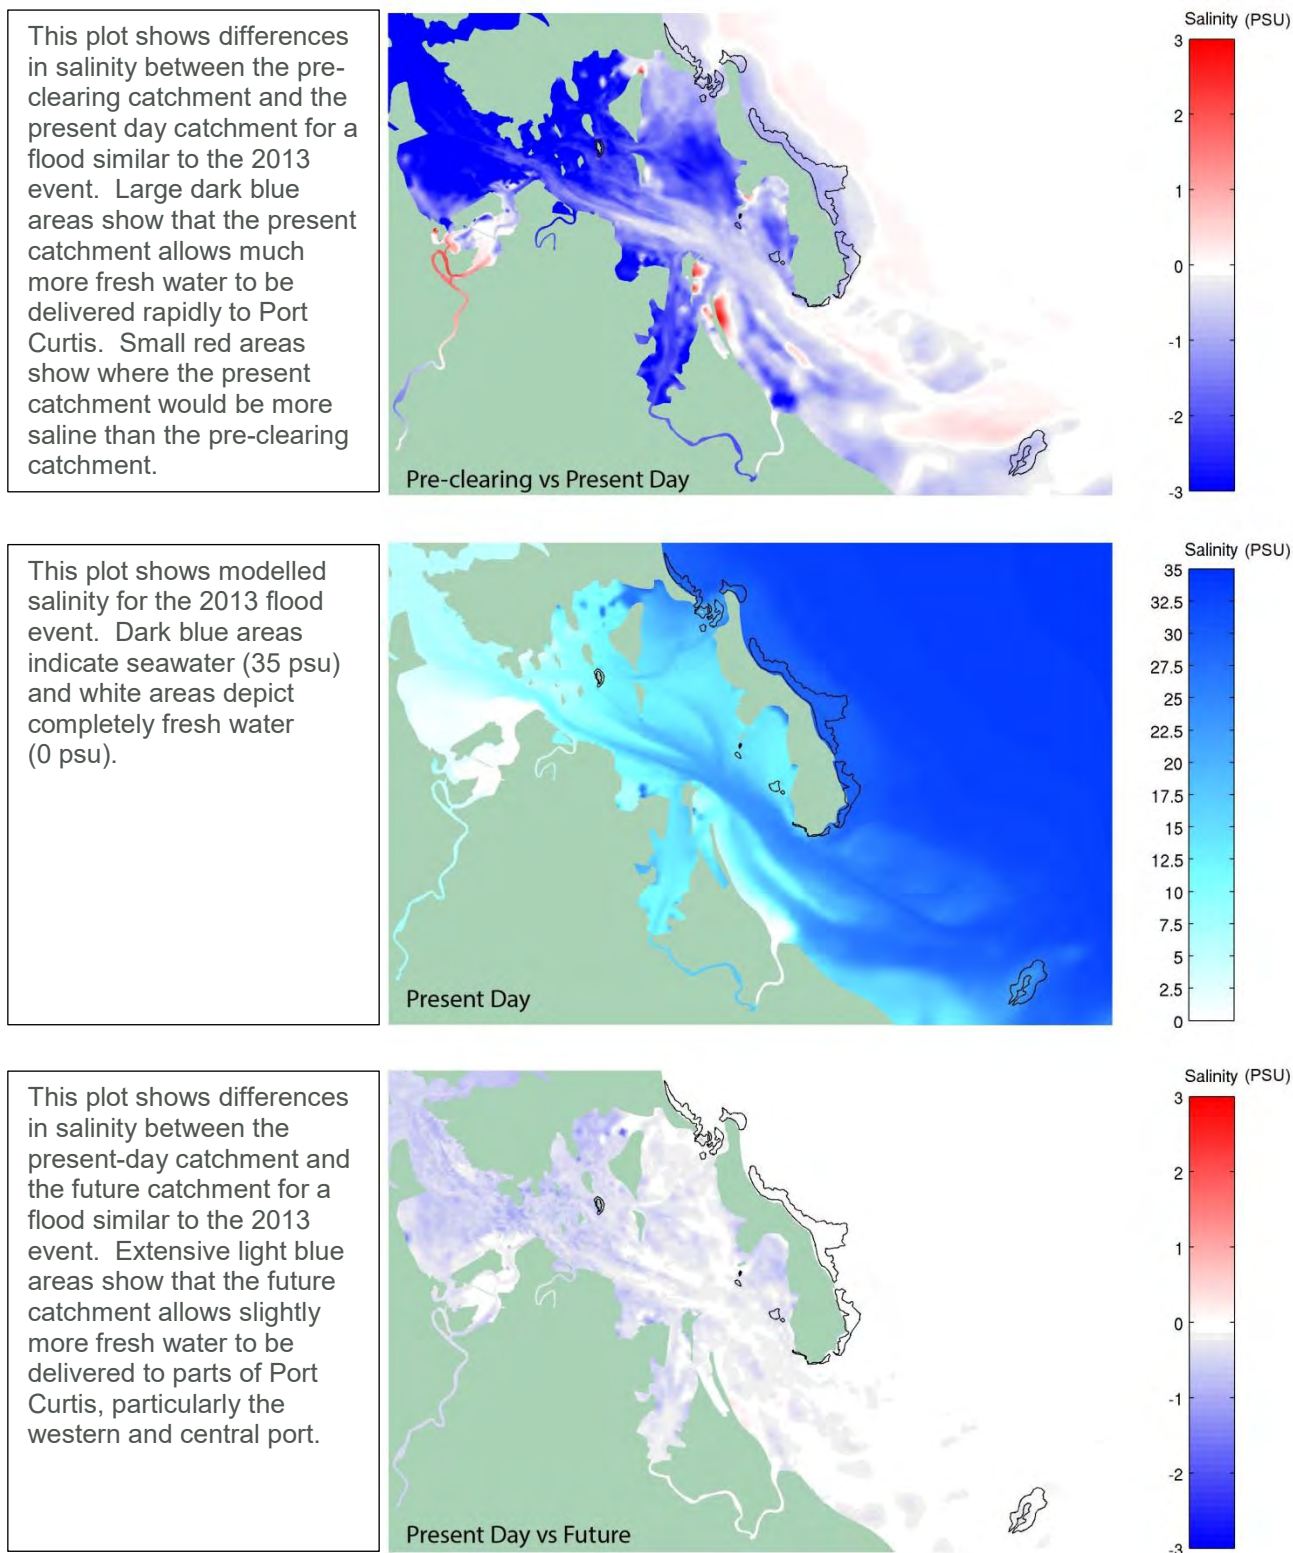
Figure 4-3 Plots showing modelled 5th percentile salinity from the 2013 flood event: differences between the past (pre-clearing) and present catchment (top); the present catchment in the 2013 flood (middle); and differences between present catchment and the future catchment (bottom)

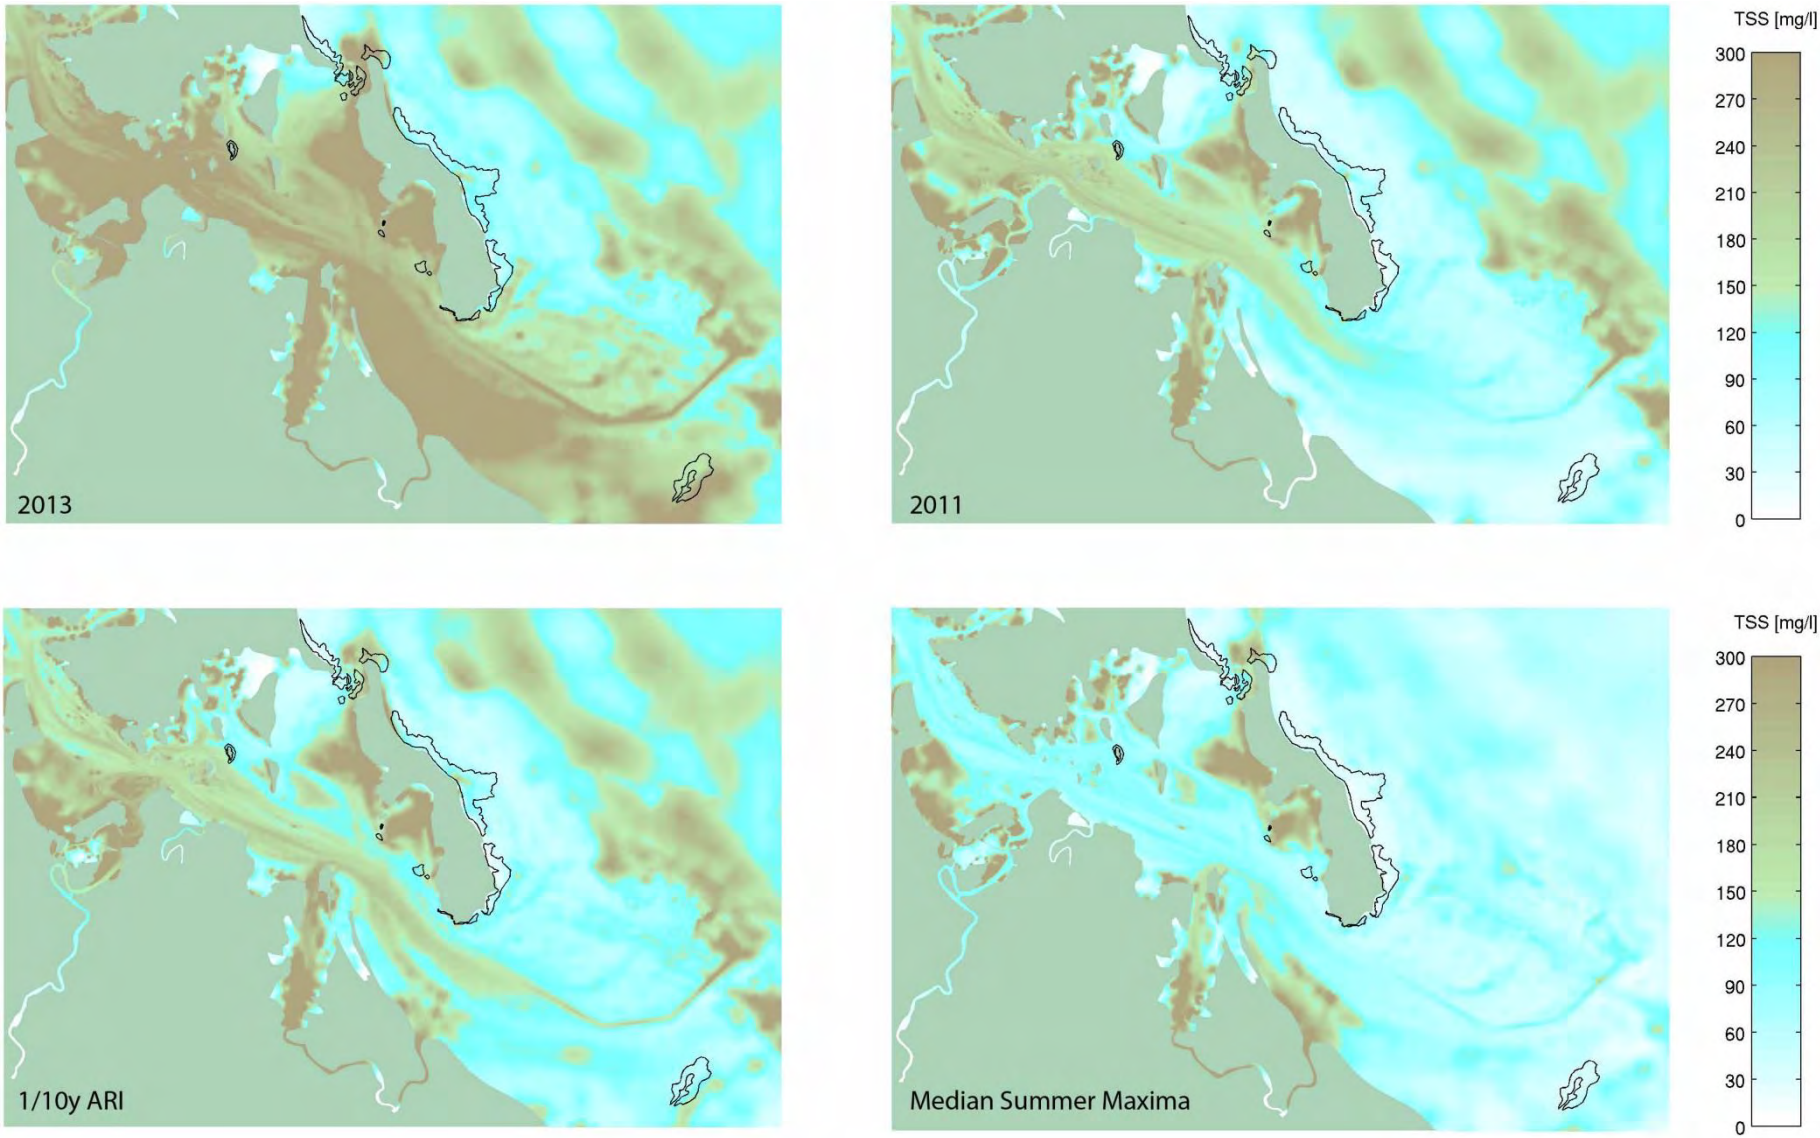
Figure 4-4 95th percentile TSS under various rainfall scenarios

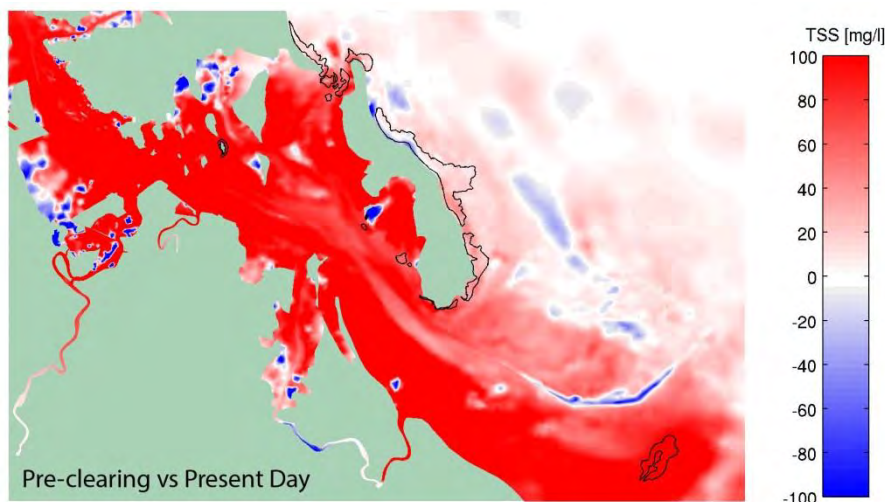
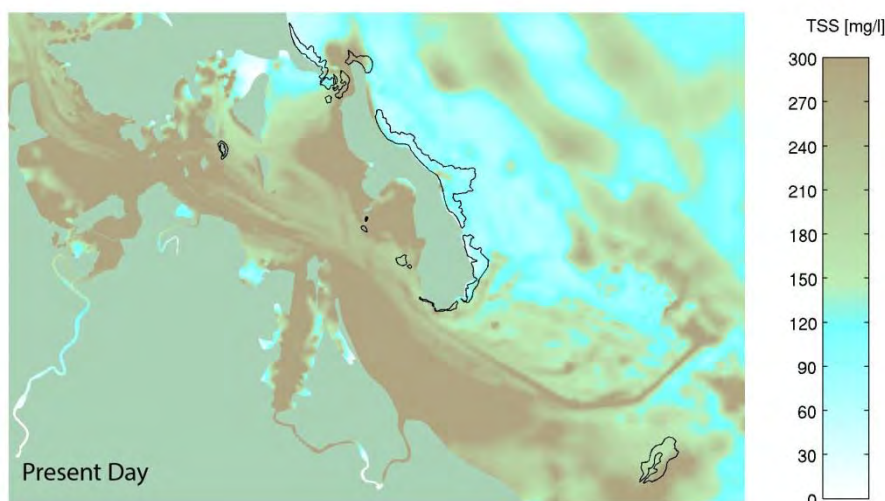
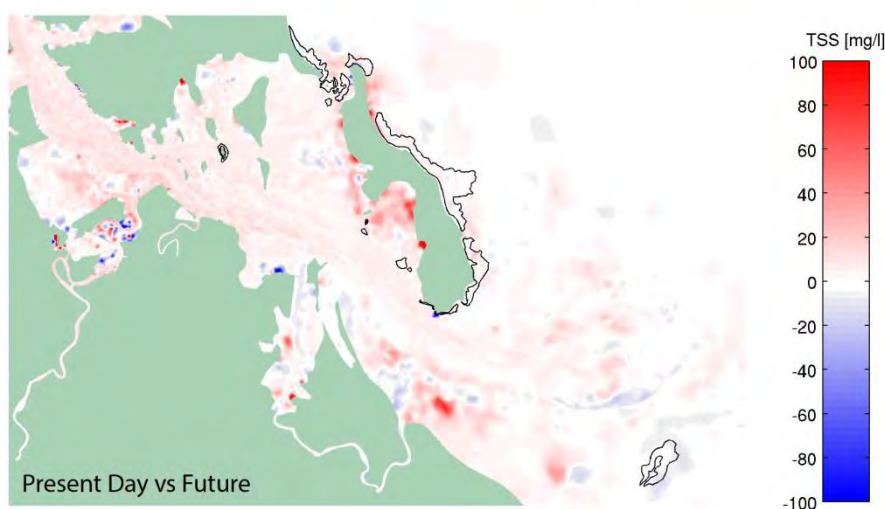
This plot shows differences in TSS between the pre-clearing catchment and the present day catchment for a flood similar to the 2013 event. Large dark-red areas show that the present catchment allows much more TSS to be delivered rapidly to Port Curtis. Small blue areas show where the present catchment would have less TSS than the pre-clearing catchment.

This plot shows modelled TSS for the 2013 flood event. Brown areas indicate heavy TSS loads (300 mg/L) and white areas depict completely clear water (0 mg/L).

This plot shows differences in TSS between the present-day and future catchments for a flood similar to the 2013 event. Extensive light-red areas show that the future catchment will result in slightly more TSS to be delivered to Port Curtis. Small blue areas show where the future catchment would have less TSS than the present day catchment.

Figure 4-5 Plots showing modelled 5th percentile TSS from the 2013 flood event: differences between the past (pre-clearing) and present catchment (top); the present catchment in the 2013 flood (middle); and differences between present catchment and the future catchment (bottom)

Changes in the catchment show that vegetation clearing to present has had an enormous impact on the concentration of TSS entering Port Curtis during major events such as the 2013 flood (Figure 4-5). While these changes have been most pronounced west of Facing Island and in Rodds Bay, they have also resulted in significant (~20 mg/L) changes at the reefs along the eastern shores of Facing Island. Changes to the catchment in the future scenario would generally result in increased peak TSS loads of between 20-40 mg/L for an event such as the 2013 flood. The areas west of Facing Island and south of Gatcombe Head would see the greatest increases in TSS.

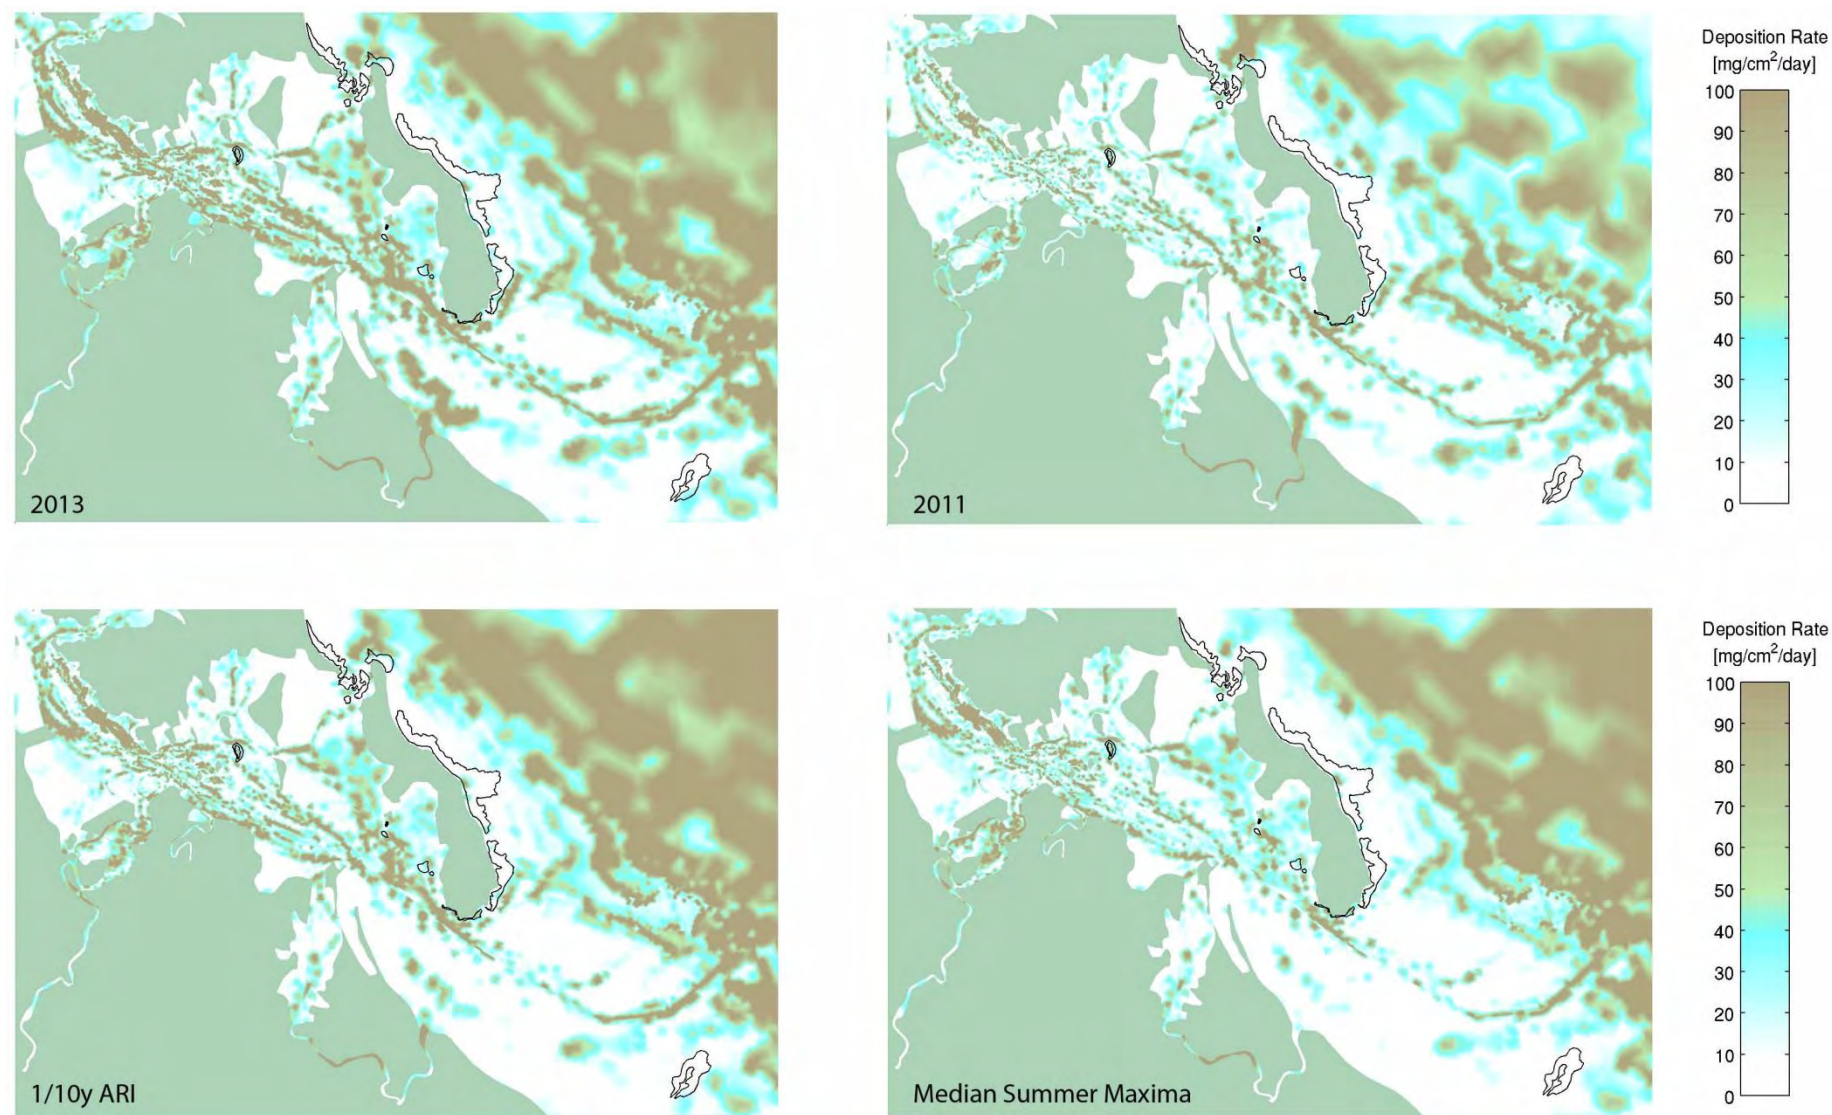
Figure 4-6 95th percentile deposition rate under various rainfall scenarios

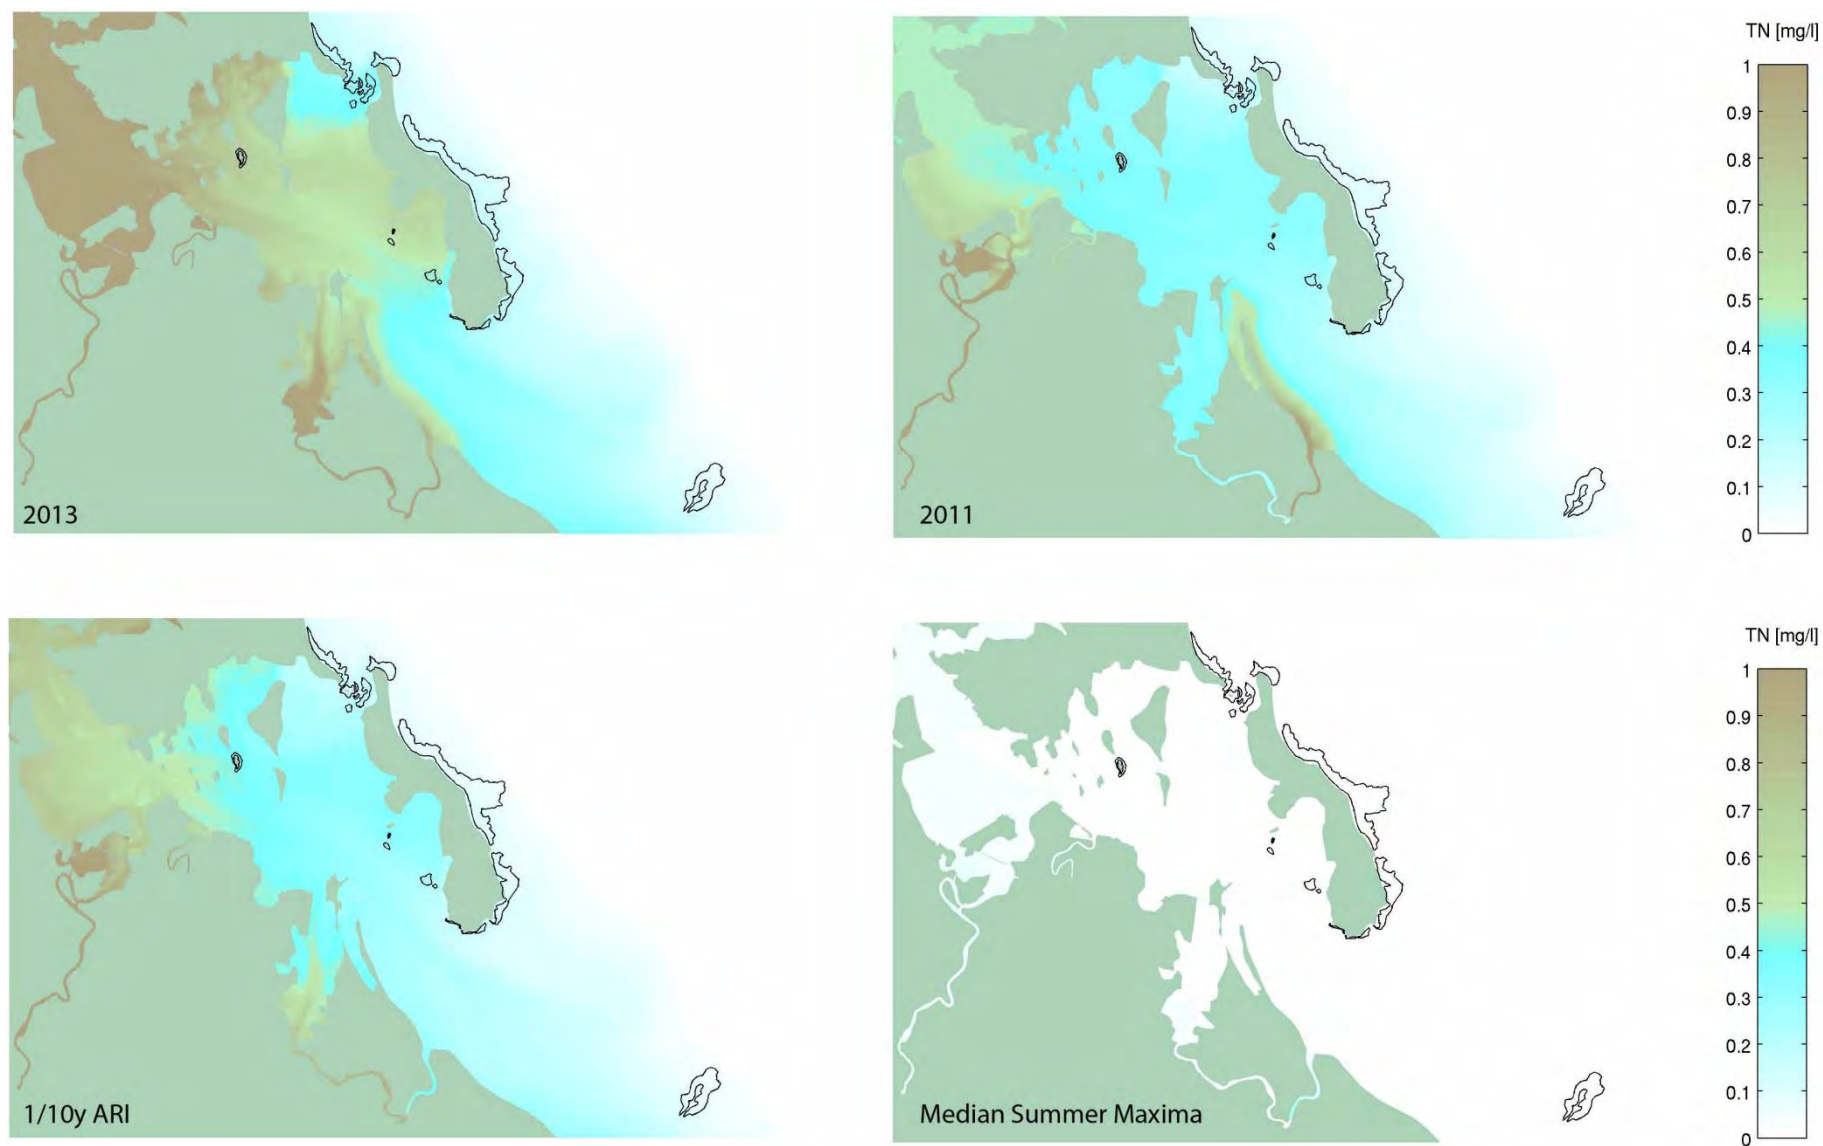
Figure 4-7 50th percentile TN under various rainfall scenarios
