Prioritisation of Reef Restoration and Enhancement Site Selection – Phase 2 and 3 Report

Reference: R.B20731.002.05.Phase 2 & 3.docx
Date: December 2015

This report has been produced for Gladstone Ports Corporation's Biodiversity Offset Strategy. The study was undertaken through a Consultancy Agreement (CA140017) between Gladstone Ports Corporation and BMT WBM to assess and prioritise sites for coral restoration and enhancement.

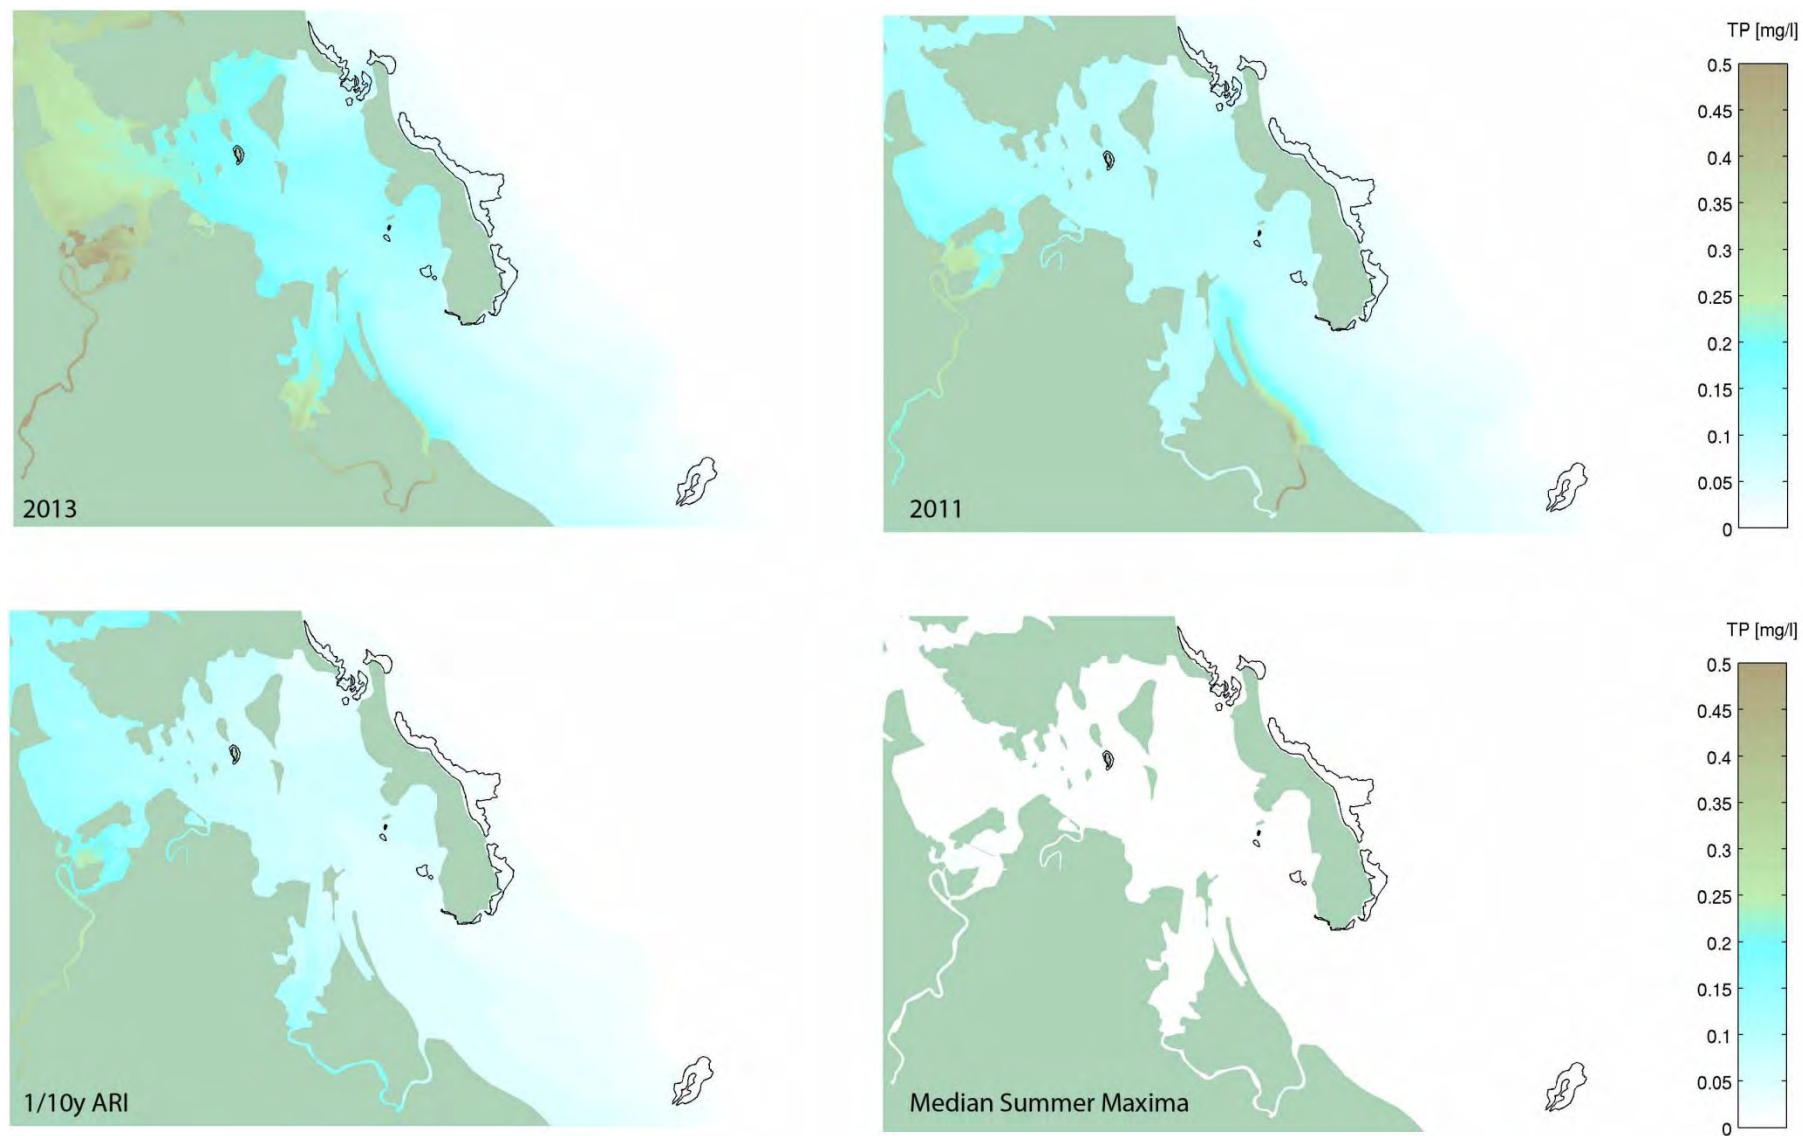
Figure 4-8 50th percentile TP under various rainfall scenarios

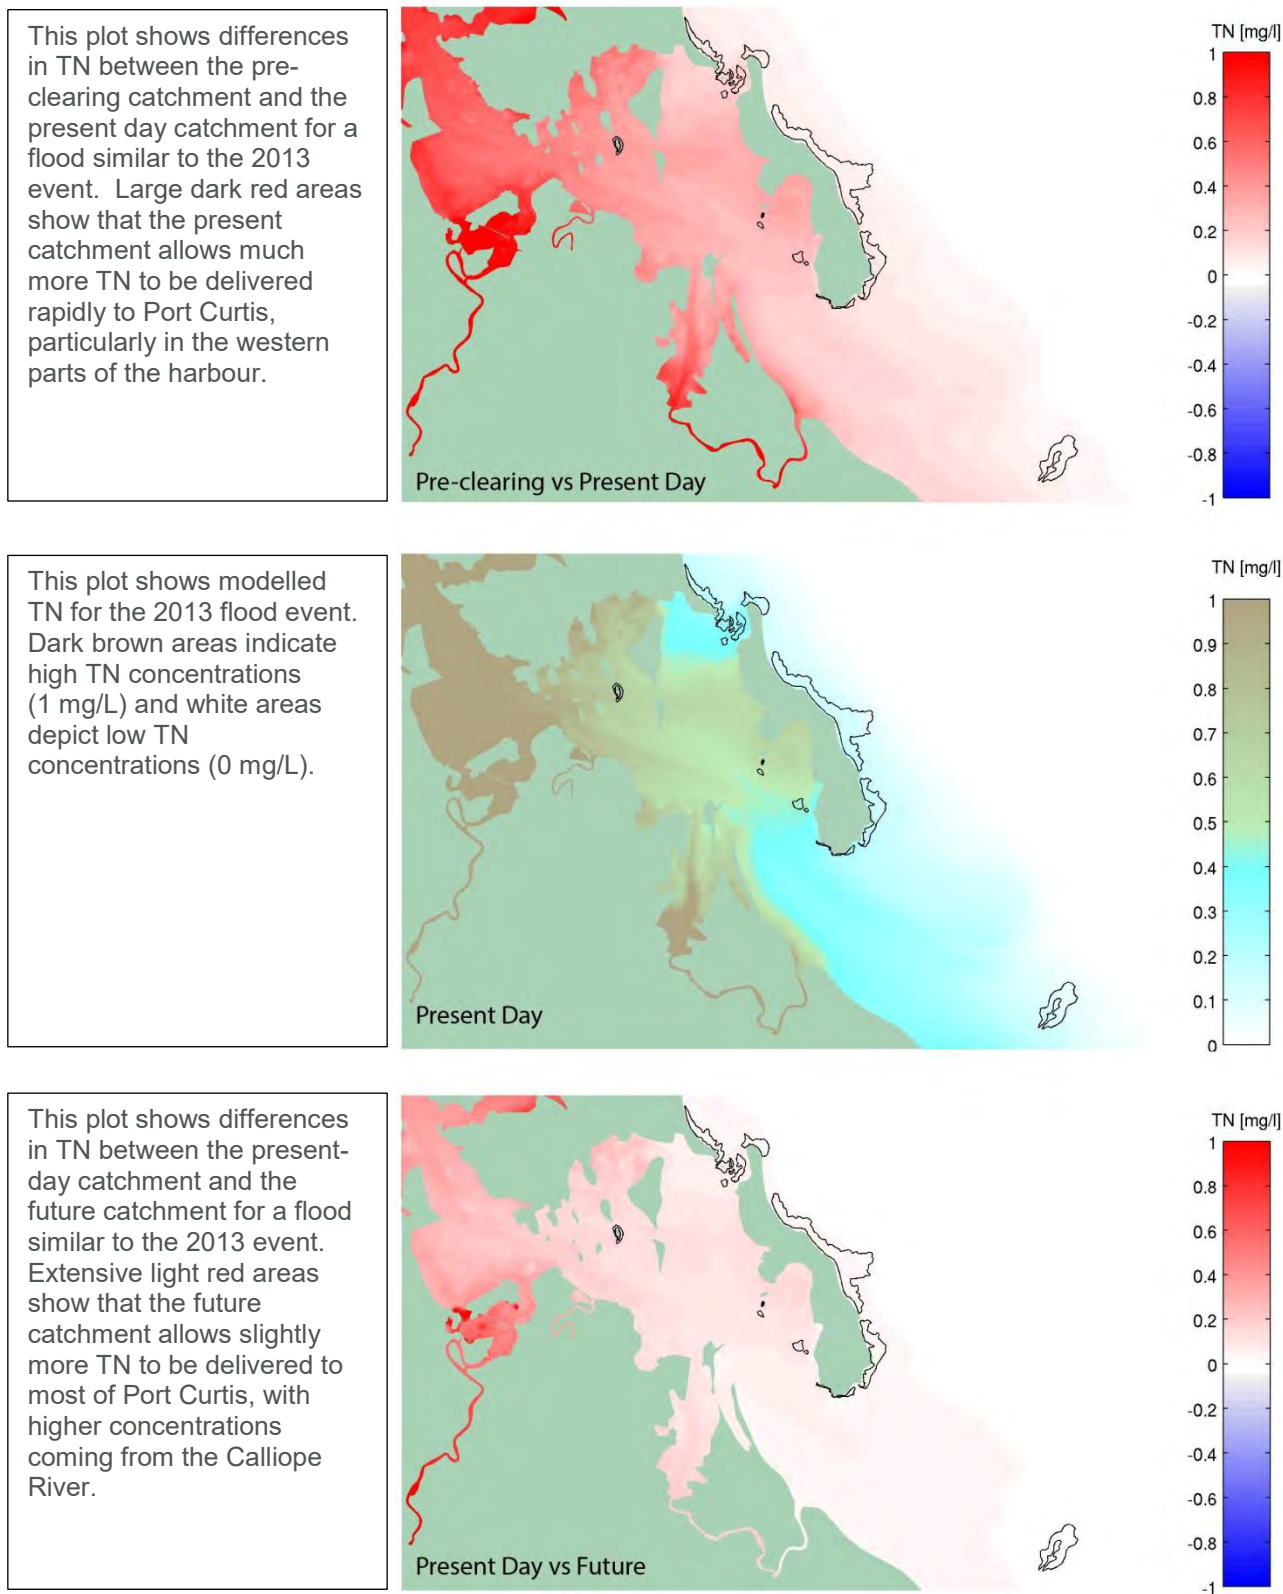
Figure 4-9 Plots showing modelled 50th percentile TN from the 2013 flood event: differences between the past (pre-clearing) and present catchment (top); the present catchment in the 2013 flood (middle); and differences between present catchment and the future catchment (bottom)

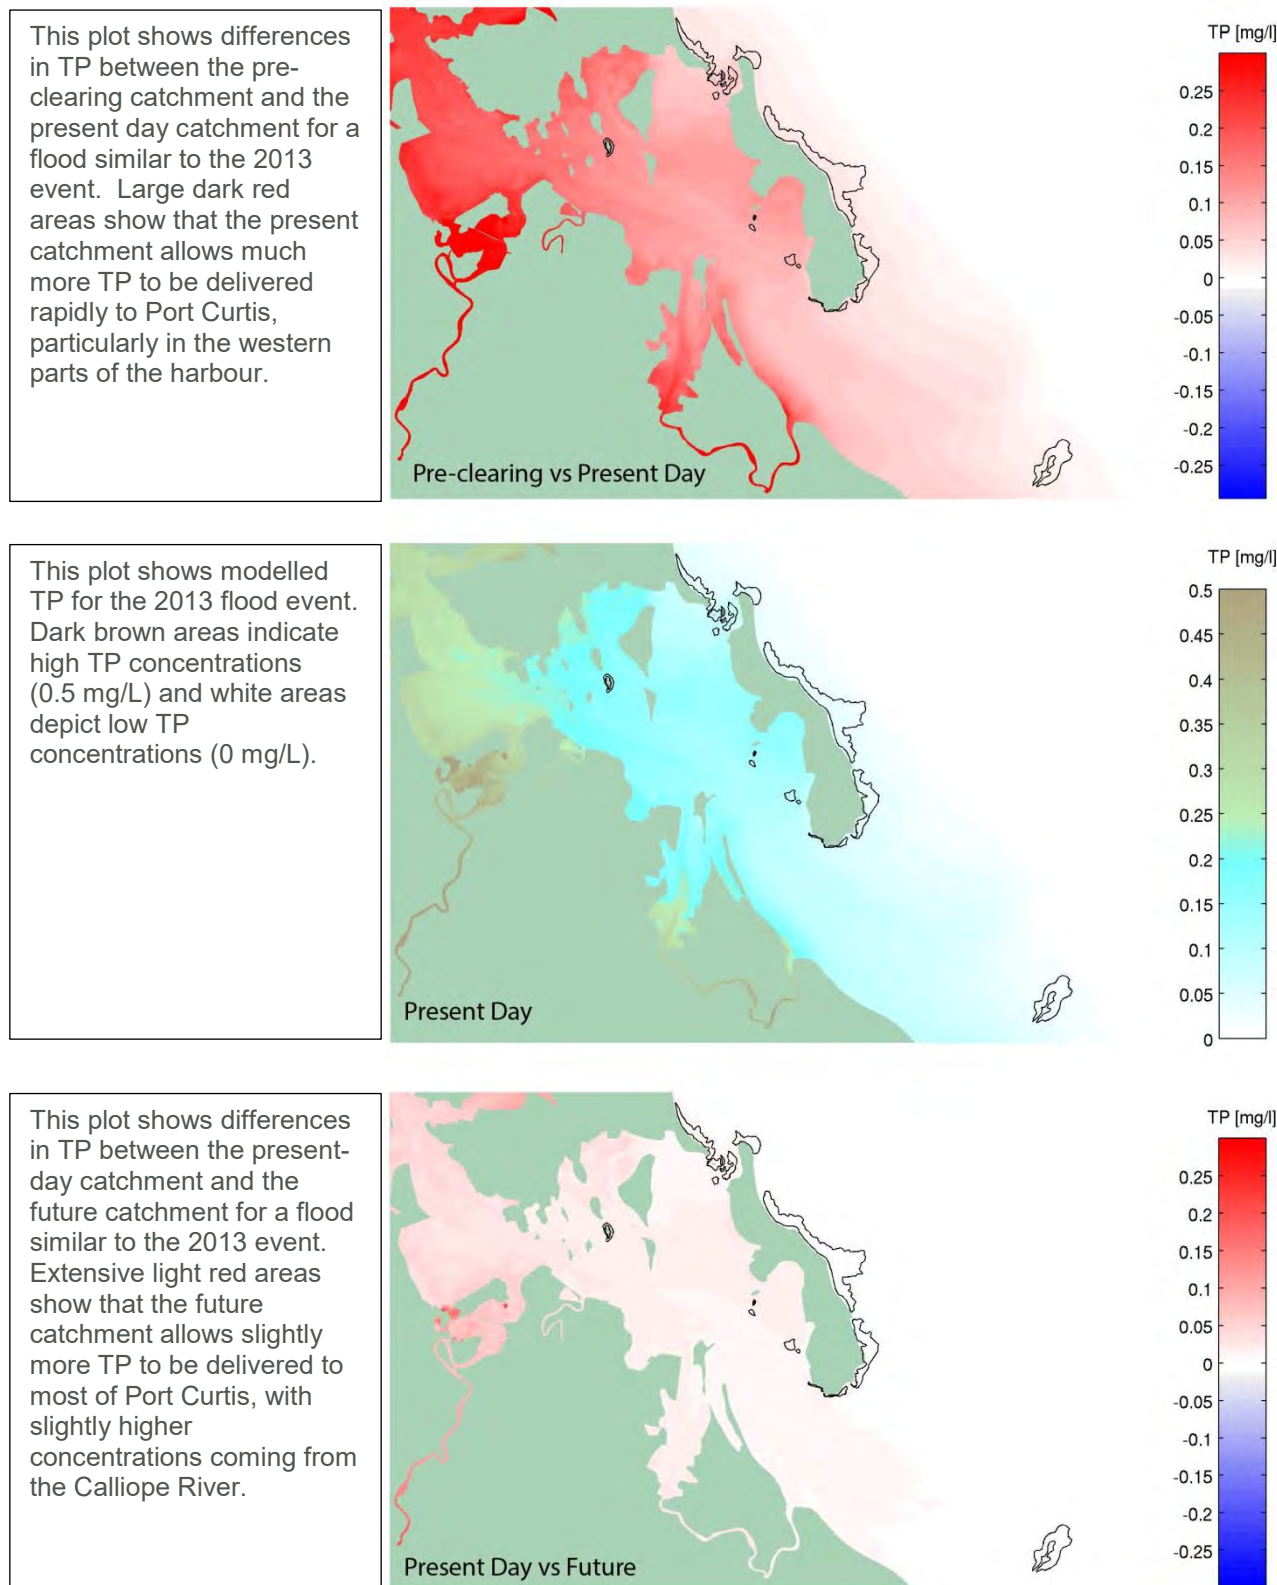
Figure 4-10 Plots showing modelled 50th percentile TP from the 2013 flood event: differences between the past (pre-clearing) and present catchment (top); the present catchment in the 2013 flood (middle); and differences between present catchment and the future catchment (bottom)

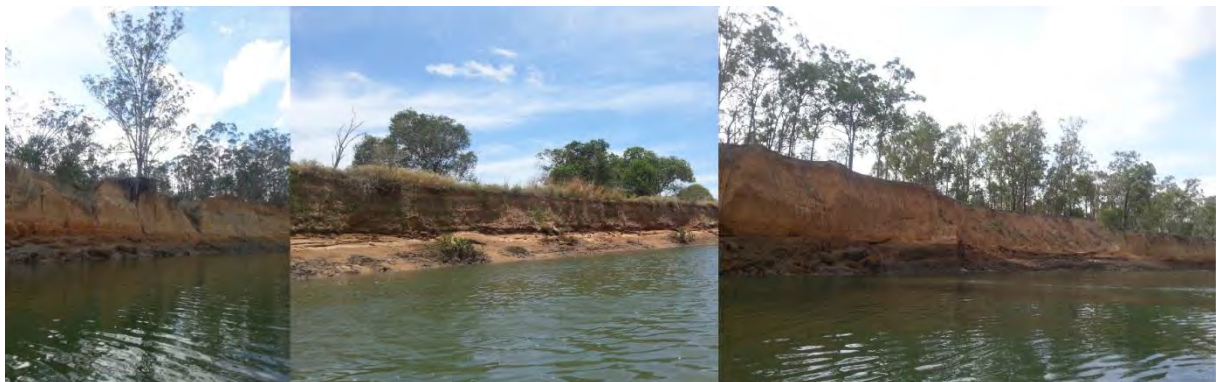
Figure 6-1 Examples of eroding banks on the Calliope River (Beecher section)

The Calliope catchment has been extensively cleared, and modelling results show that this has greatly increased pollutant loads and the rate of freshwater delivery into Port Curtis (see Figure 4-3 and Figure 4-5). There are extensive areas of bank erosion within the catchment (Figure 6-1), representing an additional source of sediment to the Calliope River and Port Curtis receiving waters.

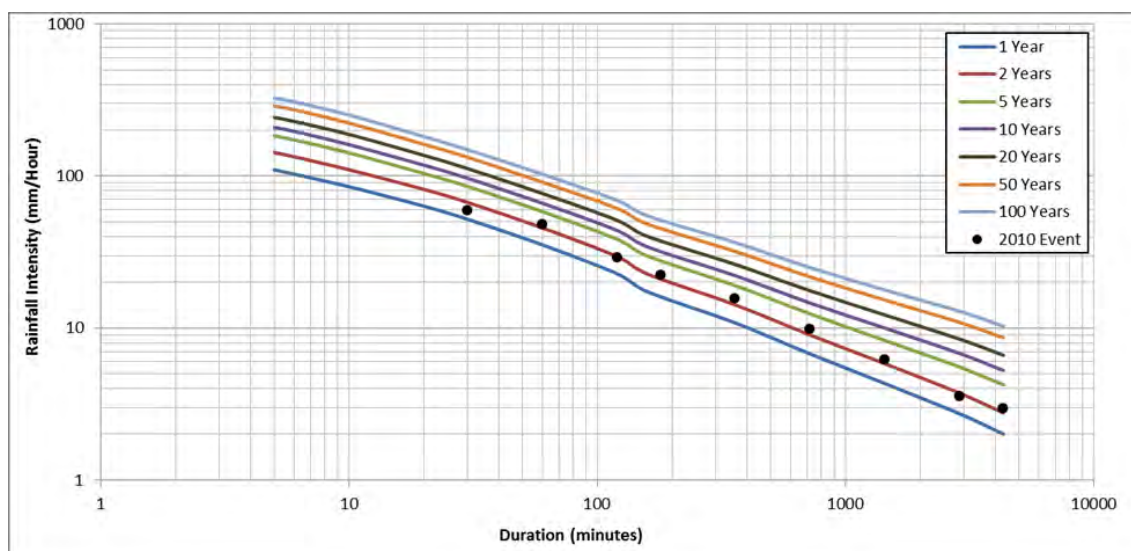
Figure B-4 IFD Analysis of 2010-11 Event

Both 2010-11 and 2013 storm events were investigated using an Intensity Frequency Duration (IFD) analysis. Here, pluviograph data (rainfall recorded at every 6 minute intervals) recorded at the Gladstone Radar gauge was analysed against the IFD rainfall chart obtained from "AR&R87 IFDs" tool (BoM) for the Gladstone Radar (BoM) coordinates. Figure B-4 and Figure B-5 present findings of the IFD analysis of both events.

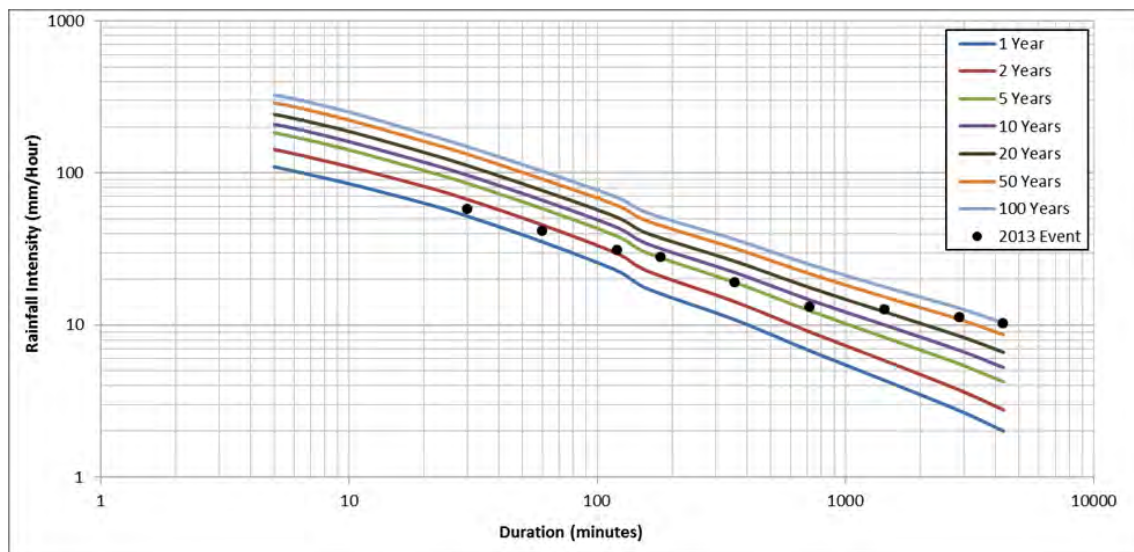
Figure B-5 IFD Analysis of 2013 Event

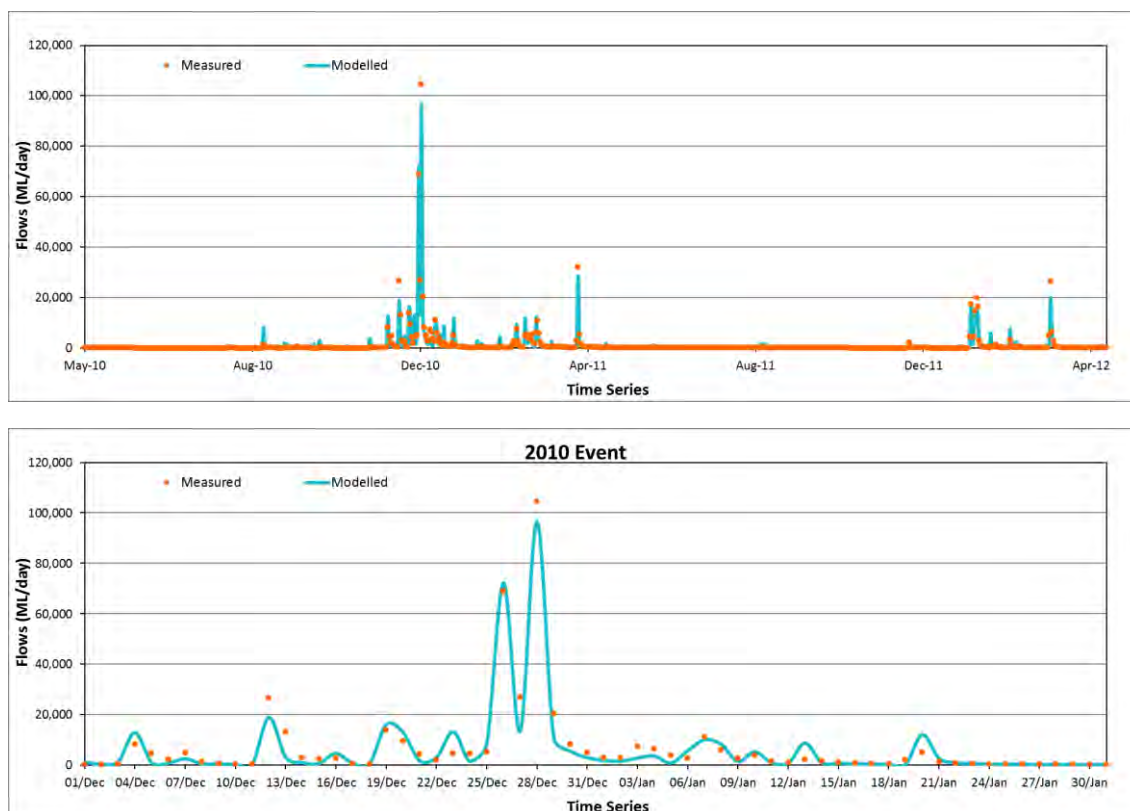
Figure B-6 Time series comparisons at Calliope River at Castlehope: the entire time series (above) and detail during the 2010-2011 flood event (below)

Figure B-6 through to Figure B-11 illustrate the qualitative performance of the rainfall runoff model calibration at both Castlehope and Milton gauges.

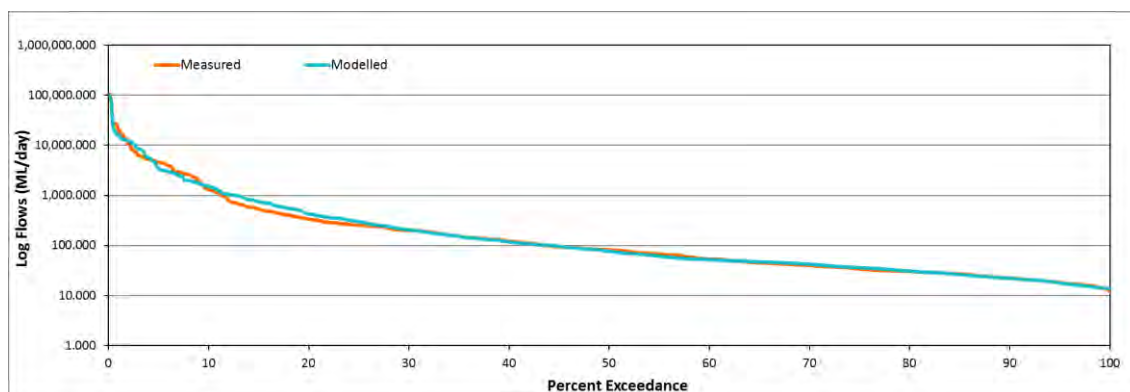
Figure B-7 Log flow duration curve comparison at Calliope River at Castlehope

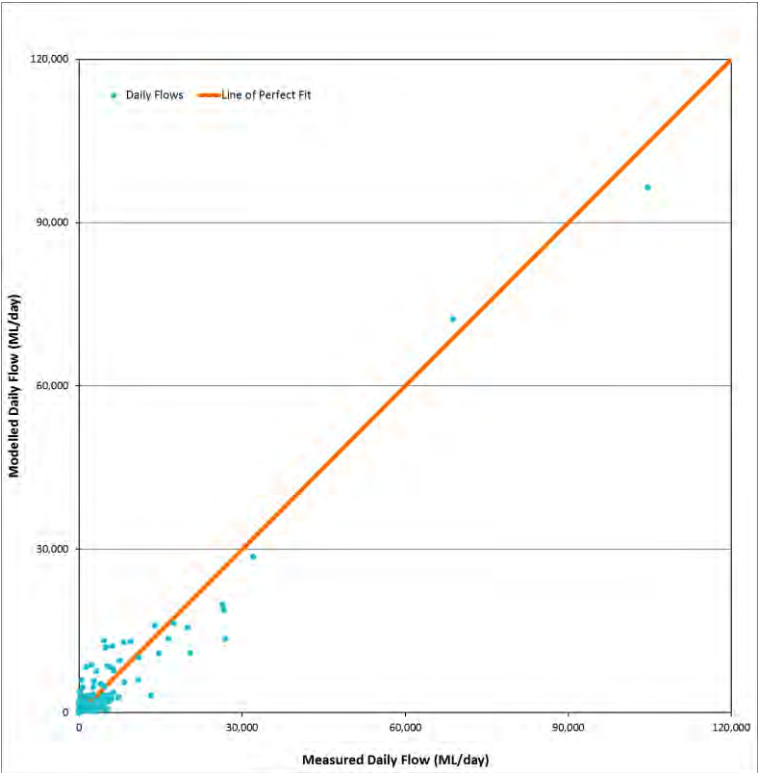
Figure B-8 Modelled vs measured daily flows at Calliope River at Castlehope

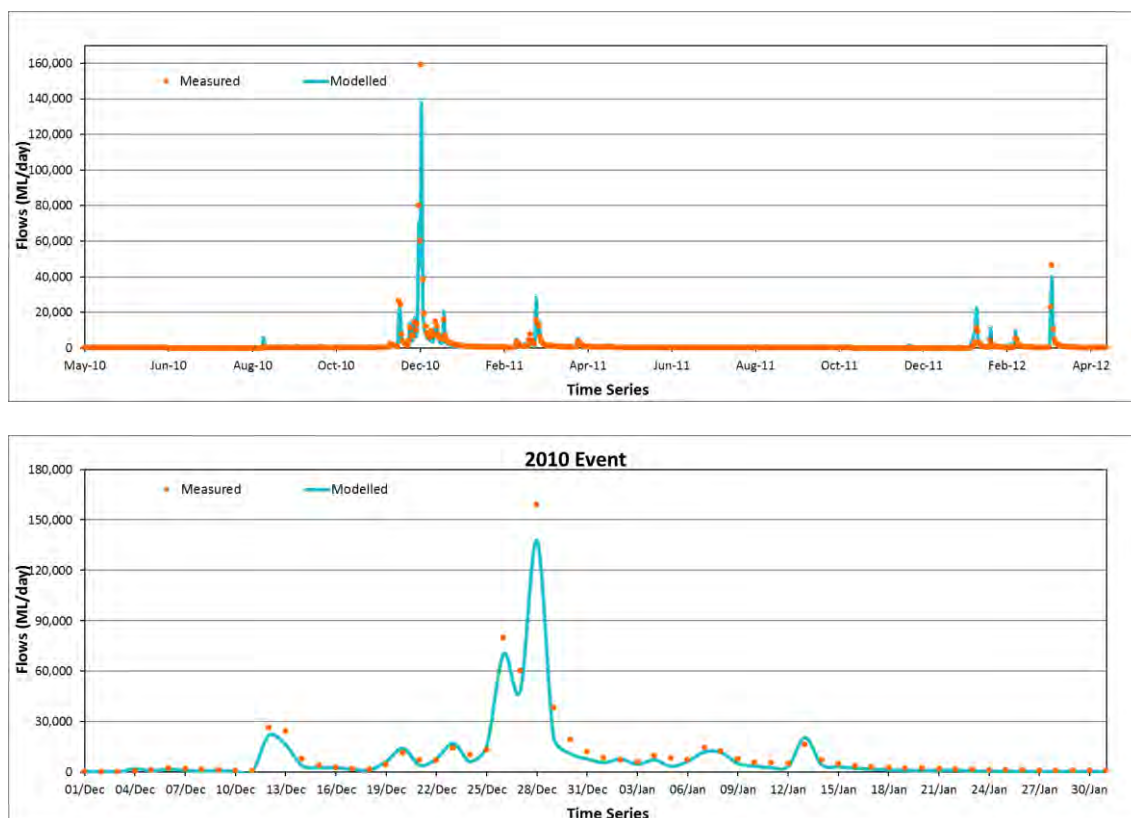
Figure B-9 Time series comparison at Boyne River at Milton: the entire time series (above) and detail during the 2010-2011 flood event (below)

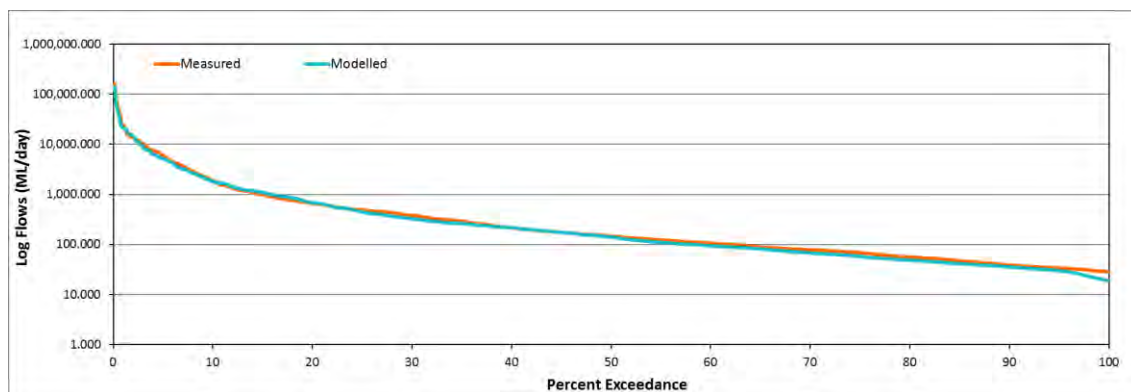
Figure B-10 Log flow duration curve comparison at Boyne River at Milton

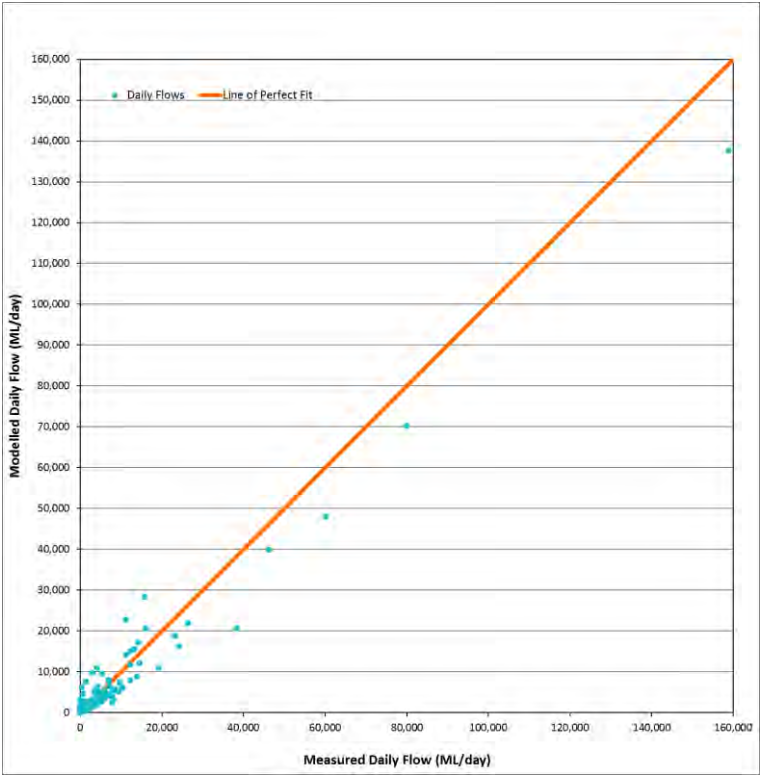
Figure B-11 Modelled vs measured daily flows at Boyne River at Milton

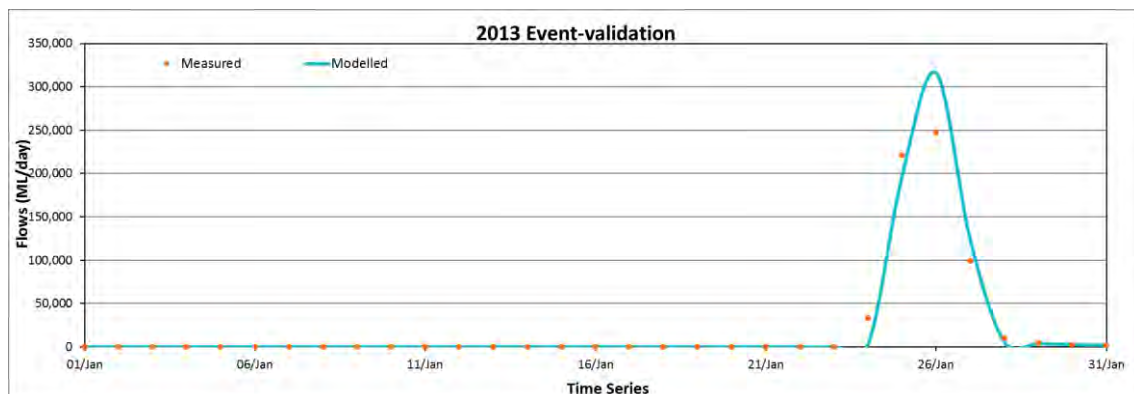
Figure B-12 Time series comparisons at Calliope River at Castlehope during the 2013 flood event

The rainfall runoff model of the Calliope Basin was validated using the 2013 event flows recorded at Castlehope gauge, while the rainfall runoff model of the Boyne Basin was validated using the 2010 event flows recorded at Marlua and Nagoorin gauges. Figure B-12 through Figure B-14 illustrate the validation performance of the catchment model.

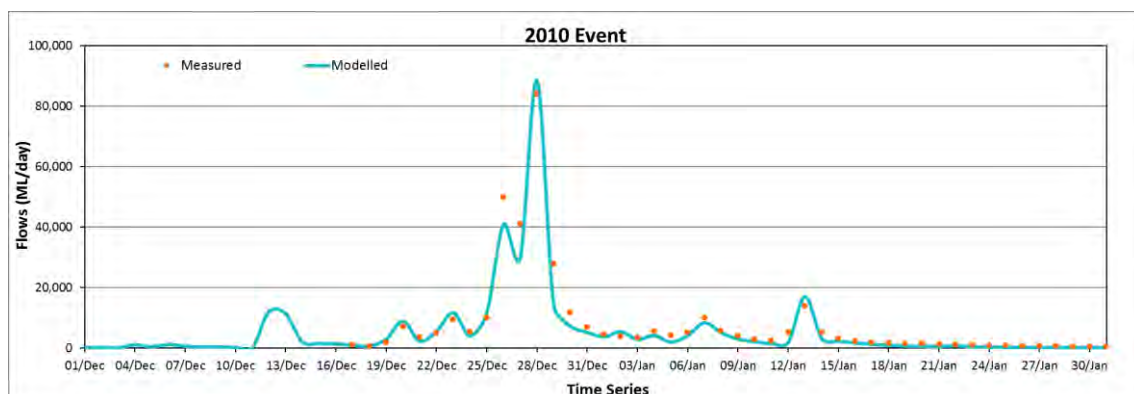
Figure B-13 Time series comparison at Boyne River at Nagoorin during the 2010-2011 flood event

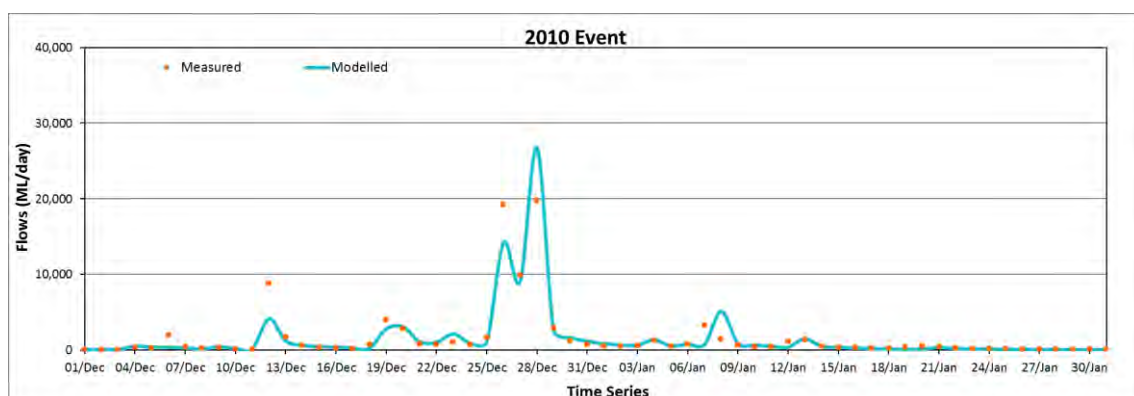
Figure B-14 Time series comparison at Diglum Creek at Marlua during the 2010-2011 flood event

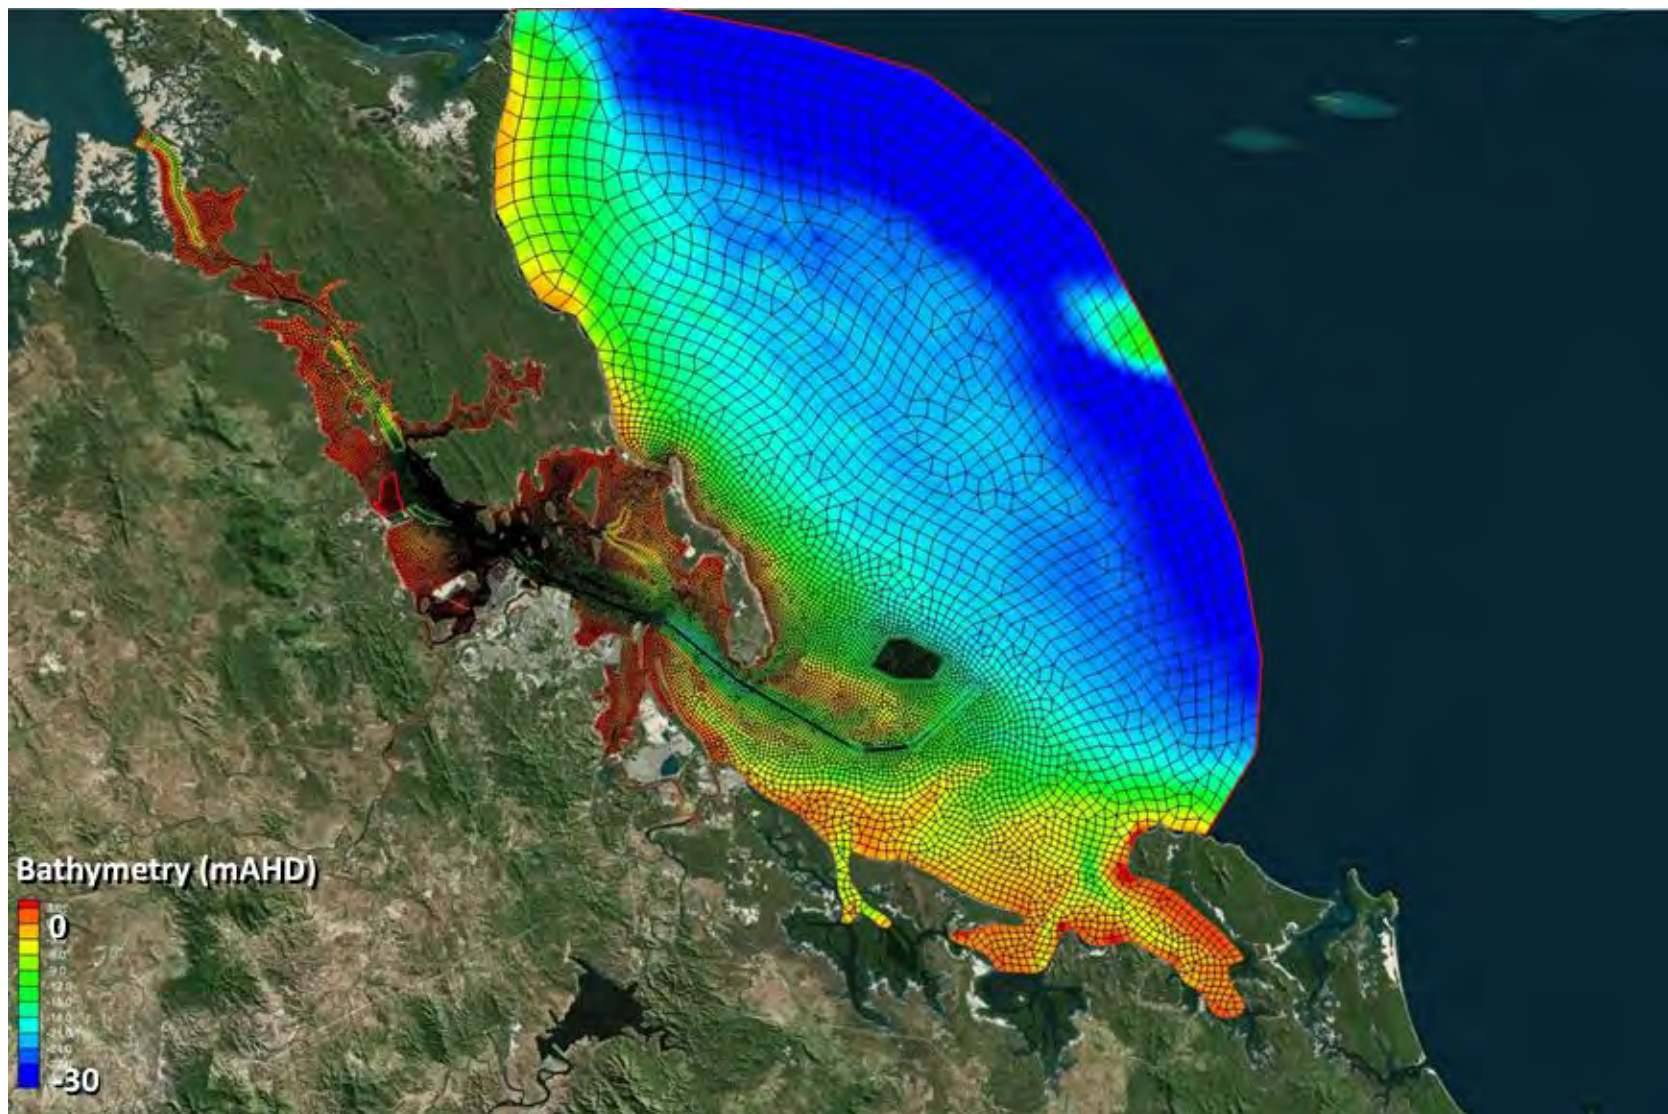
Figure C-1 TUFLOW FV Mesh of the Gladstone Region

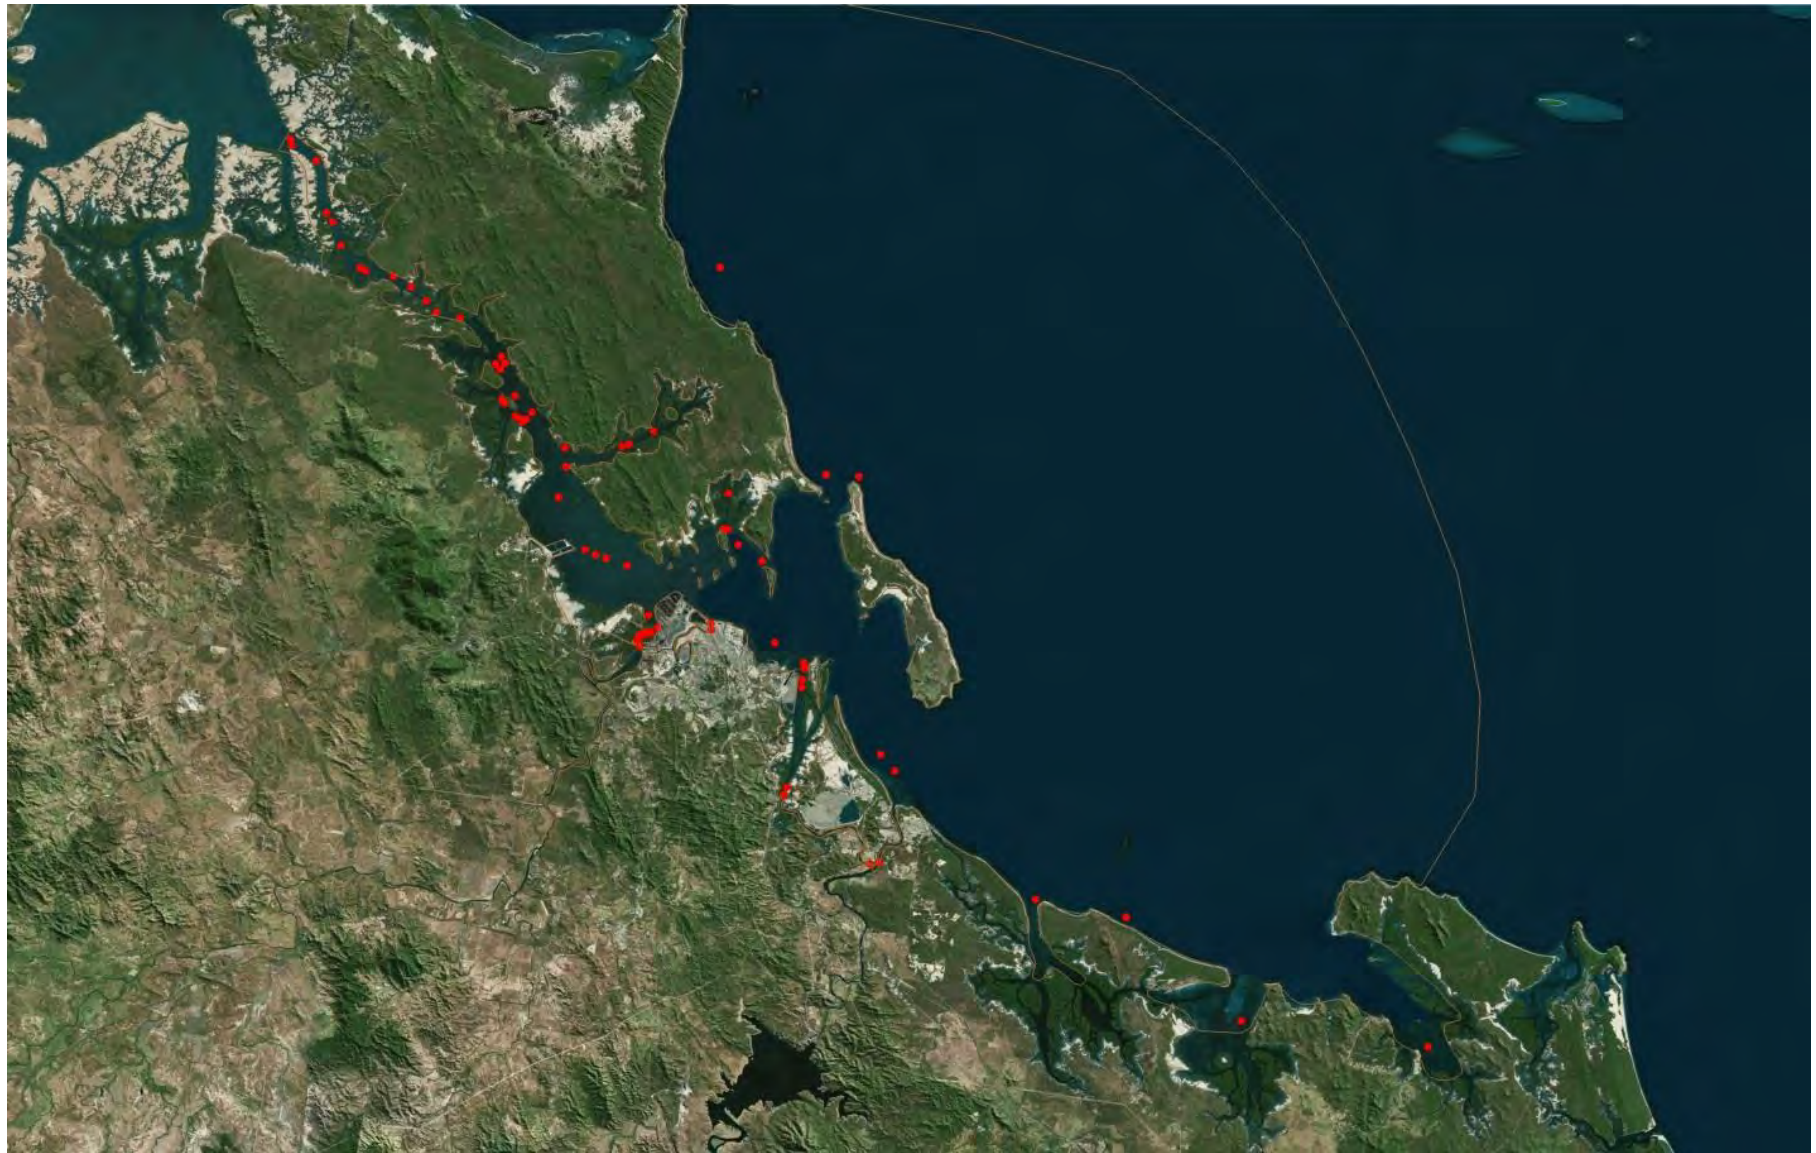
Figure C-2 Catchment Inflow Locations

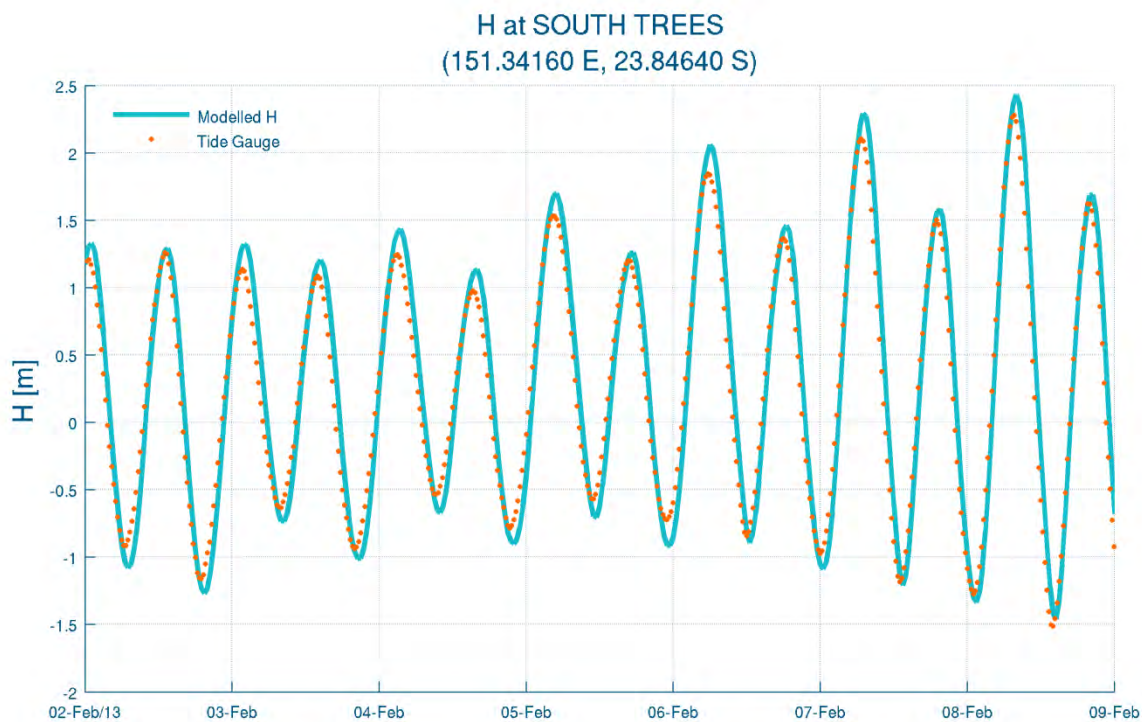
Figure C-3 Tide Calibration at South Trees

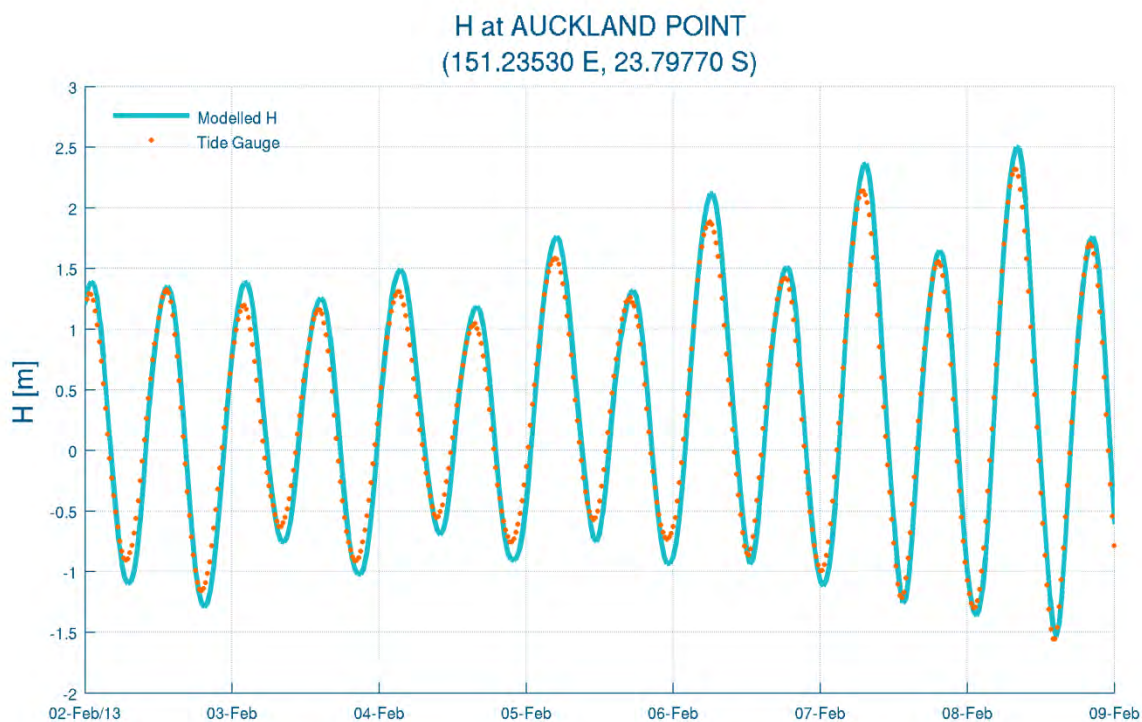
Figure C-4 Tide Calibration at Auckland Point
