Prioritisation of Reef Restoration and Enhancement Site Selection – Phase 2 and 3 Report

Reference: R.B20731.002.05.Phase 2 & 3.docx
Date: December 2015

This report has been produced for Gladstone Ports Corporation's Biodiversity Offset Strategy. The study was undertaken through a Consultancy Agreement (CA140017) between Gladstone Ports Corporation and BMT WBM to assess and prioritise sites for coral restoration and enhancement.

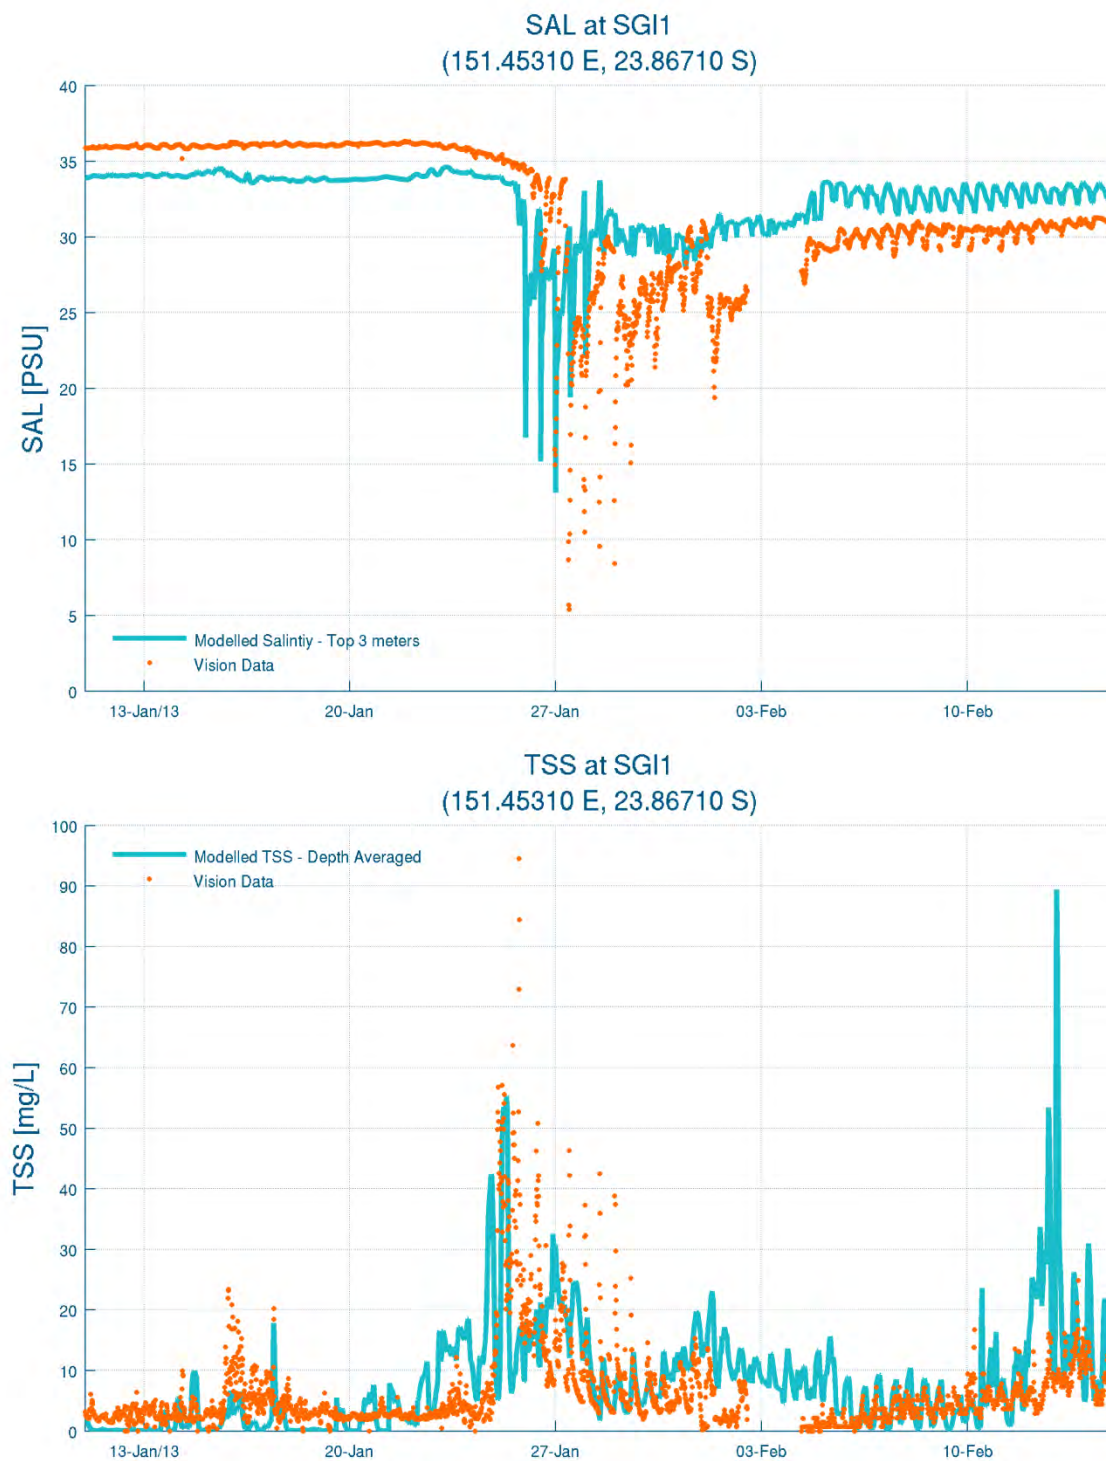
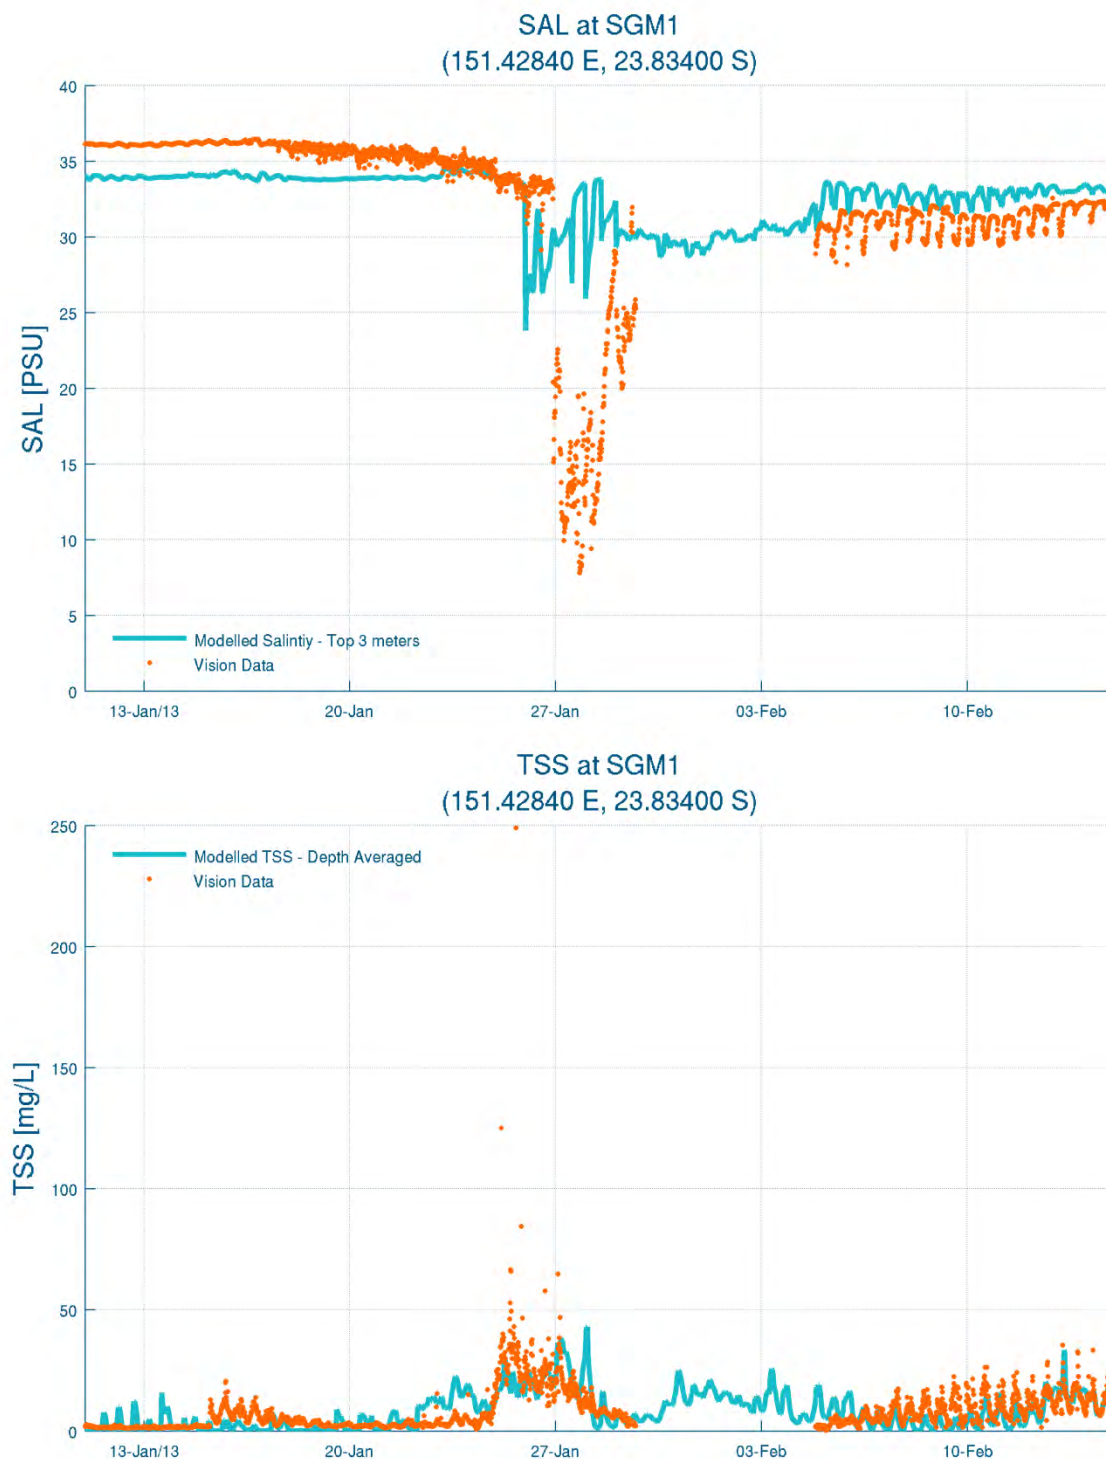
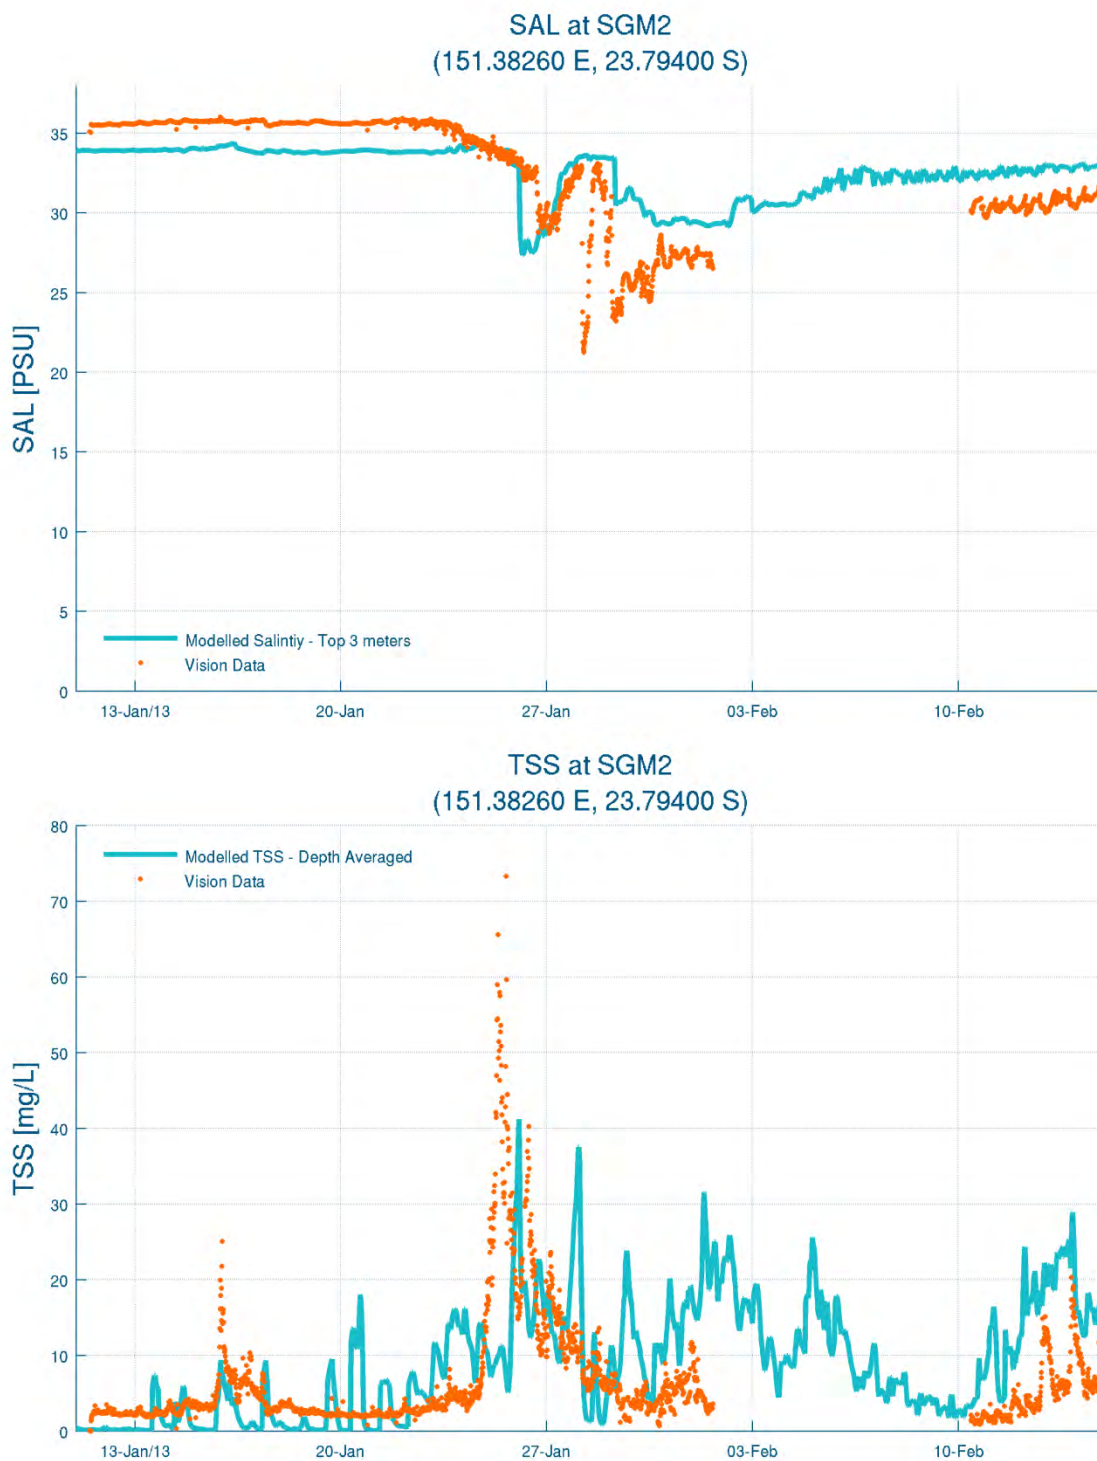
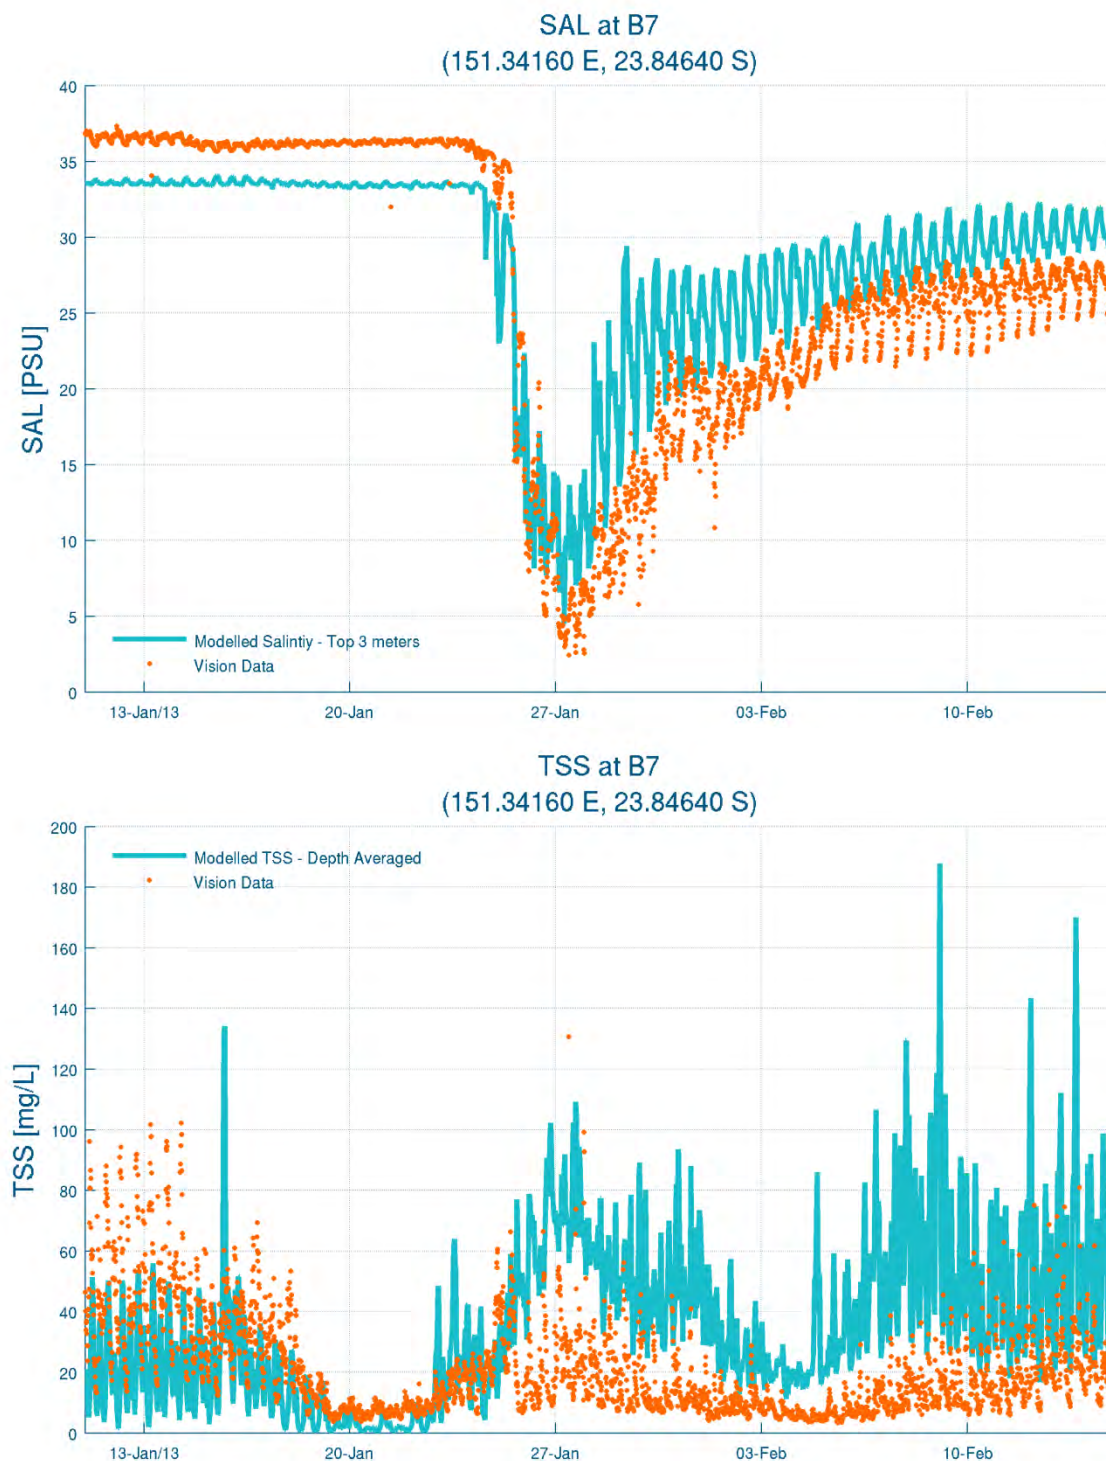
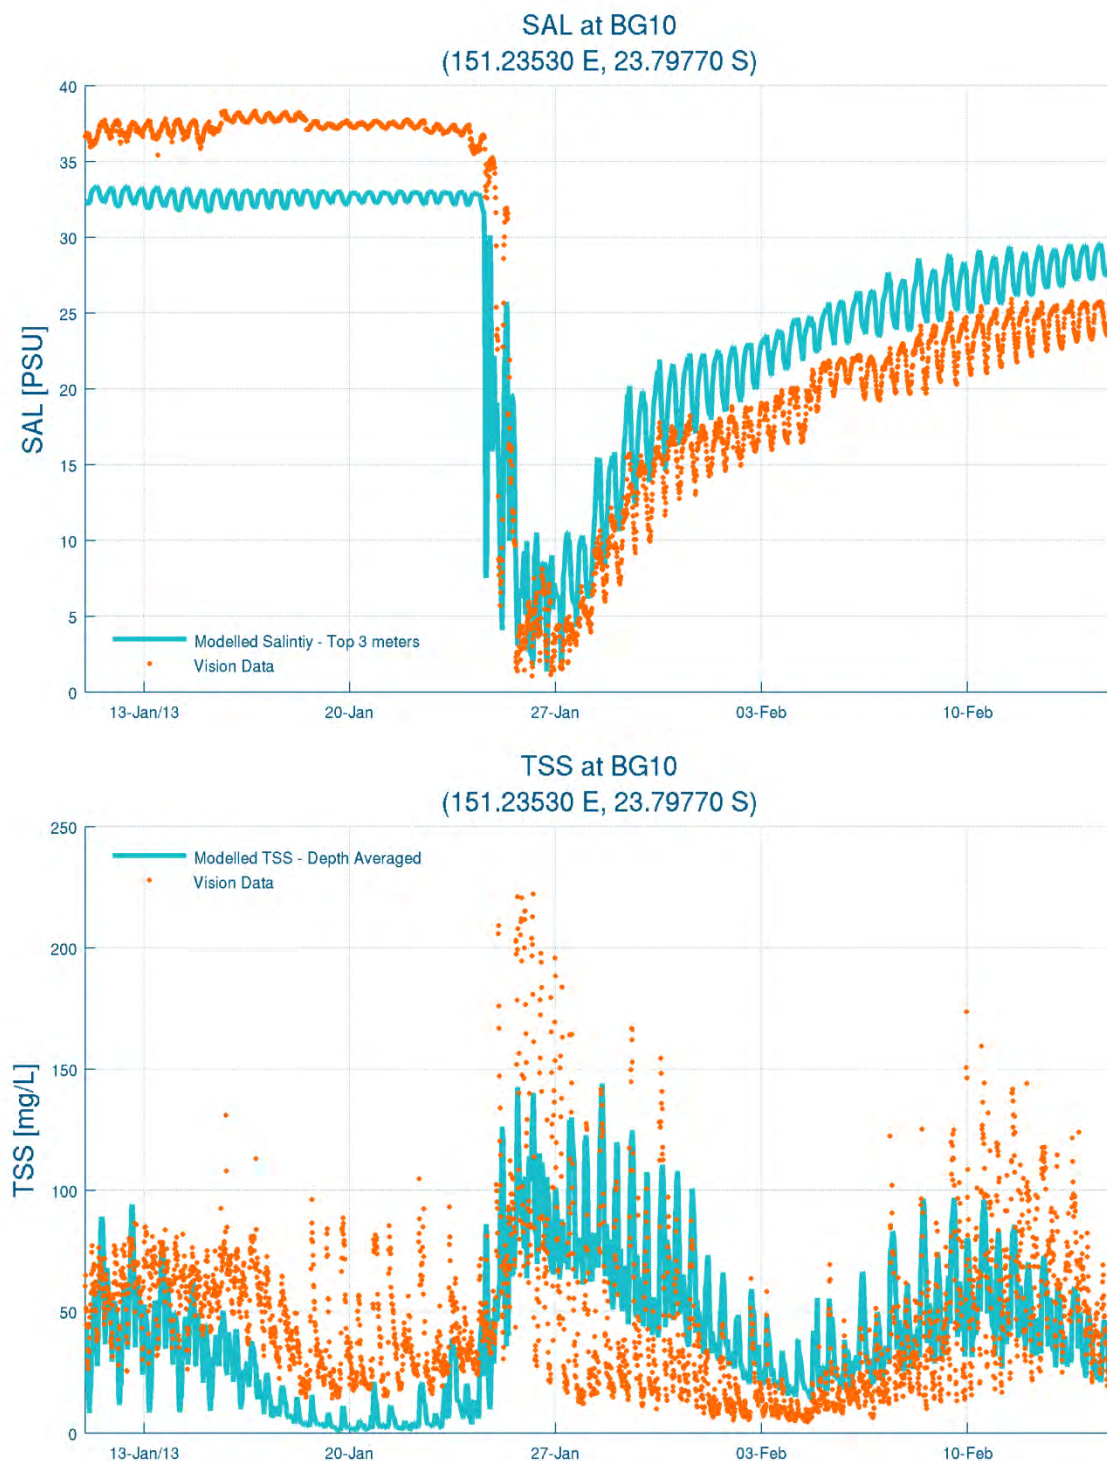
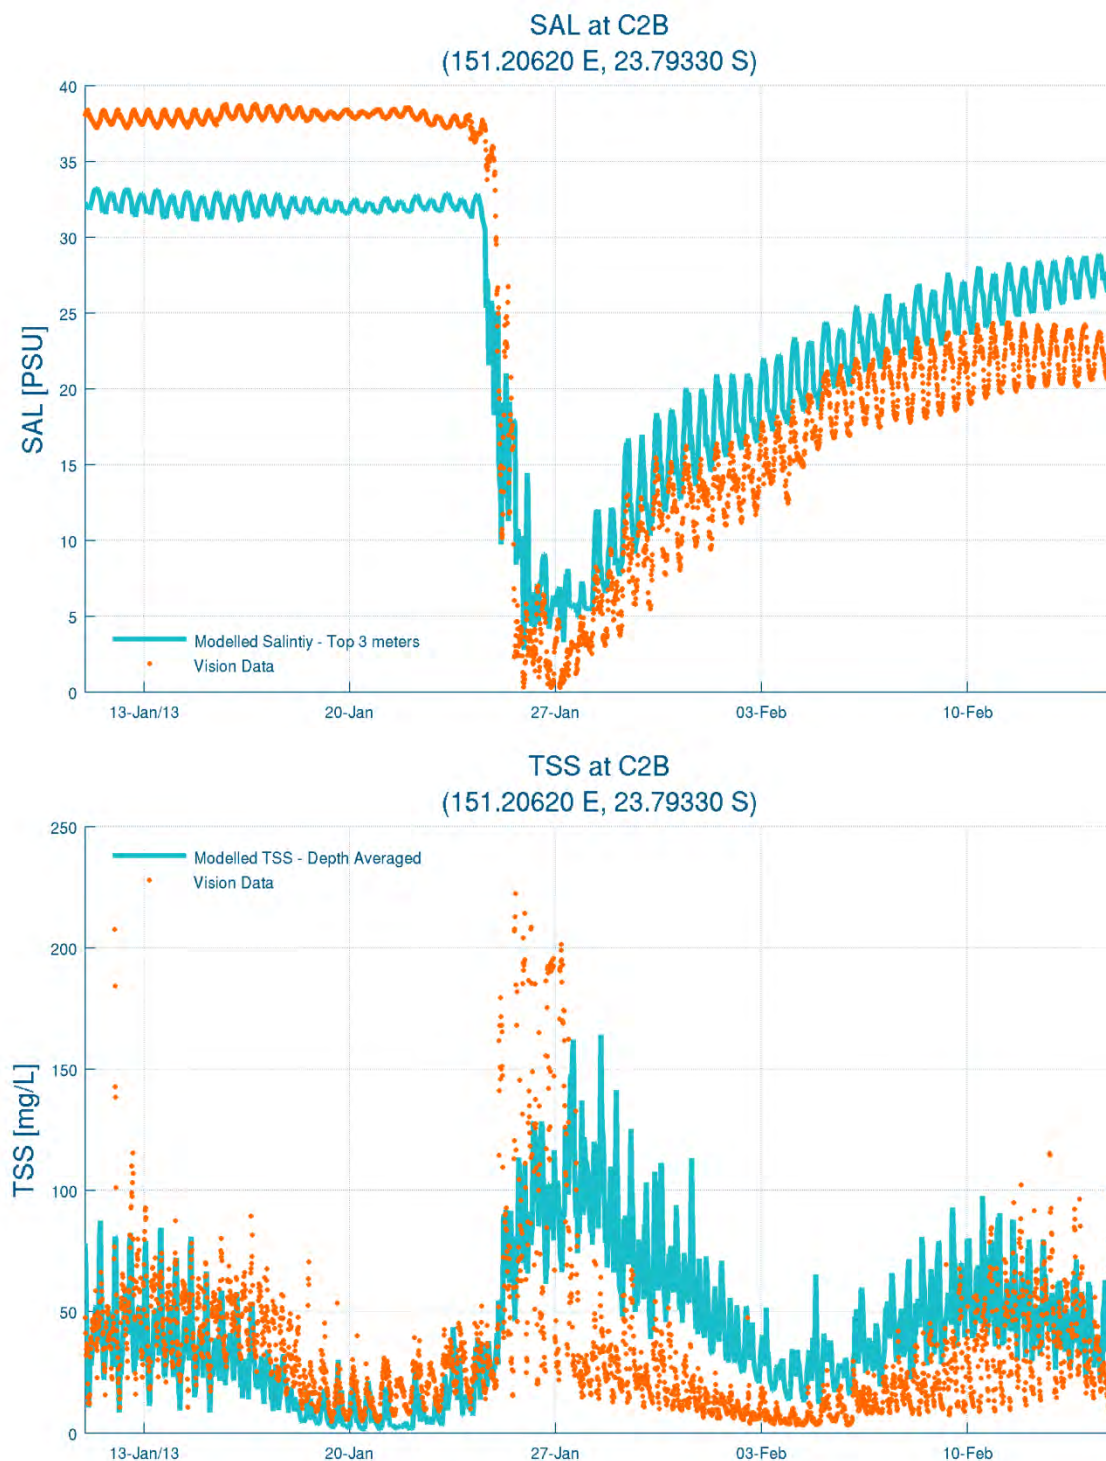
Figure C-6 TSS and Salinity Calibration at Site SG1

Figure C-7 TSS and Salinity Calibration at Site SGM1

Figure C-8 TSS and Salinity Calibration at Site SGM2

Figure C-9 TSS and Salinity Calibration at Site B7

Figure C-10 TSS and Salinity Calibration at Site BG10

Figure C-11 TSS and Salinity Calibration at Site C2B

Calibration plots of TSS and Salinity can be seen in Figure C-6 through to Figure C-21. The model displays good overall calibration for salinity especially in the western reaches of the model. Sites such as BG10 and P2 (Figure C-10 and Figure C-13) capture the sharp drops in salinity associated with large fresh water inflows from the 2013 event. Modelled salinity at the offshore site SG1 (Figure C-6) does start to fall too early when compared with the measured data. The reason for this is likely due to inaccuracies in the timing of fresh water inflows. In terms of TSS, the calibration result at all sites is good, showing close correlation to the measured data. The exception to this was site P5 (Figure C-14) where the modelled TSS is higher than the recorded TSS for a period in late January and early February. The model appears to be overestimating the TSS in the fresh water plume, which may be due to limitations in accuracy of the vertical mixing model or perhaps a problem with the level of TSS assumed in the catchment model inputs.

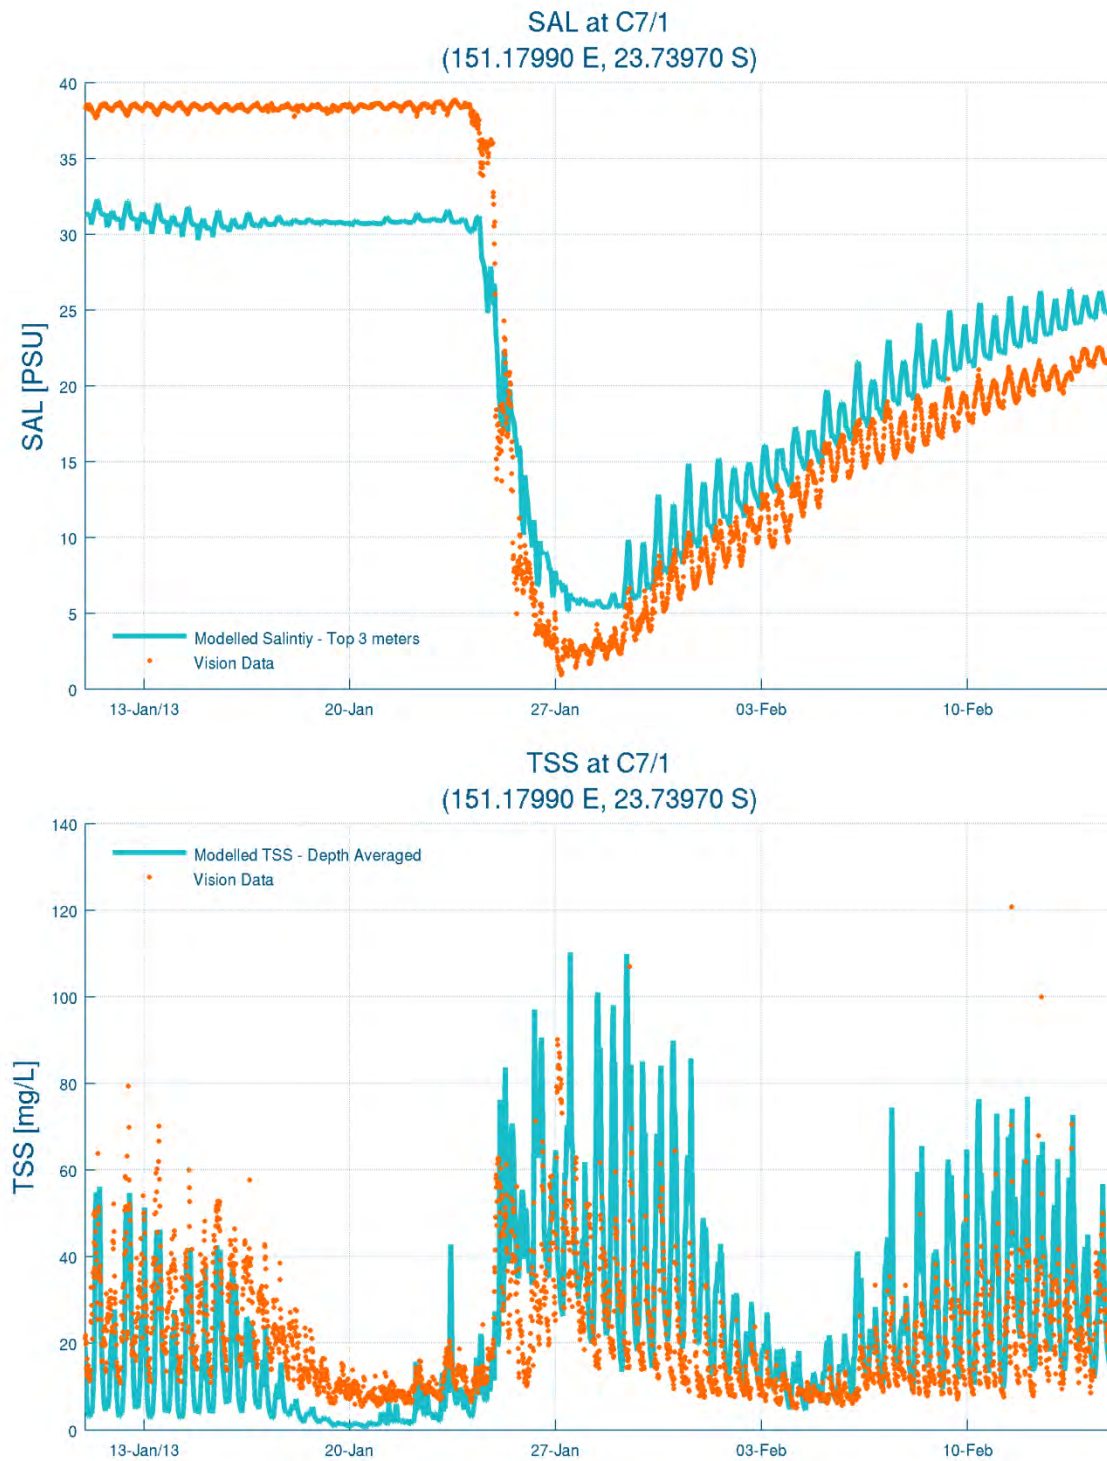
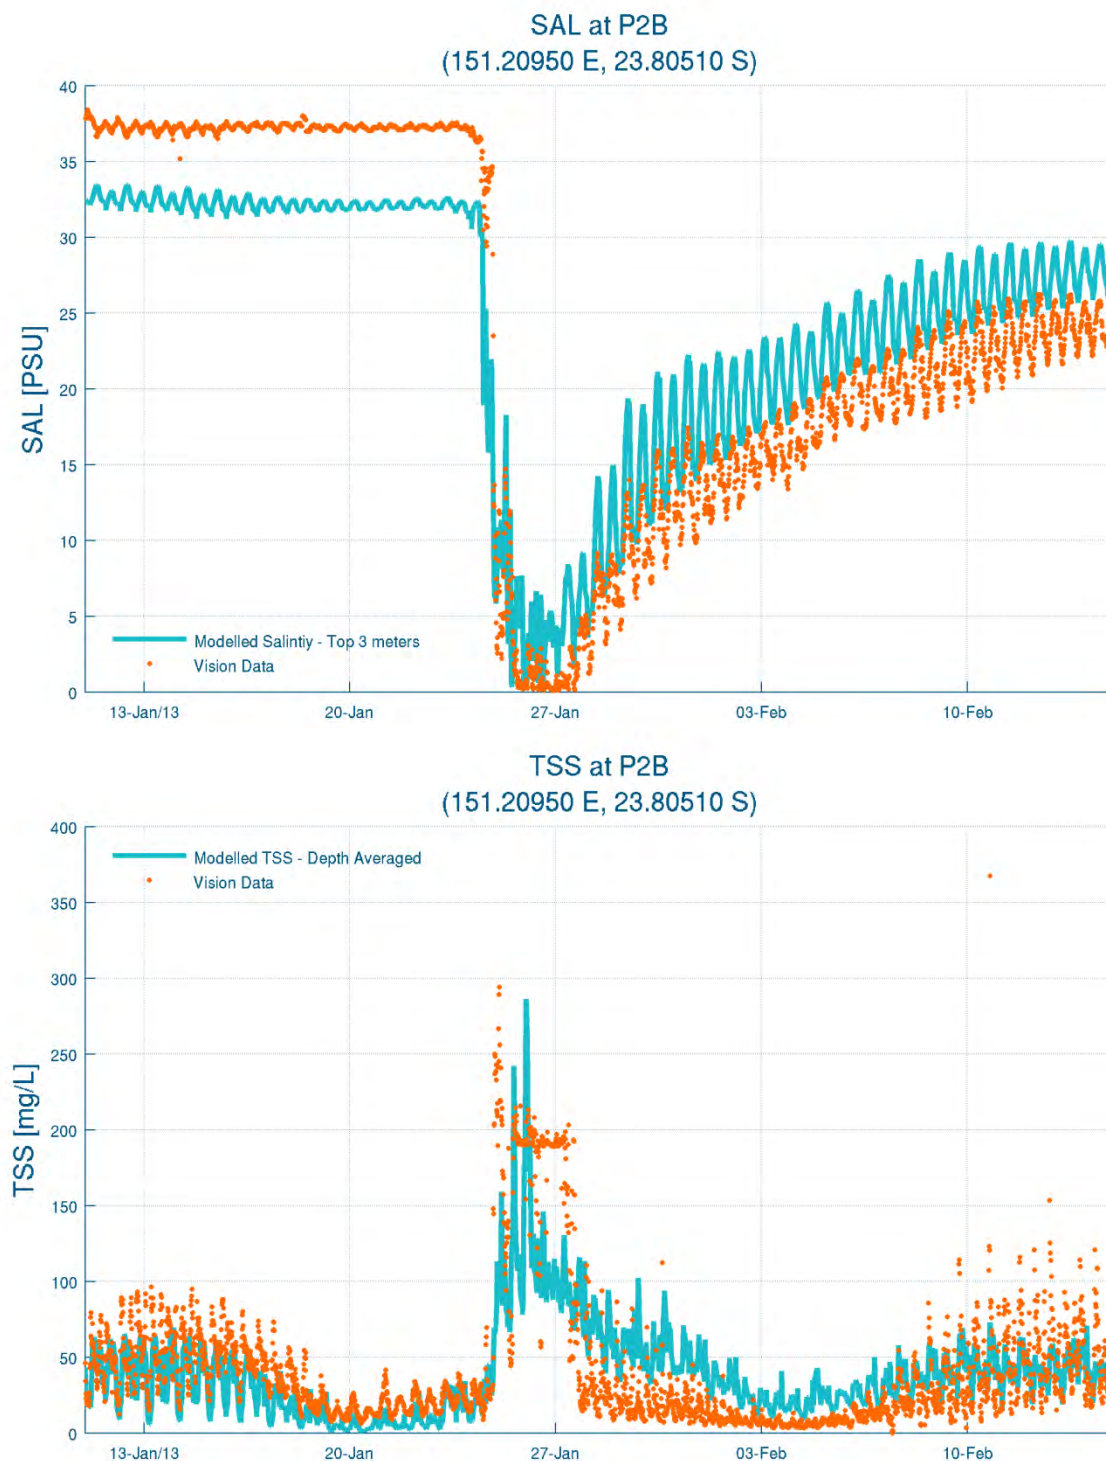
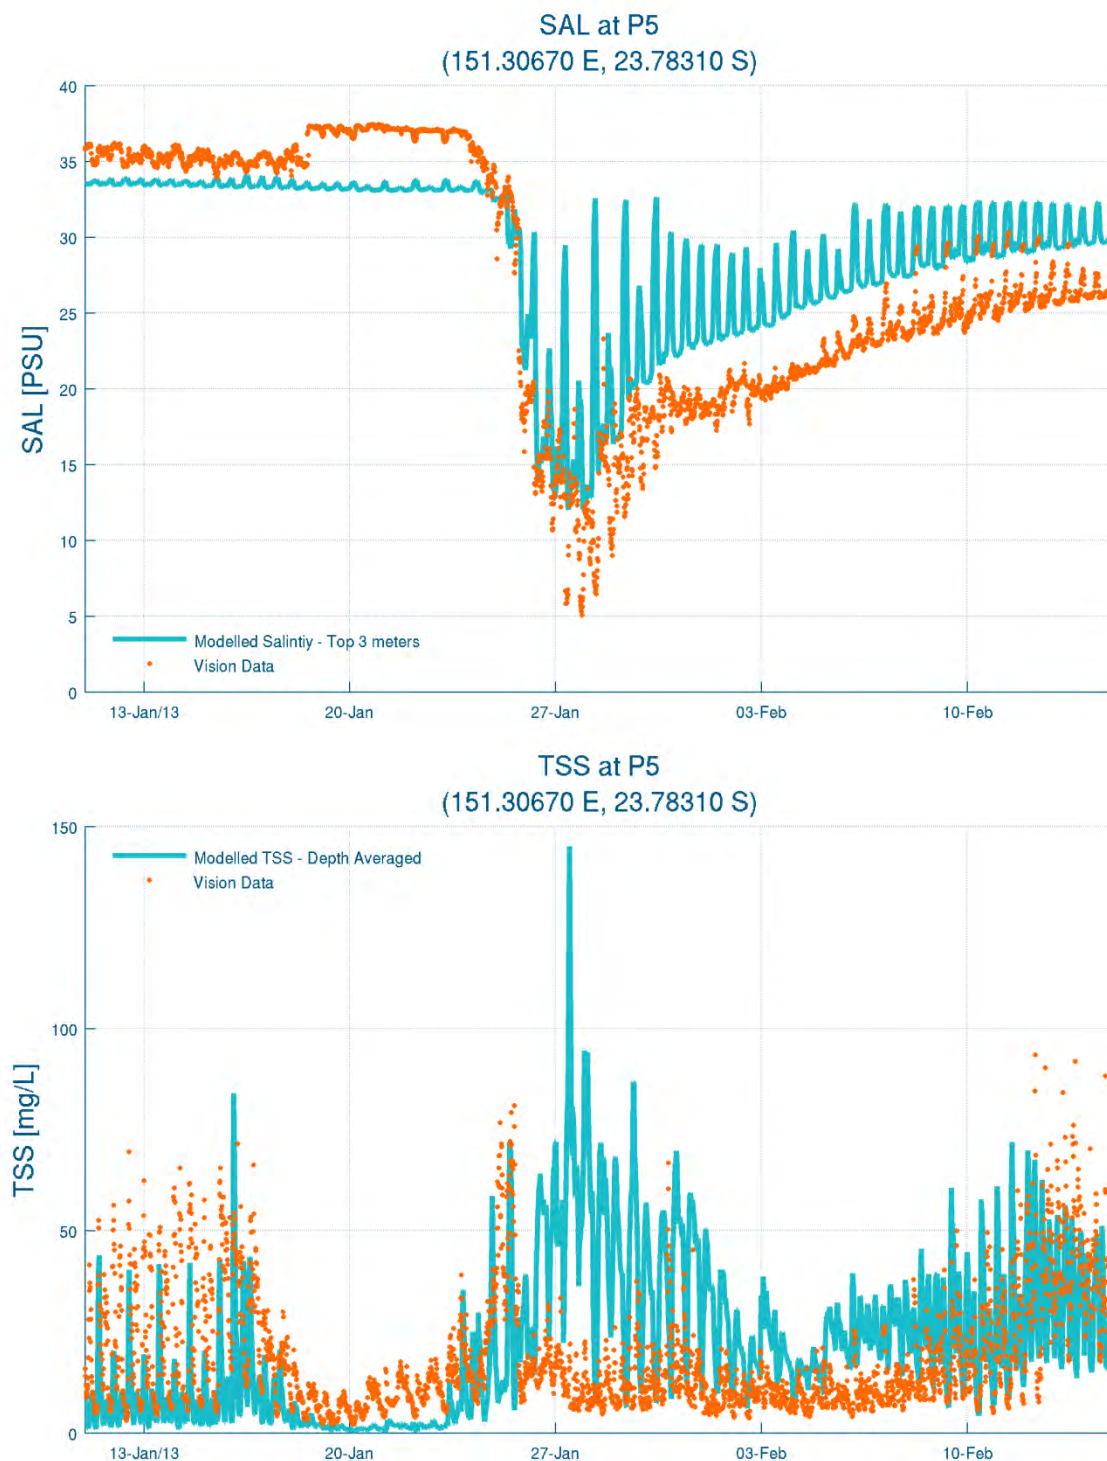
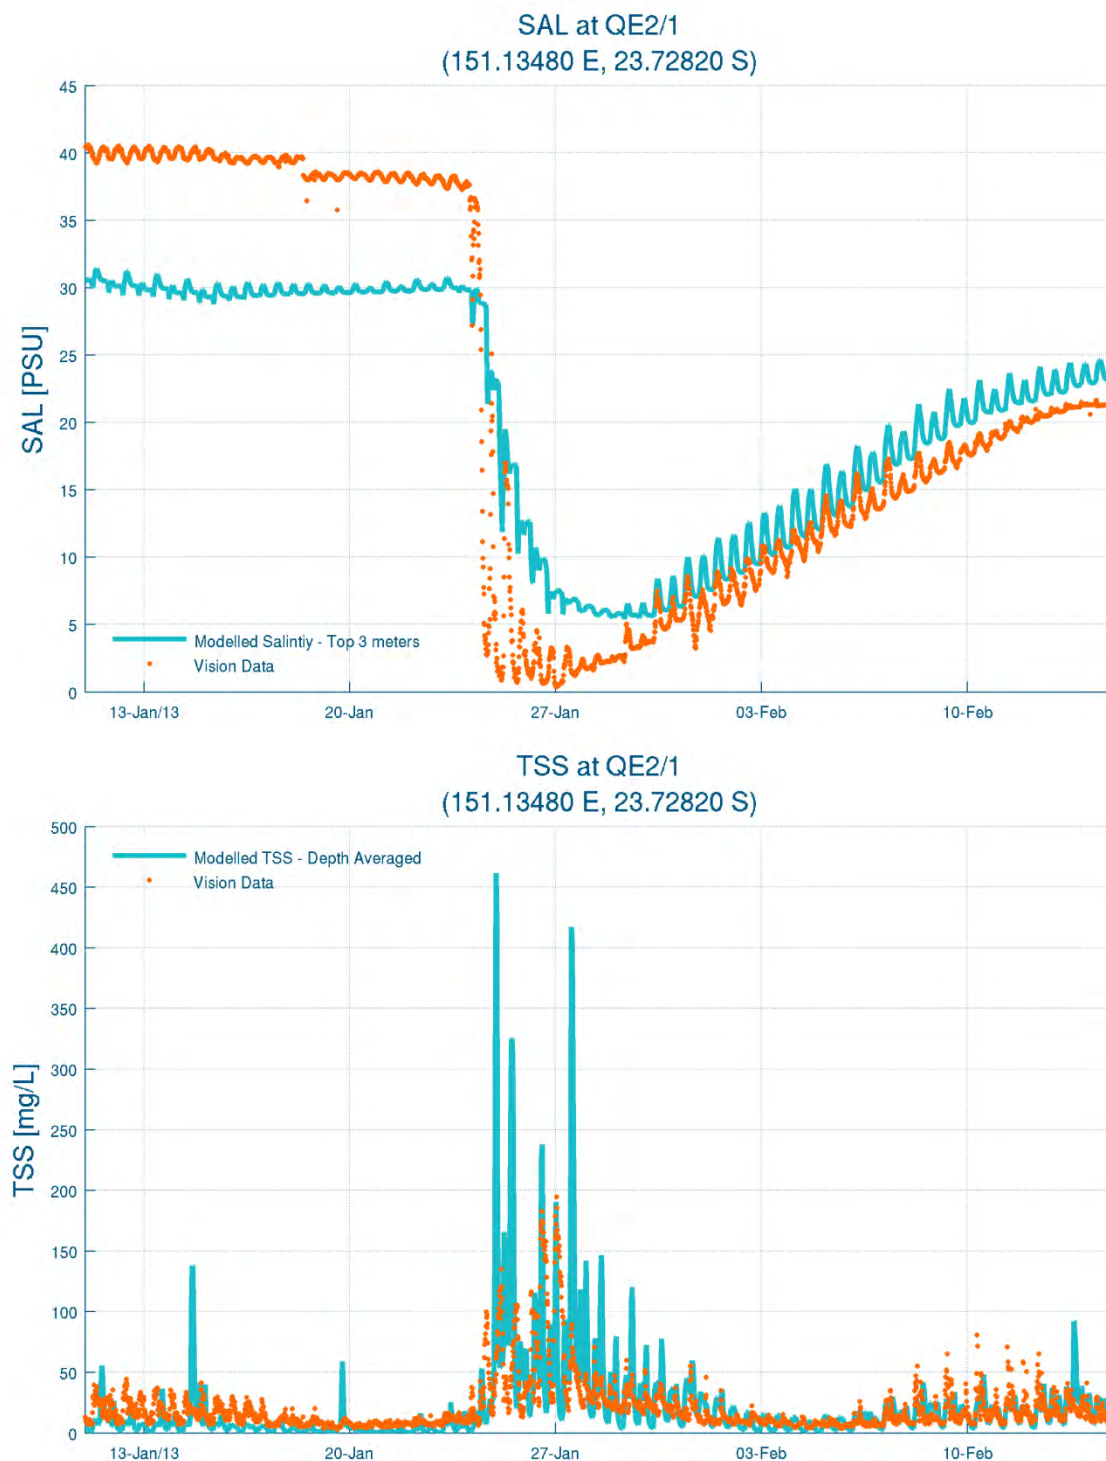
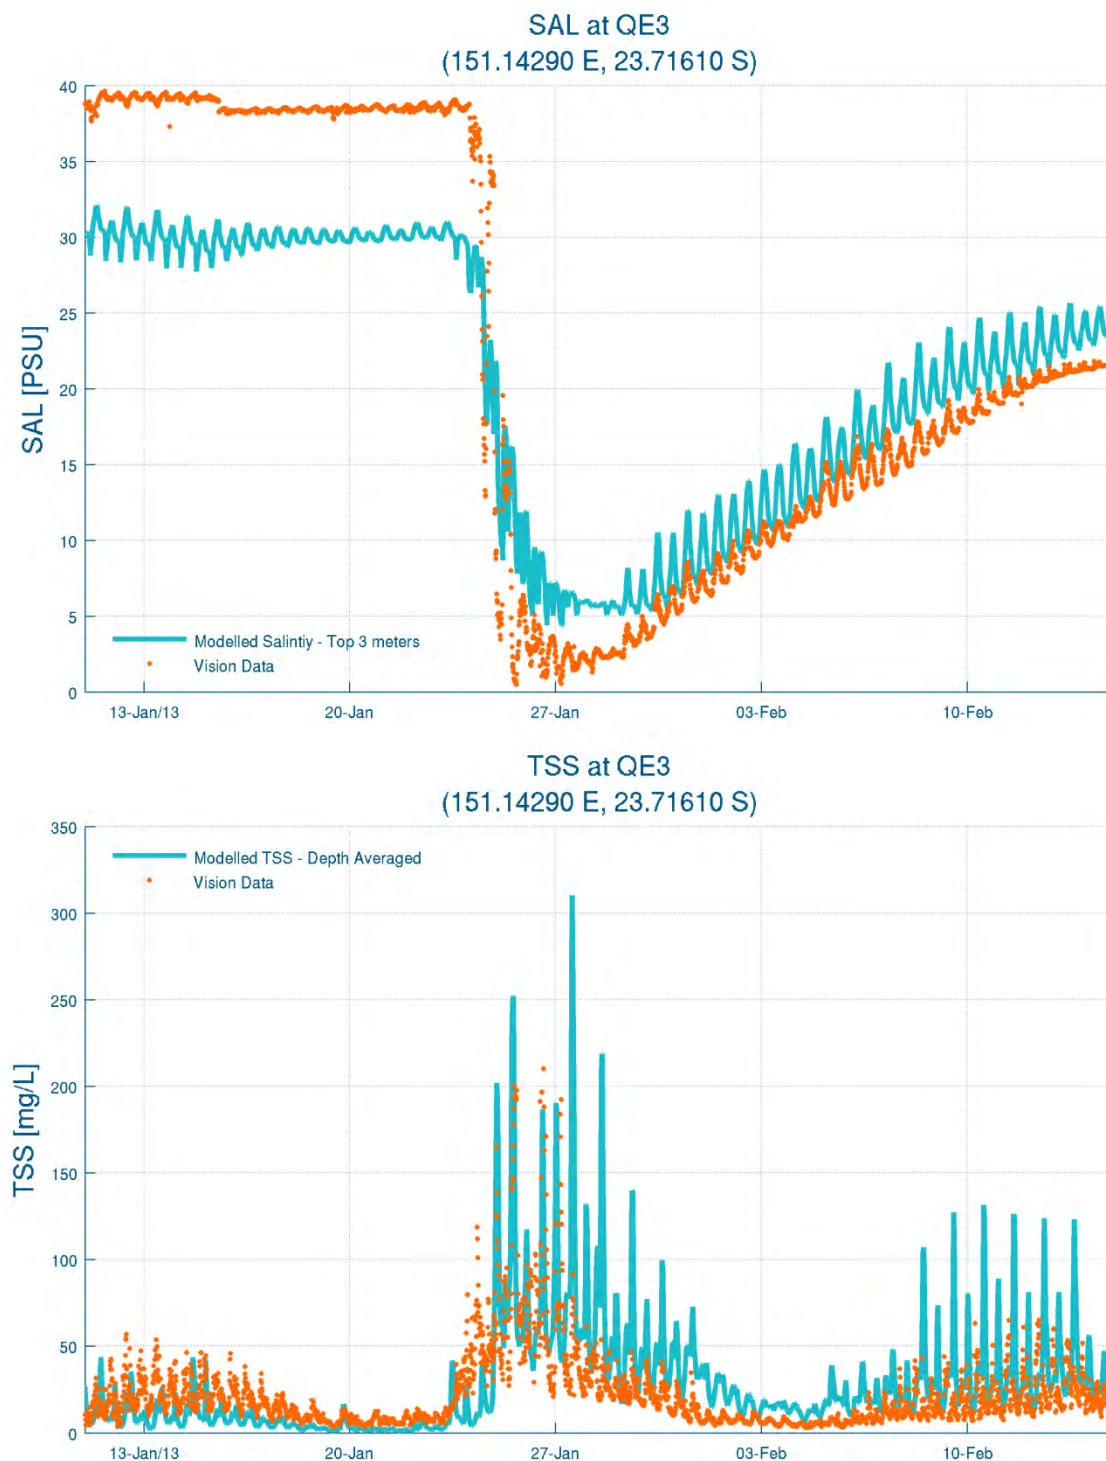
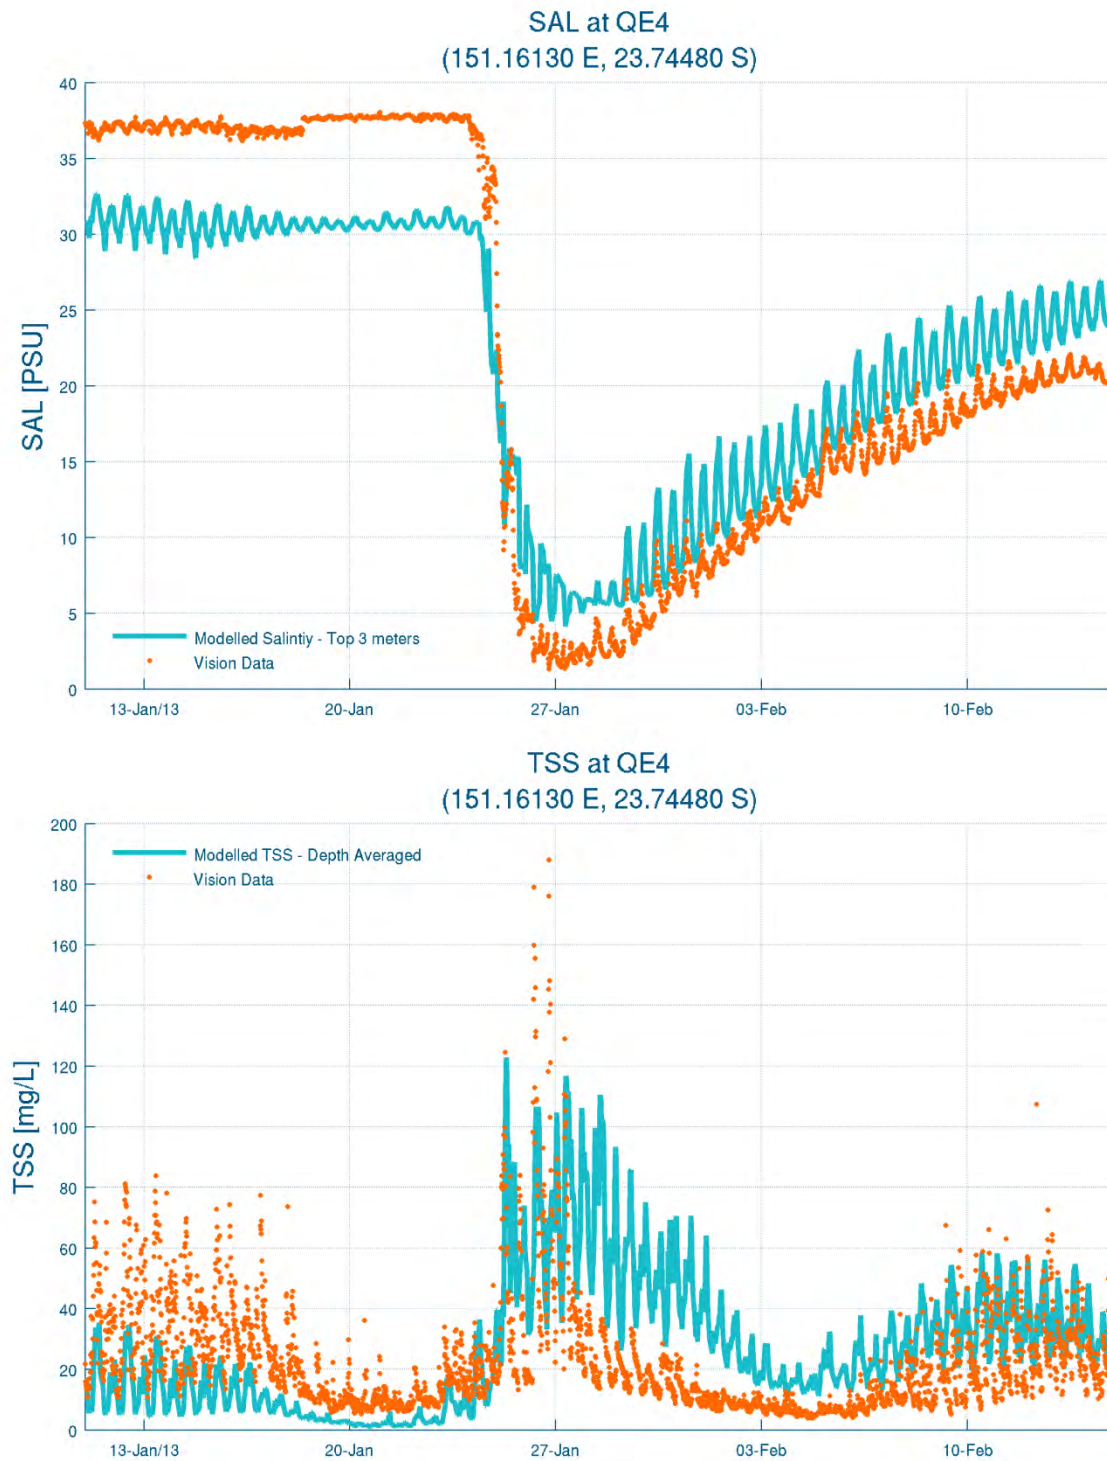
Figure C-12 TSS and Salinity Calibration at Site C7/1

Figure C-13 TSS and Salinity Calibration at Site P2B

Figure C-14 TSS and Salinity Calibration at Site P5

Figure C-15 TSS and Salinity Calibration at Site QE2/1

Figure C-16 TSS and Salinity Calibration at Site QE3

Figure C-17 TSS and Salinity Calibration at Site QE4
