Prioritisation of Reef Restoration and Enhancement Site Selection – Phase 2 and 3 Report

Reference: R.B20731.002.05.Phase 2 & 3.docx
Date: December 2015

This report has been produced for Gladstone Ports Corporation's Biodiversity Offset Strategy. The study was undertaken through a Consultancy Agreement (CA140017) between Gladstone Ports Corporation and BMT WBM to assess and prioritise sites for coral restoration and enhancement.

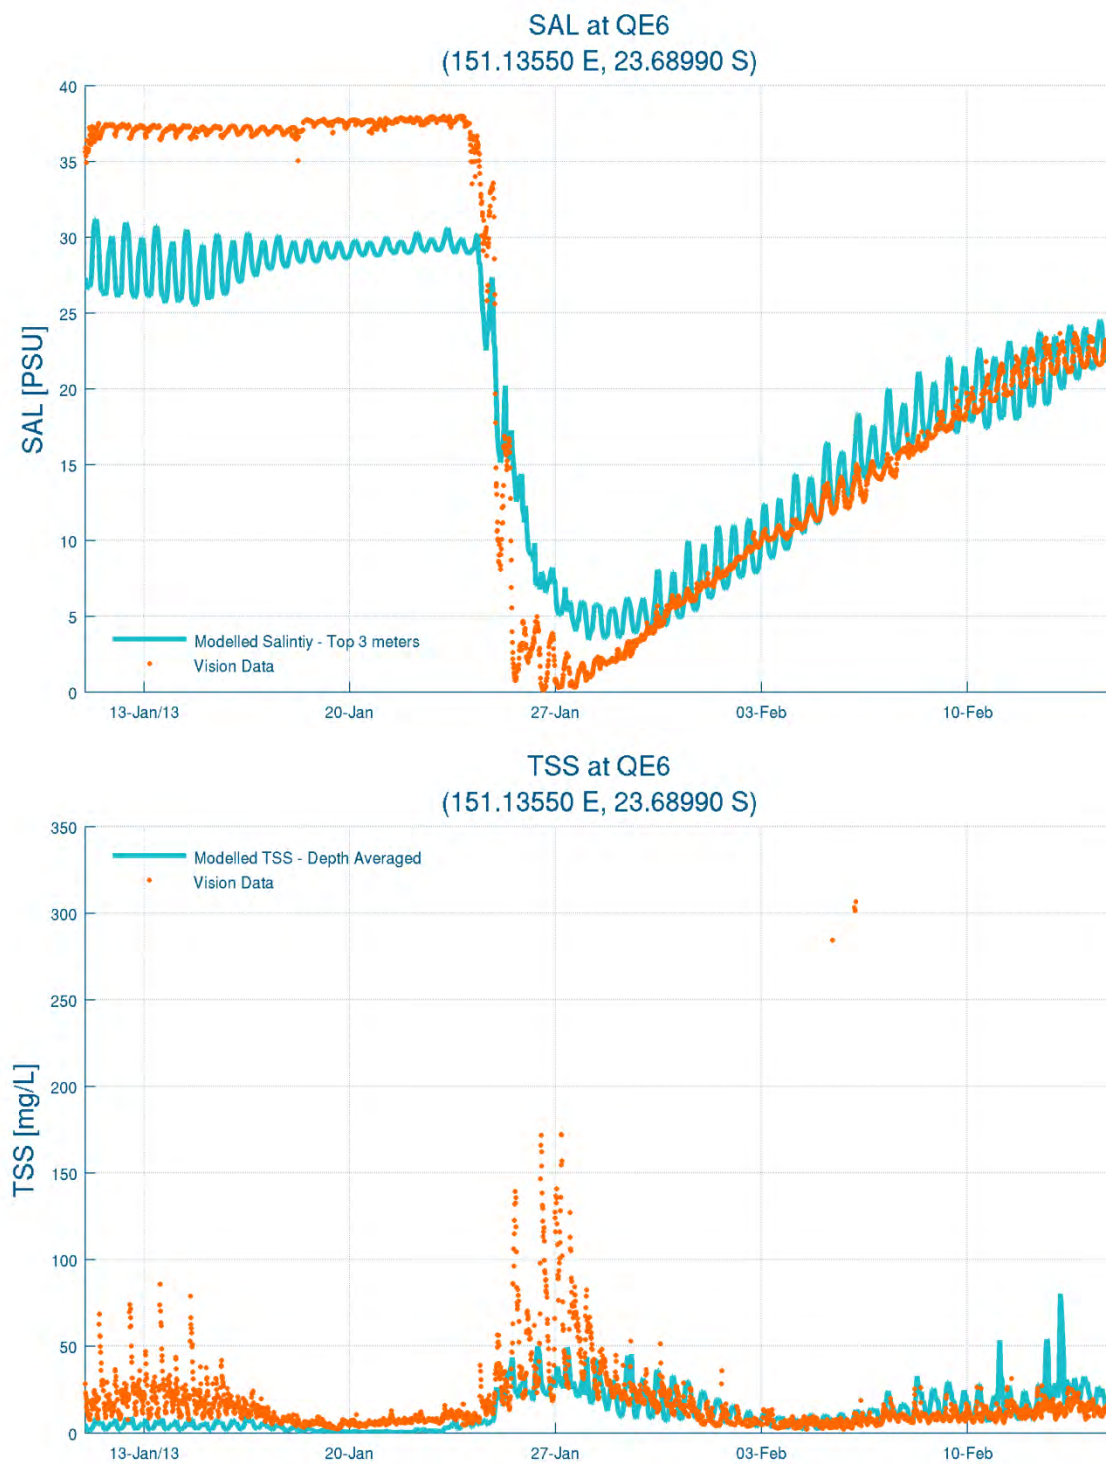
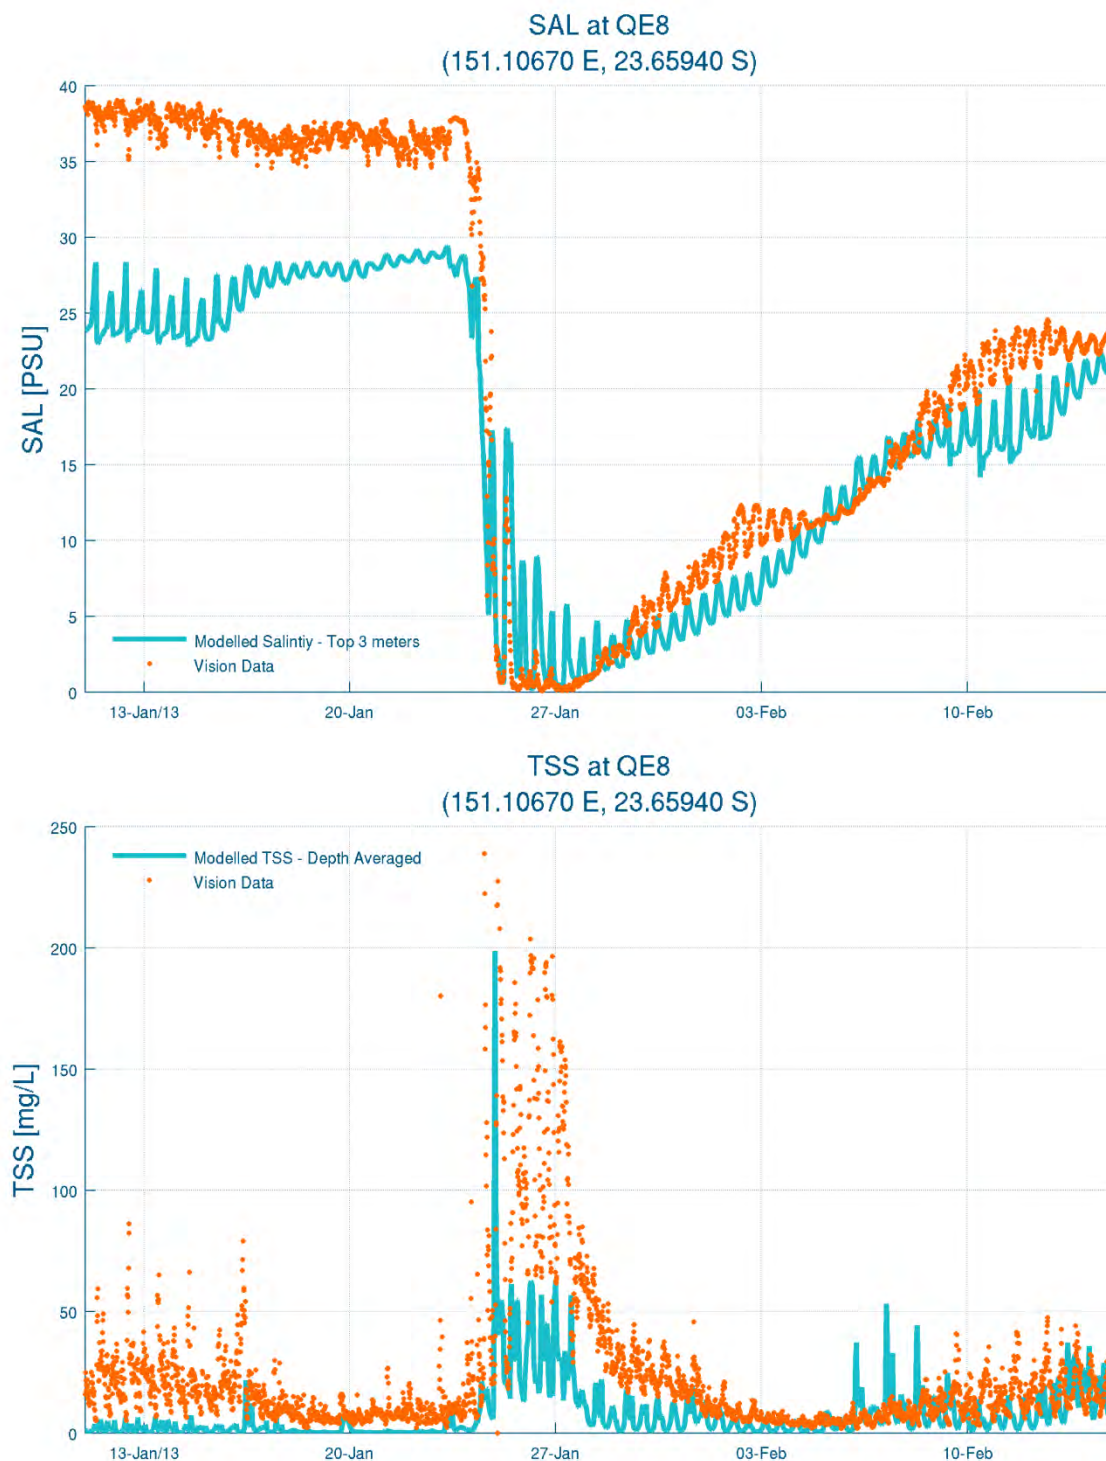
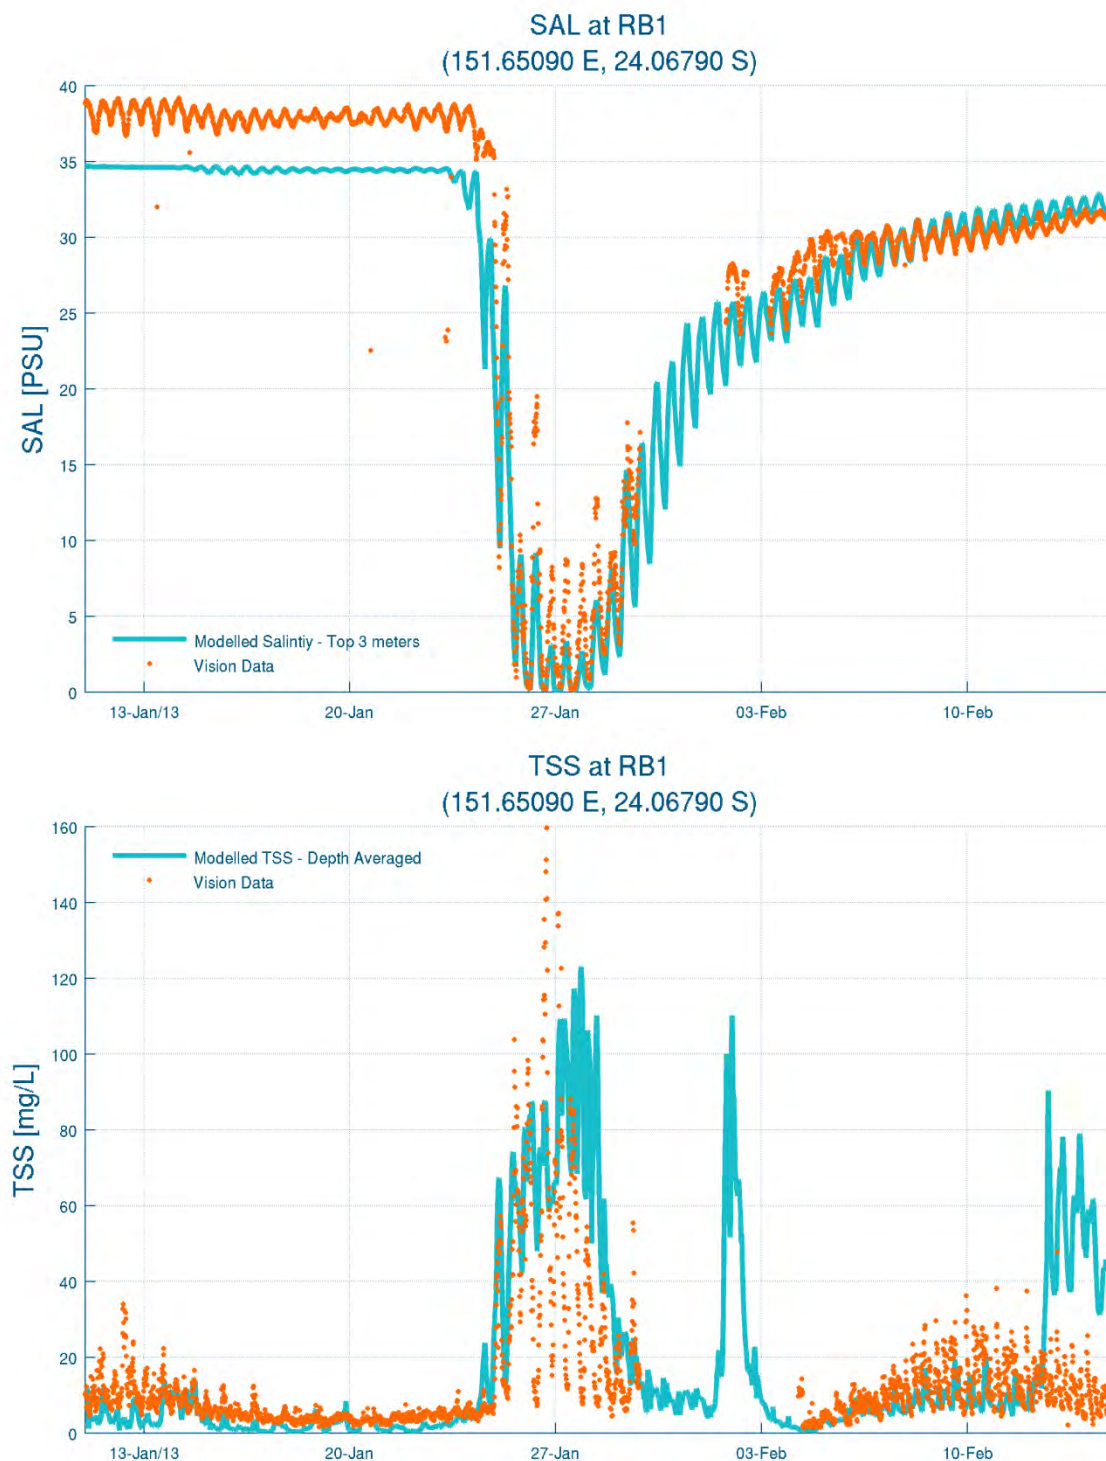
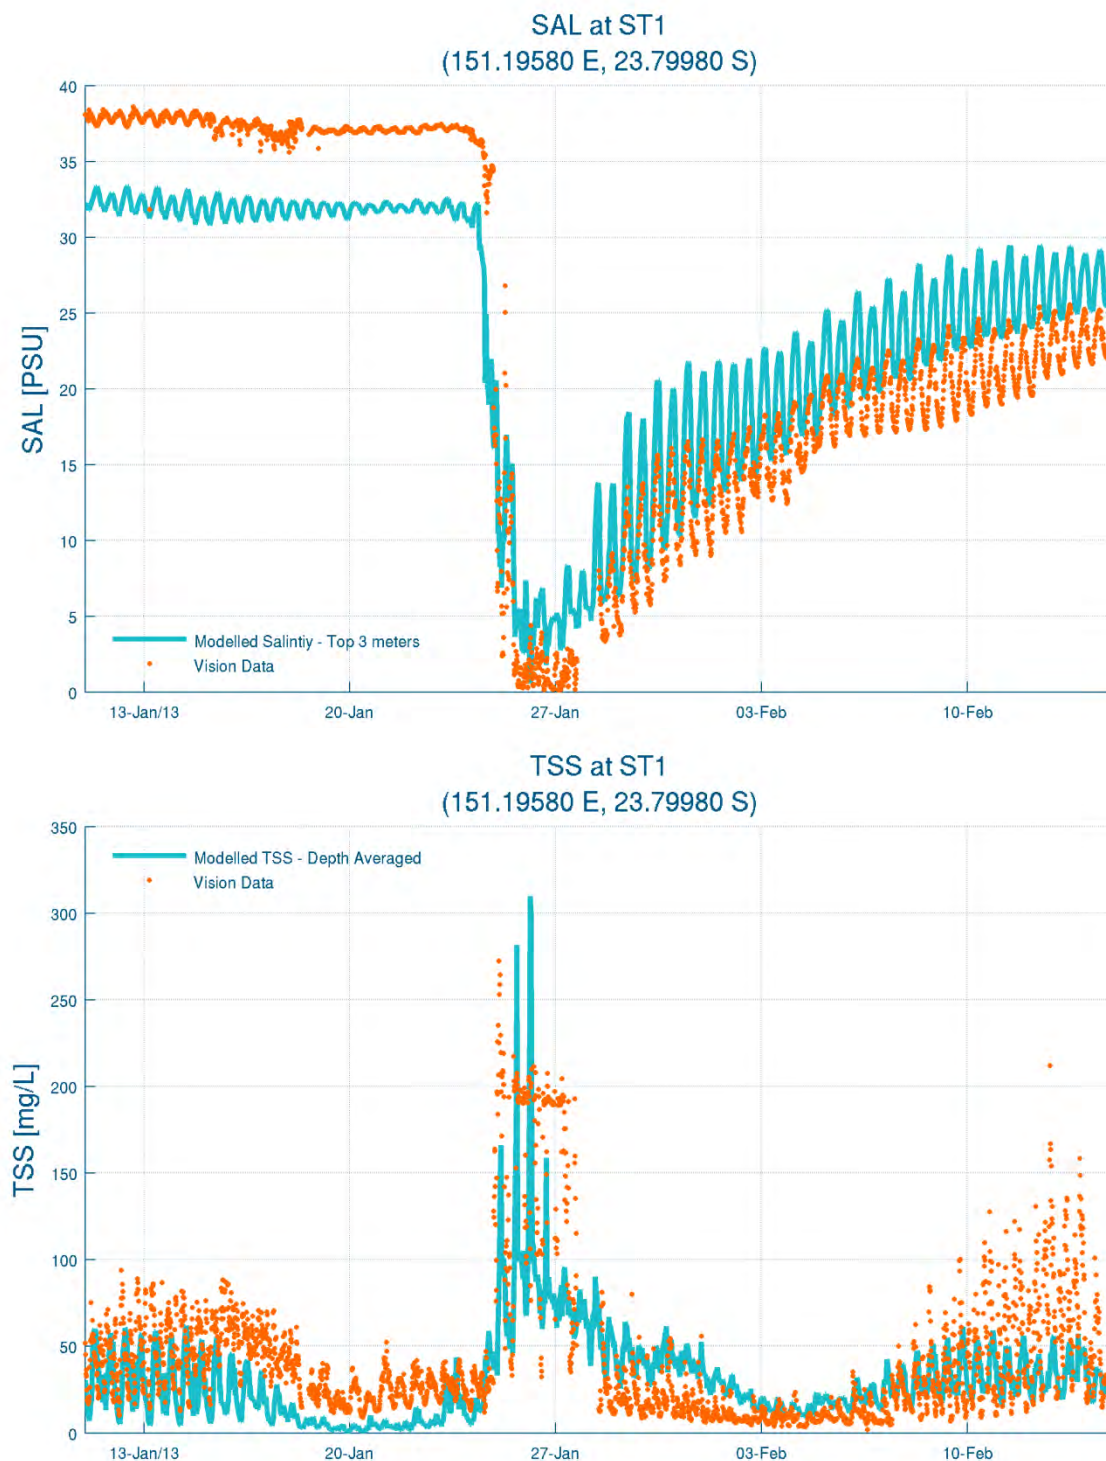
Figure C-18 TSS and Salinity Calibration at Site QE6

Figure C-19 TSS and Salinity Calibration at Site QE8

Figure C-20 TSS and Salinity Calibration at Site RB1

Figure C-21 TSS and Salinity Calibration at Site ST1

Calibration plots of TSS and Salinity can be seen in Figure C-6 through to Figure C-21. The model displays good overall calibration for salinity especially in the western reaches of the model. Sites such as BG10 and P2 (Figure C-10 and Figure C-13) capture the sharp drops in salinity associated with large fresh water inflows from the 2013 event. Modelled salinity at the offshore site SG1 (Figure C-6) does start to fall too early when compared with the measured data. The reason for this is likely due to inaccuracies in the timing of fresh water inflows. In terms of TSS, the calibration result at all sites is good, showing close correlation to the measured data. The exception to this was site P5 (Figure C-14) where the modelled TSS is higher than the recorded TSS for a period in late January and early February. The model appears to be overestimating the TSS in the fresh water plume, which may be due to limitations in accuracy of the vertical mixing model or perhaps a problem with the level of TSS assumed in the catchment model inputs.

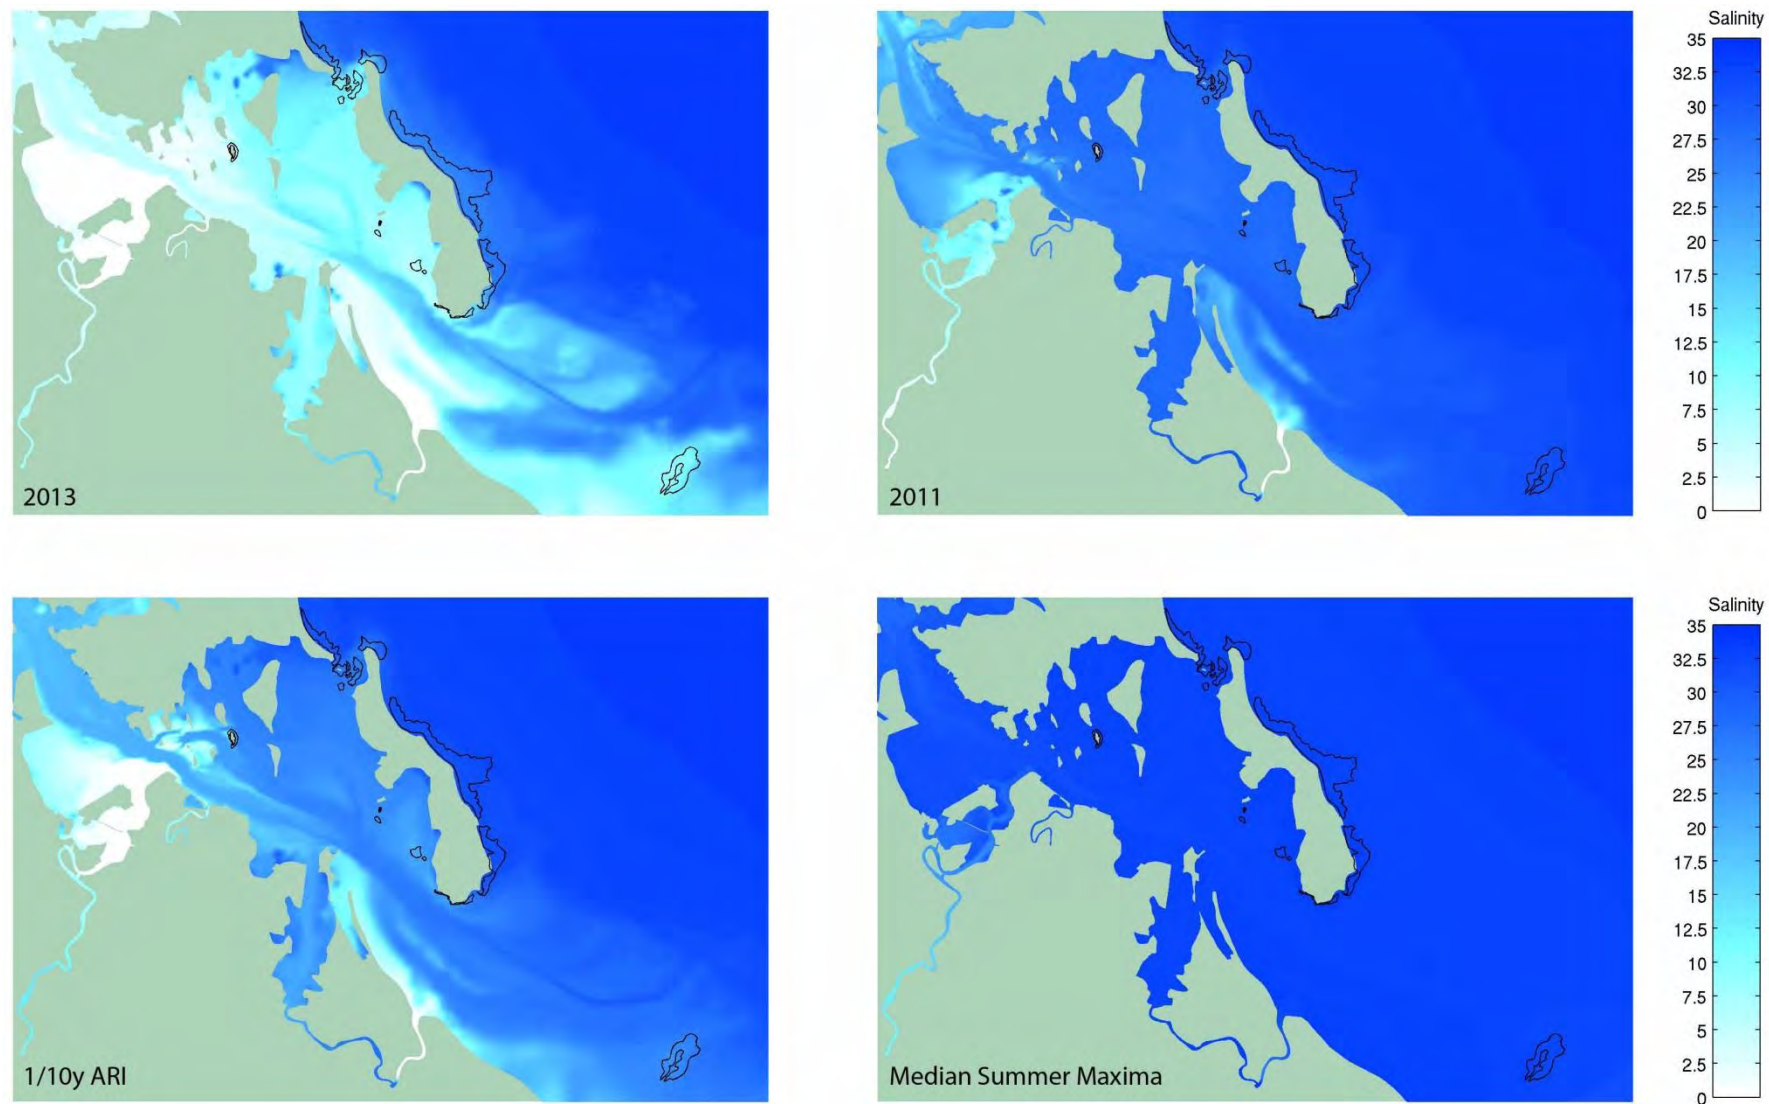
Figure D-1 0th percentile (minimum) salinity under various rainfall scenarios
