# Monitoring of Maintenance Dredging Plumes – Gladstone Harbour, November 2014

Prepared for: Gladstone Ports Corporation

Prepared by: BMT WBM Pty Ltd (Member of the BMT group of companies)

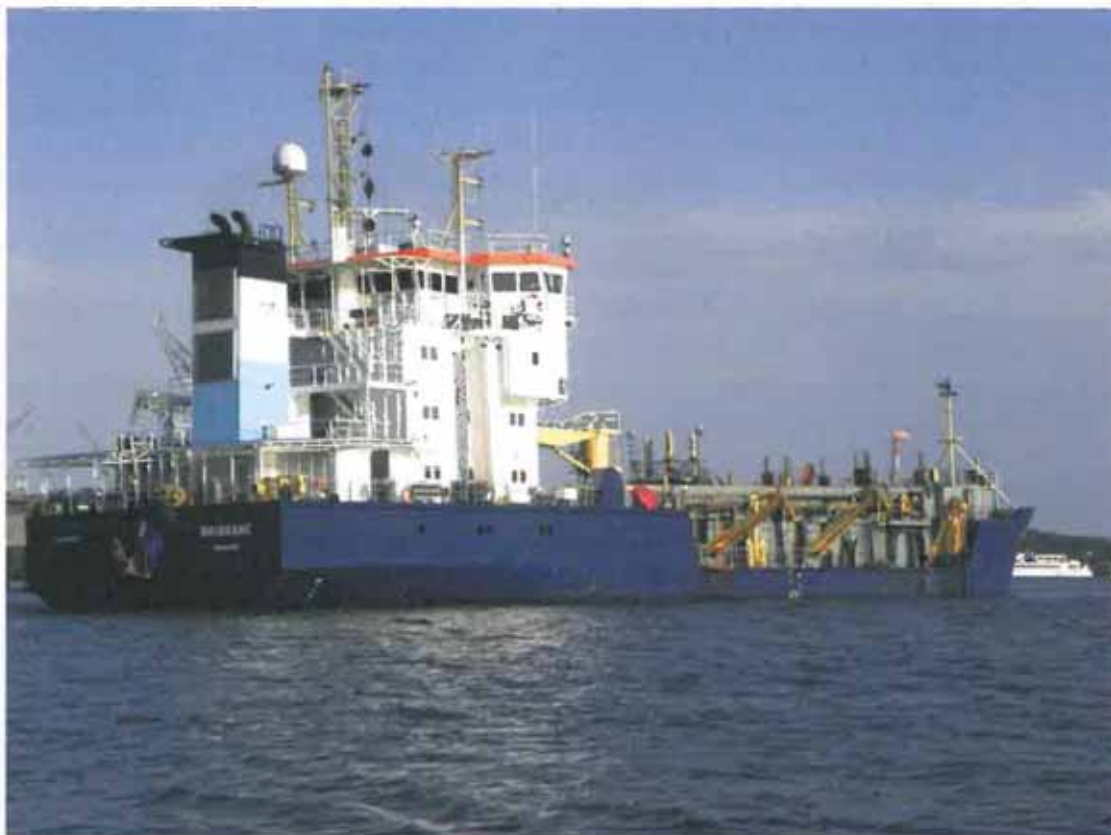
Figure 1-1 TSHD *Brisbane* Dredging in APLNG Swing Basin

Following cessation of dredging the TSHD *Brisbane* typically delivers its load of dredged material to a designated spoil ground, i.e. the EBSDS. On arrival at the EBSDS the dredger typically slows to a speed of a few knots and the dredged sediment loaded within the hopper is deposited over the required placement area by opening a series of five valves set within the bottom of the hopper, allowing for gravitational settlement of dredged material from the vessel through the water column to the seafloor.

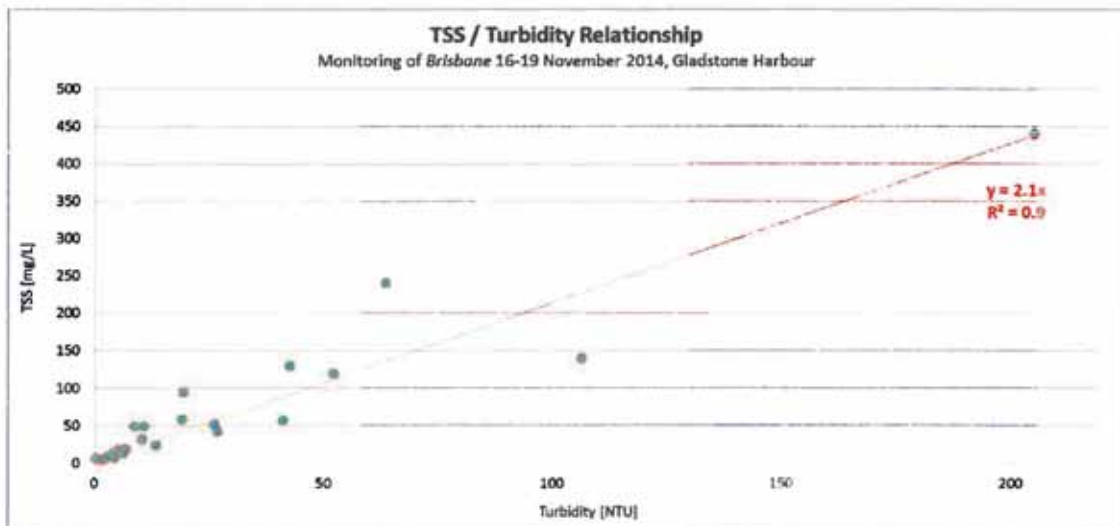
Figure 2-2 TSS / Turbidity Relationships

A total of 24 water samples were analysed for TSS and used to derive the NTU-TSS relationship of the OBS, a procedure detailed in Section 2.2. Refer to Appendix C for the tabulated TSS values and Figure 2-2 for the derived relationship. The relationship was derived using linear regression. The high coefficient of determination ( $R^2$ ) value confirms the applicability of a linear relationship with a zero intercept. The zero intercept was adopted as it was assumed that there was zero turbidity when there was zero TSS. It is possible that there were small contributions to the turbidity from sources other than suspended sediments such as algae, however as suggested from the data such contributions were insignificant with respect to the current study.

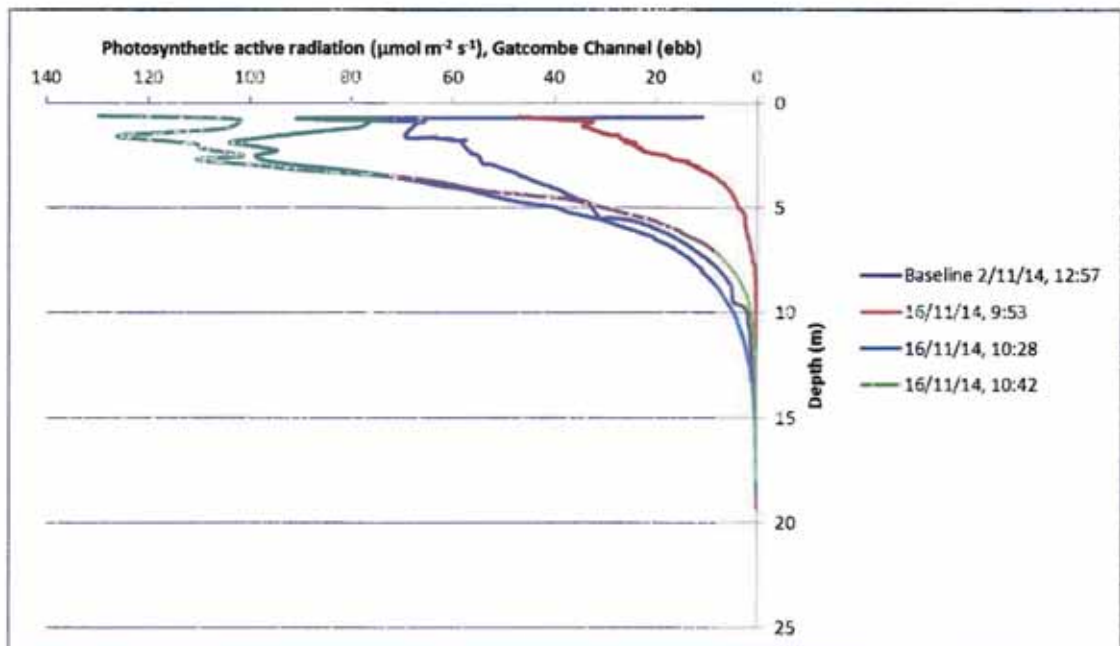
Figure 3-4 PAR profiles- Gatcombe Channel (ebb)

The measured PAR profiles including that from the baseline assessment are presented in Figure 3-4. Surface light availability was higher in two plume profiles compared to the baseline measurements mainly due to the cloudy conditions during the baseline assessment compared to the sunny conditions during the plume measurements at this location. Light availability was lowest through the water column for the first plume profile, consistent with the high turbidity values measured in this profile. Light availability declined rapidly down the water column with no light available below about 10m water depth for both baseline and plume measurements.

It is noted that the baseline light availability close to the water surface at the Gatcombe Channel was lower than measured in some of the plume profiles. This can be explained by the cloudy conditions at this location during the baseline measurements compared to the sunny conditions during the ebb and flood dredge plume measurements. The baseline light availability at Gatcombe Channel through the water column profile during cloudy conditions was comparable to light availability affected by turbid dredge plumes during sunny conditions at this location.

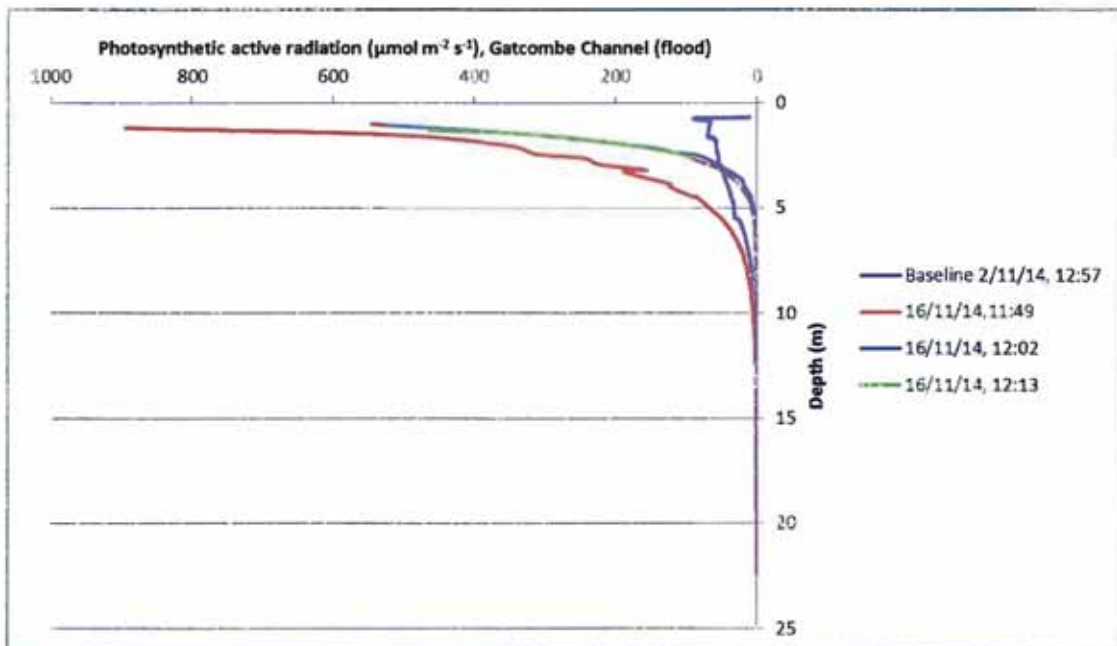
Figure 3-8 PAR profiles- Gatcombe Channel (flood)

The measured PAR profiles including that from the baseline assessment are presented in Figure 3-8. Surface light availability was higher in all plume profiles compared to the baseline measurements due to the cloudy conditions during the baseline assessment. Light availability diminished rapidly with depth with no light available at about 5 to 8m water depth during the plume assessment. This was comparable to baseline light availability under cloudy conditions. The measurements of light availability were consistent with the turbidity measurements for the respective plume profiles.

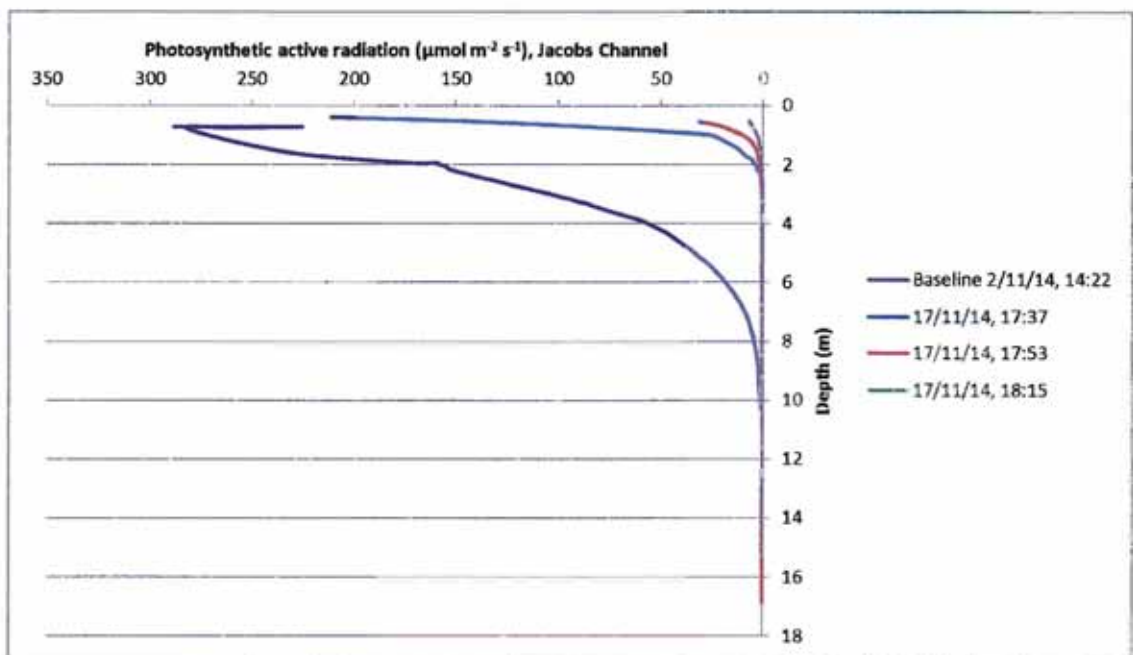
Figure 3-14 PAR profiles- Jacobs Channel

The measured PAR profiles including that from the baseline assessment are presented in Figure 3-14. Surface light availability was lower in all plume profiles compared to the baseline measurements. While it was sunny during both baseline and plume measurements, it is noted that the plume light profiles were taken in the late afternoon hours compared to early afternoon for the baseline measurements. Light availability diminished rapidly with depth with maximum light penetration down to 2 m water depth during the plume assessment. Light penetrated down to about 9m water depth during the baseline assessment.

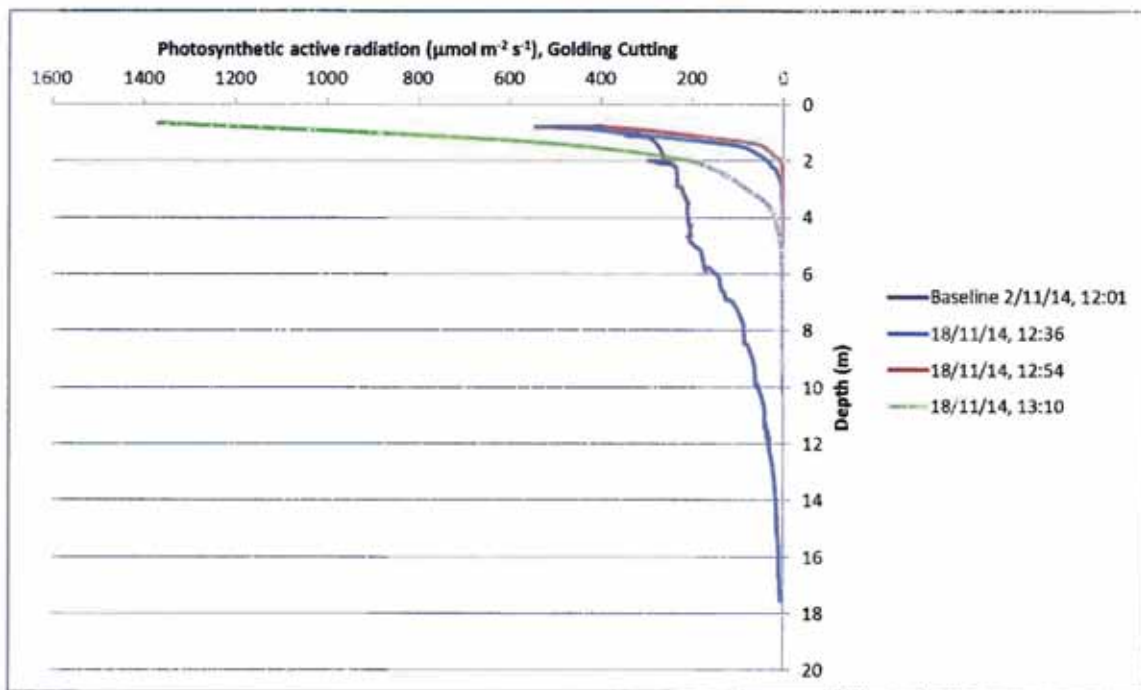
Figure 3-20 PAR profiles- Golding Cutting

The measured PAR profiles for the baseline and plume measurements are shown in Figure 3-20. The availability of light diminished rapidly with depth in the dredge plume profiles with no light available between 2 and 4.5m of water depth. In contrast, light was available down to about 14 m of water depth during baseline conditions. Ambient light conditions were similar between baseline and plume measurements. The PAR results agree with the observed turbidity values measured during baseline and dredging.

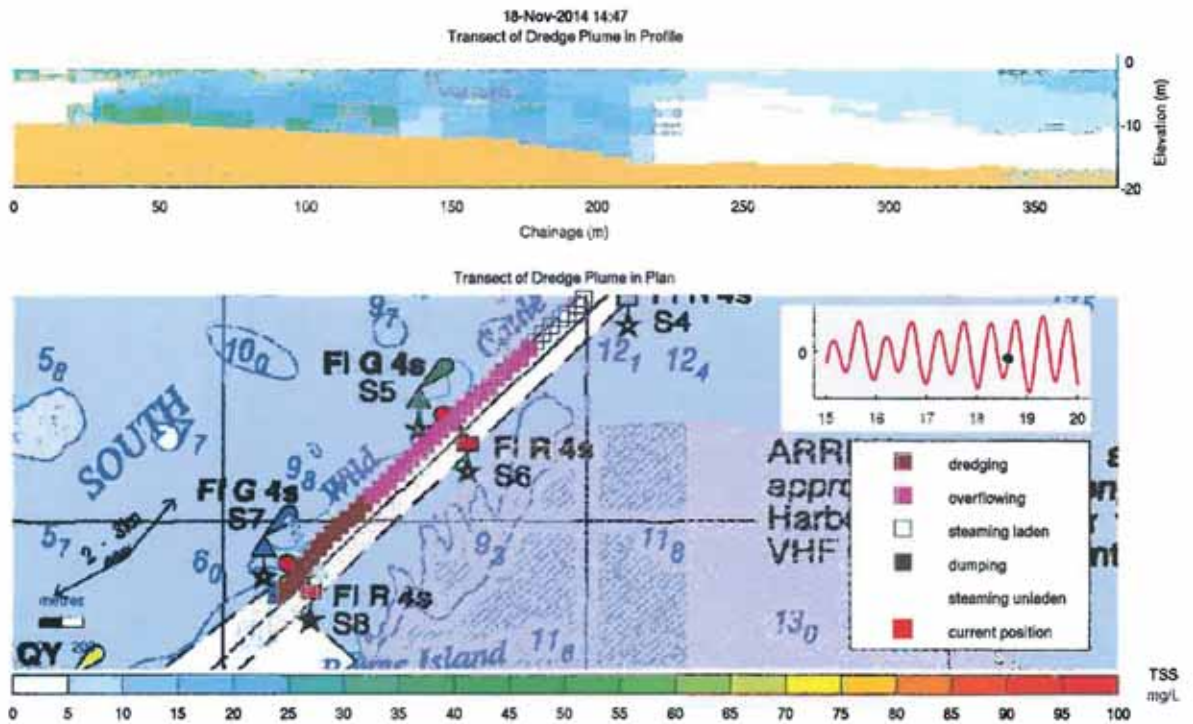
Figure 3-21 Dredging at Wild Cattle Cutting – flood tide

A single long plume was generated parallel to the channel. The dredge plume was advected by the flooding tide in a south-westerly direction mainly along the channel (towards the Boyne Cutting) but also with some displacement over and beyond the northern edge of the channel onto East Banks. The plume was advected along the channel over 1 km by the flooding tide over a period of almost 2 hours until near background turbidity conditions were achieved. The plume component displaced onto East Banks fell short of the rocky reef area by approximately 6 km. The plume was not advected towards the rocky reef areas at Jenny Lind Bank and did not pass over the deep water seagrass meadow in any detectable quantities.

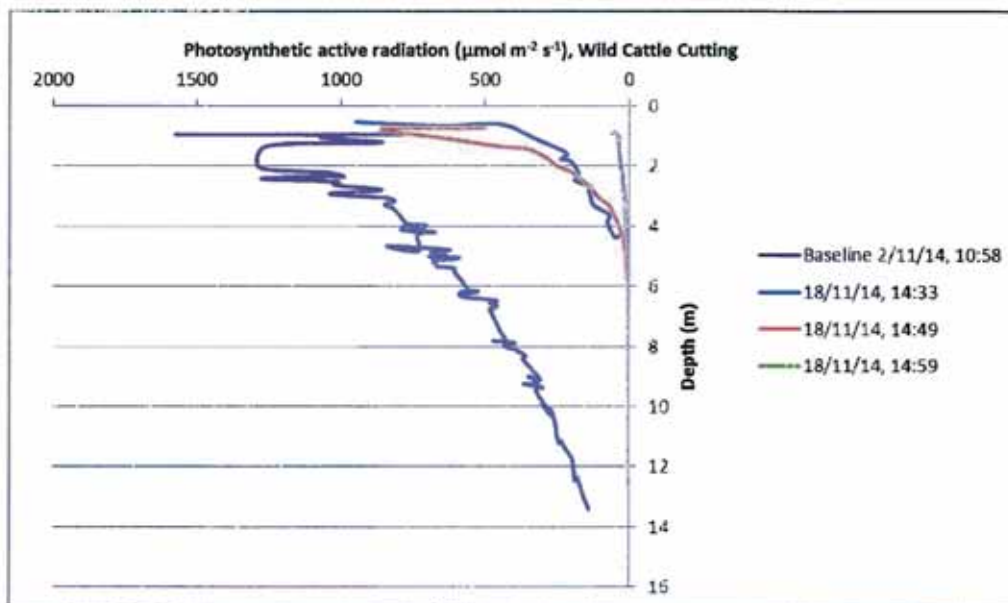
Figure 3-25 PAR profiles- Wild Cattle Cutting

The measured PAR profiles for the baseline and plume measurements are shown in Figure 3-25. The availability of light diminished rapidly with depth in the dredge plume profiles with no light available at about four m of water depth. In contrast, light was available down to the seafloor at about 14 m of water depth during baseline conditions. The PAR results agree well with the observed turbidity values measured during baseline and dredging. Ambient light conditions were similar for both baseline and plume measurements.

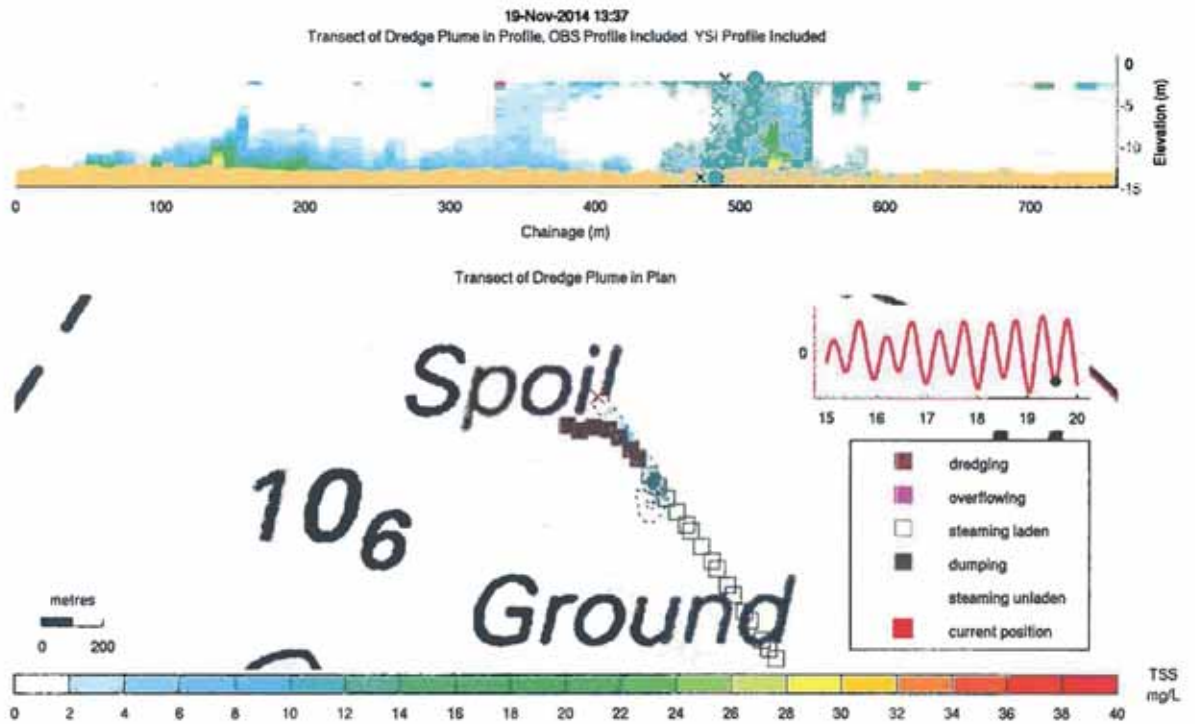
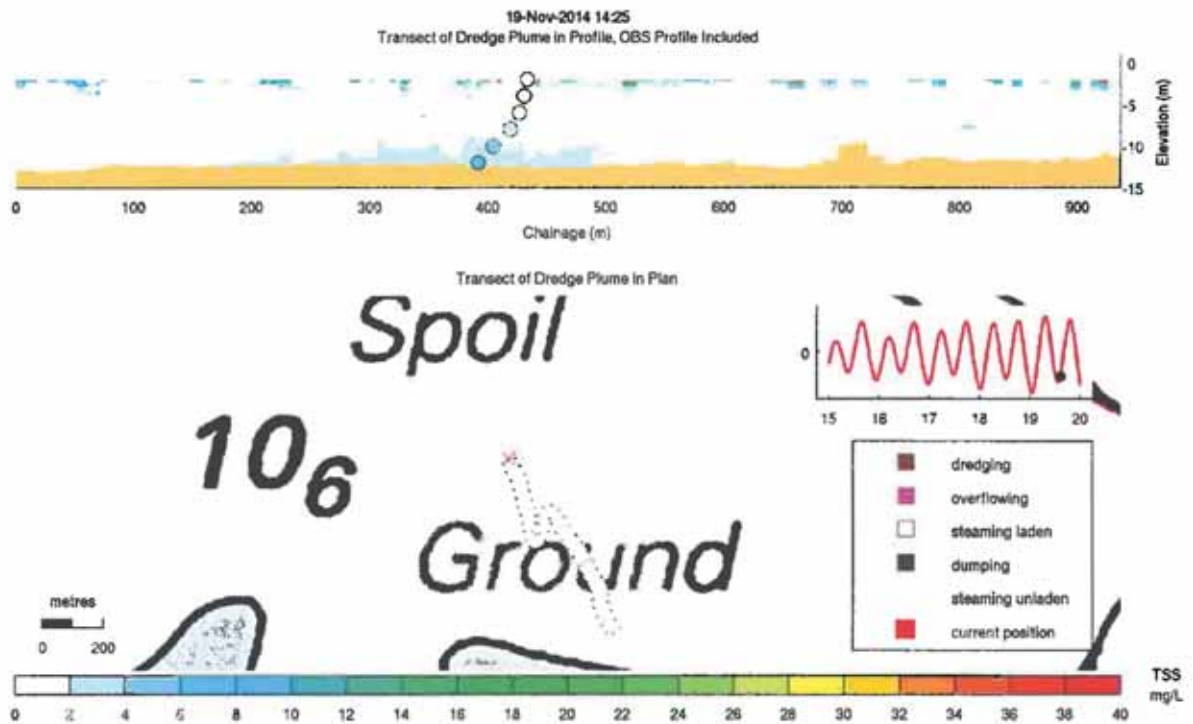
Figure 3-26 Disposal at EBSDS

The turbid dredge plume generated by disposal activities at the EBSDS was advected by the recently flooding tide south towards the deep water seagrass meadow. The plume was localised and of low intensity. The plume was identifiable for approximately 1.5 hours above the background concentrations by which time it had travelled approximately 1 km. The plume fell short of the deep water seagrass meadow by over 1 km.

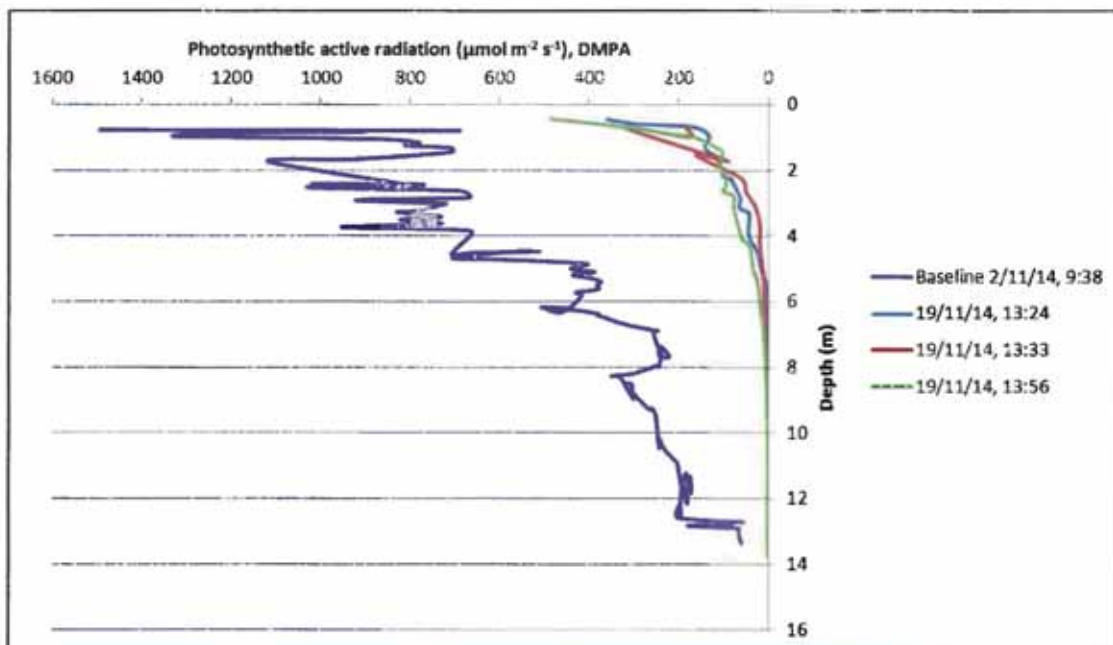
Figure 3-30 PAR profiles- EBSDS

The measured PAR profiles for the baseline and plume measurements are shown in Figure 3-30. The availability of light diminished rapidly with depth in the dredge plume profiles with no light available in about 4 to 5 m of water depth. In contrast, light was available down to at least 13 m of water depth during baseline conditions. Ambient light conditions were similar for both baseline and plume measurements. The PAR results agree well with the observed turbidity values measured during baseline and dredging.
