Seagrasses in Port Curtis and Rodds Bay 2023

Annual long-term monitoring

March 2024 | Report No. 24/07

A report for Gladstone Ports Corporation

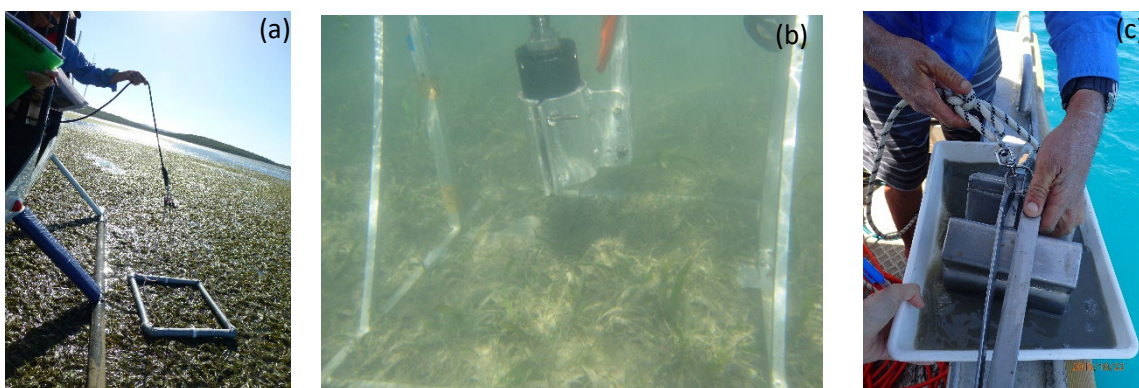
Figure 6. Seagrass monitoring methods in 2023. (a) helicopter survey of intertidal seagrass, (b, c) boat-based camera drops and van Veen grab for subtidal seagrass.

Intertidal meadows were surveyed at low tide using a helicopter. GPS was used to map the position of meadow boundaries and sites were scattered haphazardly within each meadow. Sites were surveyed as the helicopter hovered within one metre above the substrate (Figure 6a). Shallow subtidal meadows were sampled by boat using camera drops and a Van Veen grab (16.5 cm x 17.5 cm, depth 8 cm, Figure 6b, c). Subtidal sites were positioned at ~50-500 m intervals running perpendicular from the shoreline, or where major changes in bottom topography occurred, and extended offshore beyond the edge of each meadow. The appropriate number of sites required to detect seagrass change for each monitoring meadow was informed by power analysis (Rasheed et al. 2003). Where underwater visibility was poor, additional sites using the van Veen grab were used to assist in determining the presence of seagrass for mapping meadow boundaries. The details recorded at each site are listed in Section 2.3.

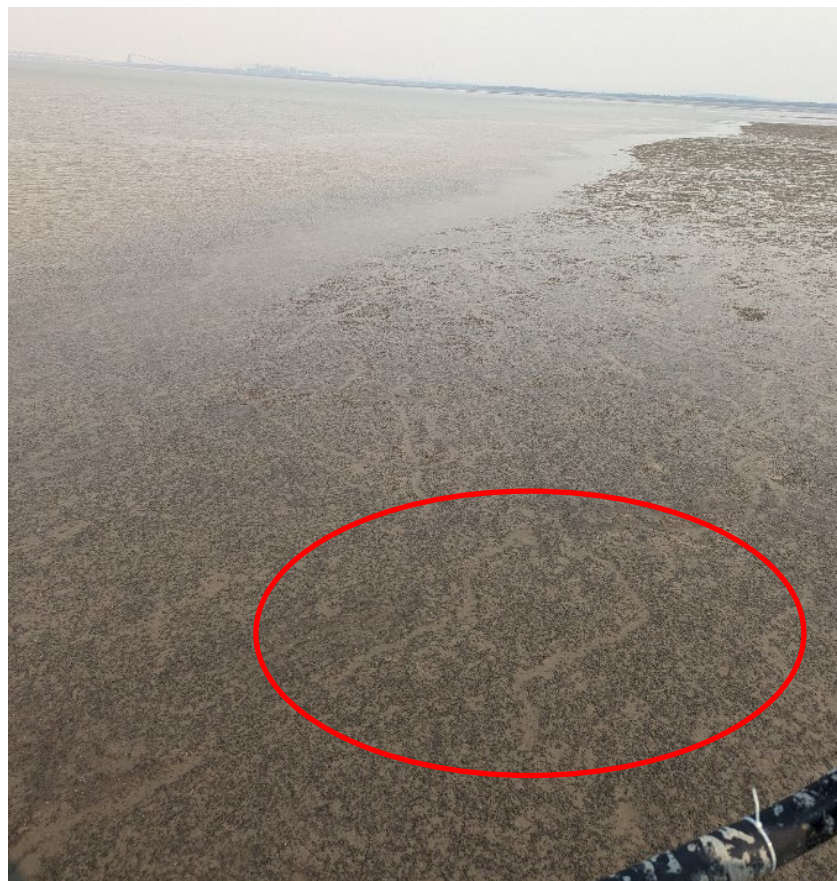
Figure 11. DFTs on seagrass patches in Meadow 6.

The seagrass meadow at Pelican Banks is historically the largest and highest biomass meadow in the Port Curtis and Rodds Bay region. In 2023, the meadow remained in poor condition with biomass remaining below the long-term average. This meadow has had poor or very poor biomass since 2015 and undergone a reduction of the foundation species *Zostera muelleri* over the six years prior to 2022. In this survey there were improvements in the proportion of *Z. muelleri* but biomass has remained low. Ongoing low biomass at Pelican Banks is potentially linked to grazing by megaherbivores (green turtles and dugongs). Turtle and dugongs were commonly sighted during the survey, and Dugong Feeding Trails (DFTs) were common in the Western Basin (Meadow 5, 6, 52-57) and Pelican Banks.

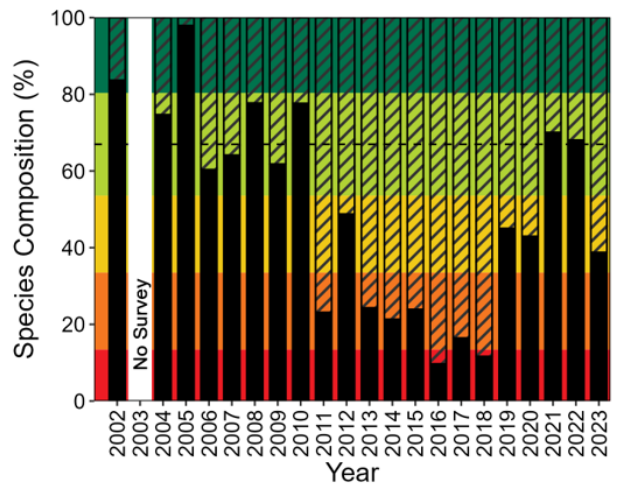
Figure 17. Changes in meadow area, biomass and species composition for Meadow 8, North Fisherman's Landing (Western Basin Zone), 2002–2023 (biomass error bars = SE; area error bars = "R" reliability estimate).

In 2023, Meadow 8 at North Fisherman's Landing was in satisfactory condition for the second year in a row. Meadow biomass decreased to a good condition 0.82 ± 0.15 g DW m⁻² and just below the long term average (1.08 g DW m⁻²) (Figure 17). Meadow area (235.22 ± 4.36 ha), improved to be in good condition and above the long-term average for first time in three years (Figure 17). Species composition shifted to being dominated by less persistent species *H. ovalis* and was in a satisfactory condition in 2023. Notable, was the addition of a small patch of *Halophila spinulosa*, not previously recorded in this meadow (Figure 17).

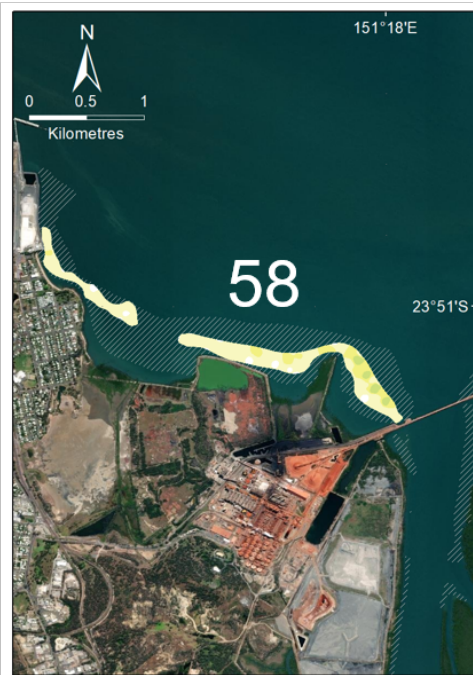
Figure 20. Changes in meadow area, biomass and species composition for Meadow 58, (Inner Harbour Zone), 2002–2023 (biomass error bars = SE; area error bars = "R" reliability estimate). CR = calculation restriction due to the absence of seagrass.

Overall seagrass meadow condition was poor due to absence of tracking species *Z. muelleri*. Both biomass and area improved to very good condition, however the absence of tracking species *Z. muelleri* meant the overall condition was poor. Biomass has improved to a very good condition from a very poor condition to 3.44 ± 0.46 g DW m⁻², and was well above the long term average. Meadow area also improved to above the long-term baseline and is in a very good condition covering 41.52 ± 3.68 ha. Species composition of this meadow was dominated by *H. uninervis* and *H. ovalis* which are less persistent than the tracking species *Z. muelleri* which has been absent for the past three years (Figure 20). Historically, species composition within meadow 58 fluctuates and has not been in a good condition since 2019 (Figure 20; Appendix 2).

Meadow 58 in the Inner Harbour has been in poor or very poor condition for the past three years. In 2023, this meadow improved in biomass and footprint to be in very good condition for both of these indicators however the species composition has failed to return to tracking species *Z. muelleri*. Prior to 2010, Meadow 58 had higher biomass (5-6 g DW m⁻²) before it underwent severe decline after high rainfall and river flow. During this time, *Z. muelleri* contributed 40-90% of the meadow biomass. Since the meadow was lost in 2010, it has transformed to be predominantly *H. uninervis*/*H. ovalis*, and the ongoing low contributions of *Z. muelleri* to the meadow suggest that it has not been able to re-establish and persist. This is the third year in a row that a total absence of the foundation species *Z. muelleri* has been recorded in the meadow, which has been replaced with less persistent *H. uninervis* and *H. ovalis*. The absence of *Z. muelleri* not only results in a very poor species composition score, but also leads to lower meadow biomass as *Z. muelleri* generally has greater biomass than *H. uninervis* and *H. ovalis*.

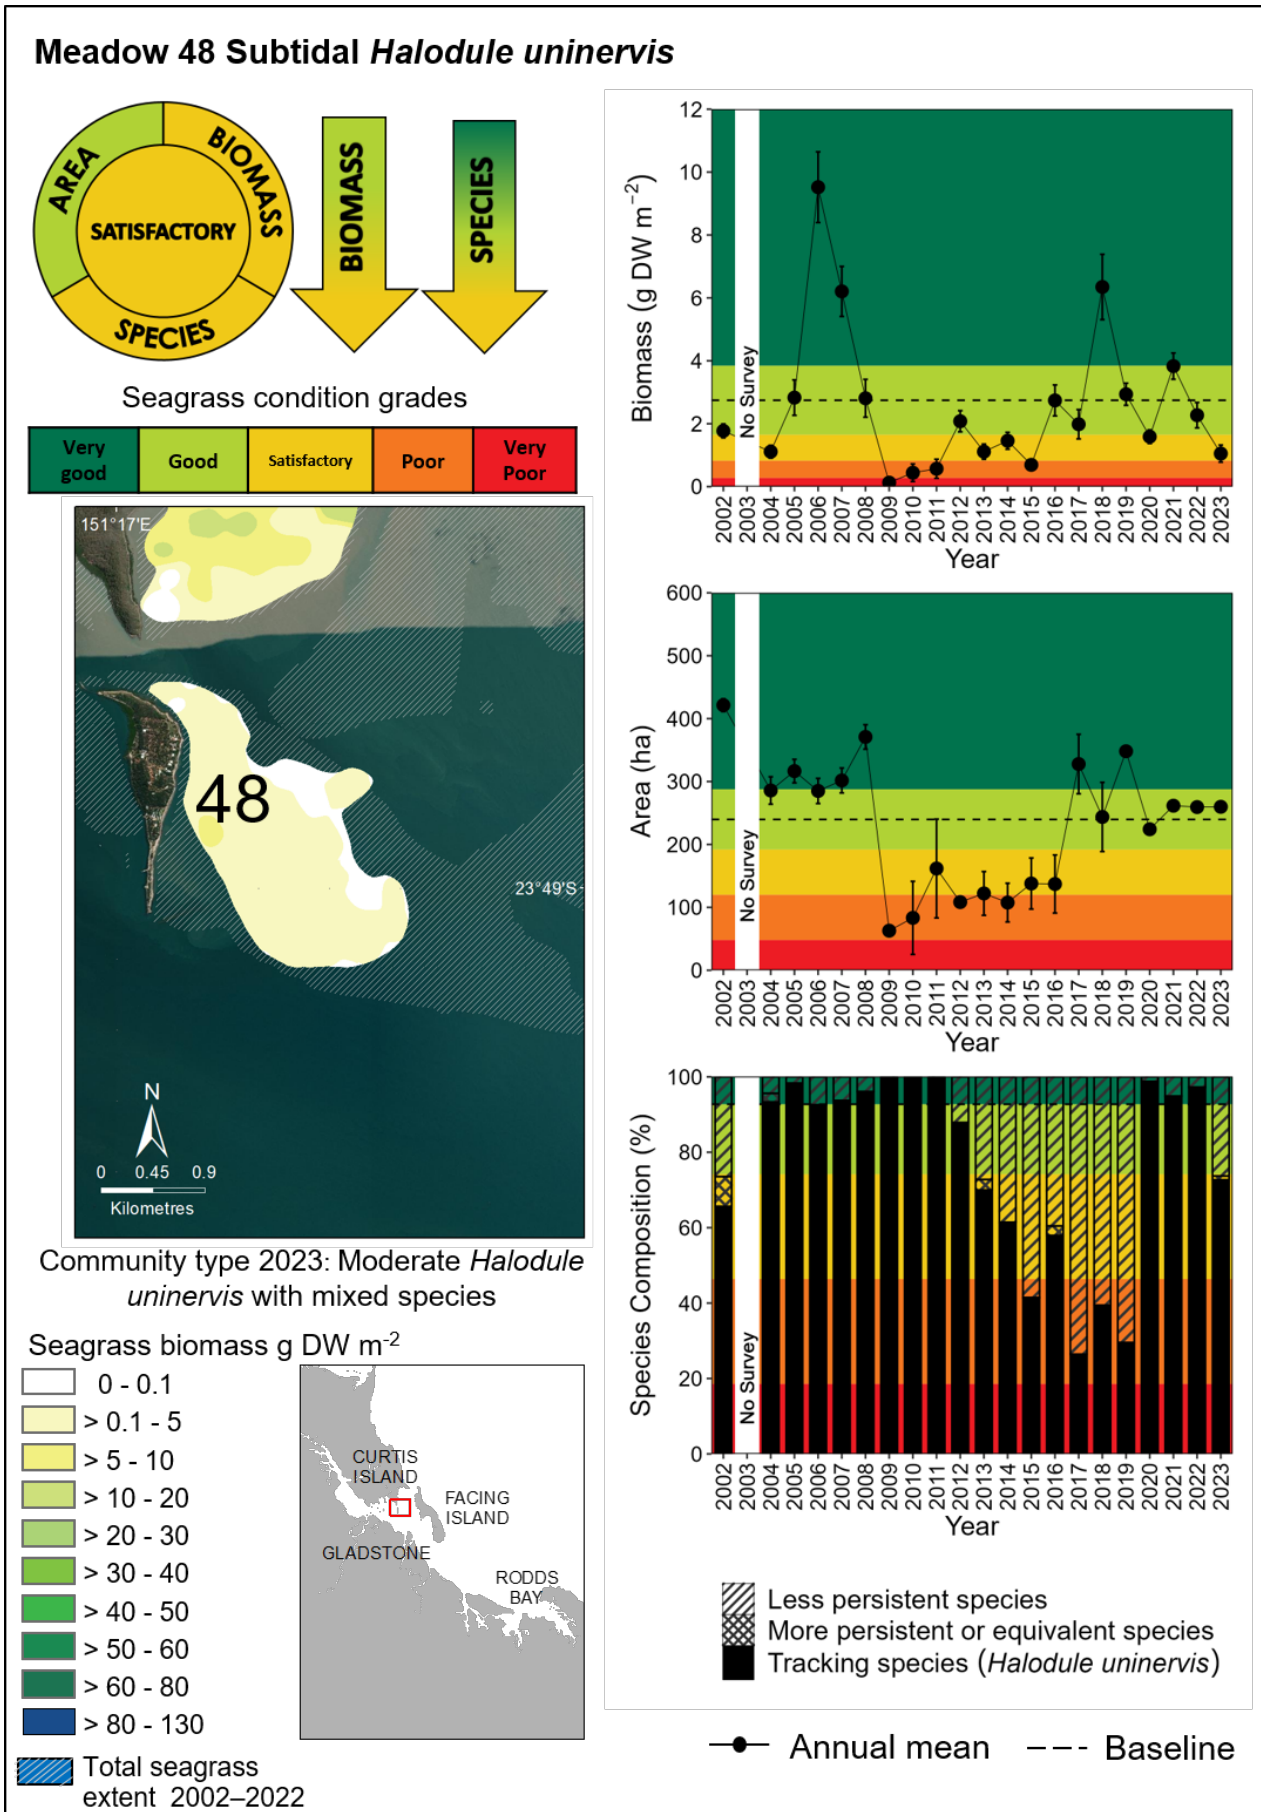
Figure 22. Changes in meadow area, biomass and species composition Meadow 48, Quoin Island (Mid Harbour Zone), 2002–2023 (biomass error bars = SE; area error bars = "R" reliability estimate).

Meadow 48 is a predominantly subtidal meadow on the eastern side of Quoin Island. Overall meadow condition was in a satisfactory condition in 2023 (Figure 22). Meadow biomass declined to a satisfactory condition, while meadow area was in a good condition and showed little variation from 2022. Species composition also declined to a satisfactory condition with a greater proportion of less persistent species *Halophila spp.* and lower proportion of the tracking species *H. uninervis*.

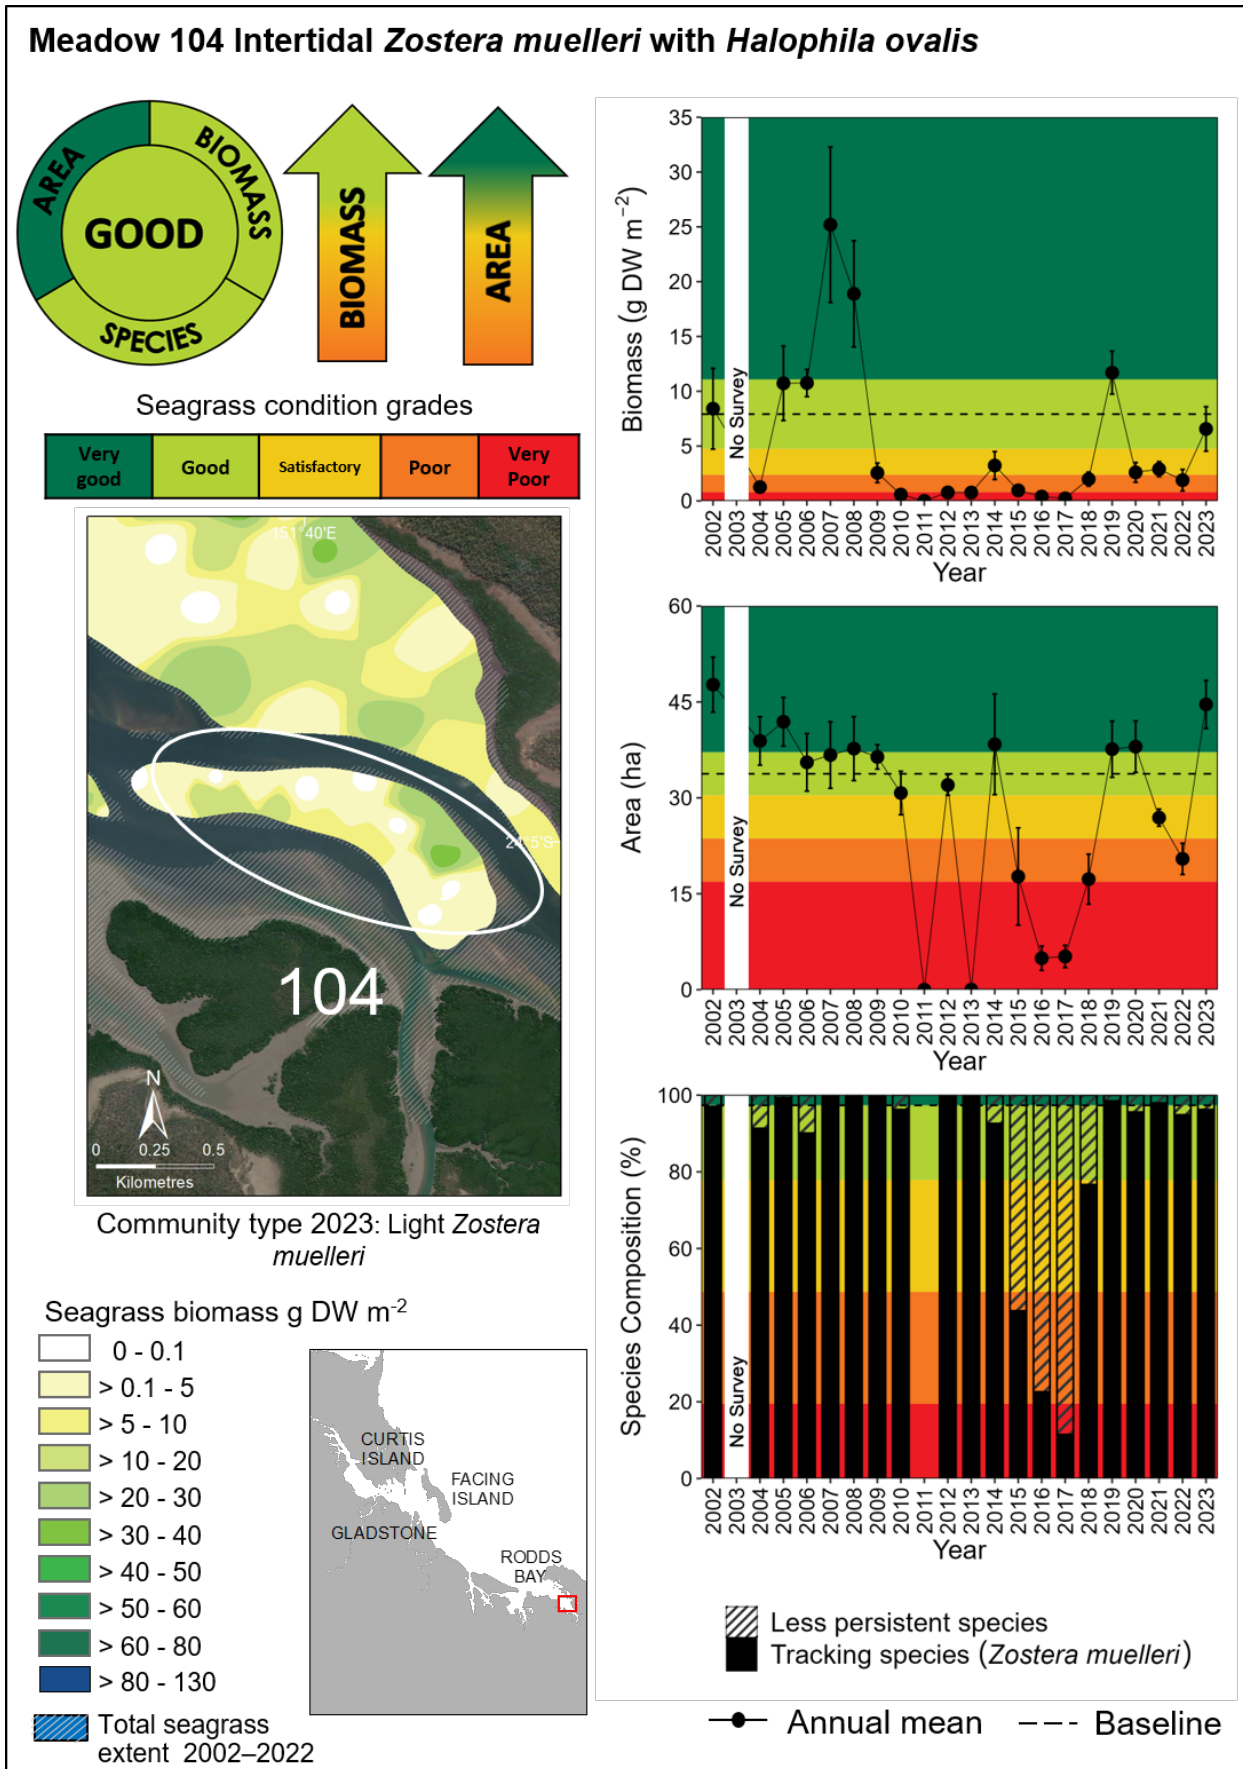
Figure 24. Changes in meadow area, biomass and species composition for Meadow 104, Rodds Bay Zone, November 2002–2023 (biomass error bars = SE; area error bars = "R" reliability estimate).

Meadow 104 was in a good condition, an improvement from poor in 2022 (Figure 24). Biomass improved from poor to good with 6.57 ± 2.03 g DW m⁻² in 2023, an increase from 1.89 ± 0.98 g DW m⁻² in 2022. Area increased to one of the highest since monitoring began covering 44.61 ± 3.75 ha resulting in a very good condition for the first time in two years. Species composition was also in a good condition with *Z. muelleri* persisting in this meadow (Figure 24).
