# Clinton Vessel Interaction Project

Annual Compliance Report: Environment Protection and  
Biodiversity Conservation Act Approval (EPBC) 2017/7976  
April 2026

# GPC FSOP – Langmorn Creek

## Bi-yearly Reporting: Report 2

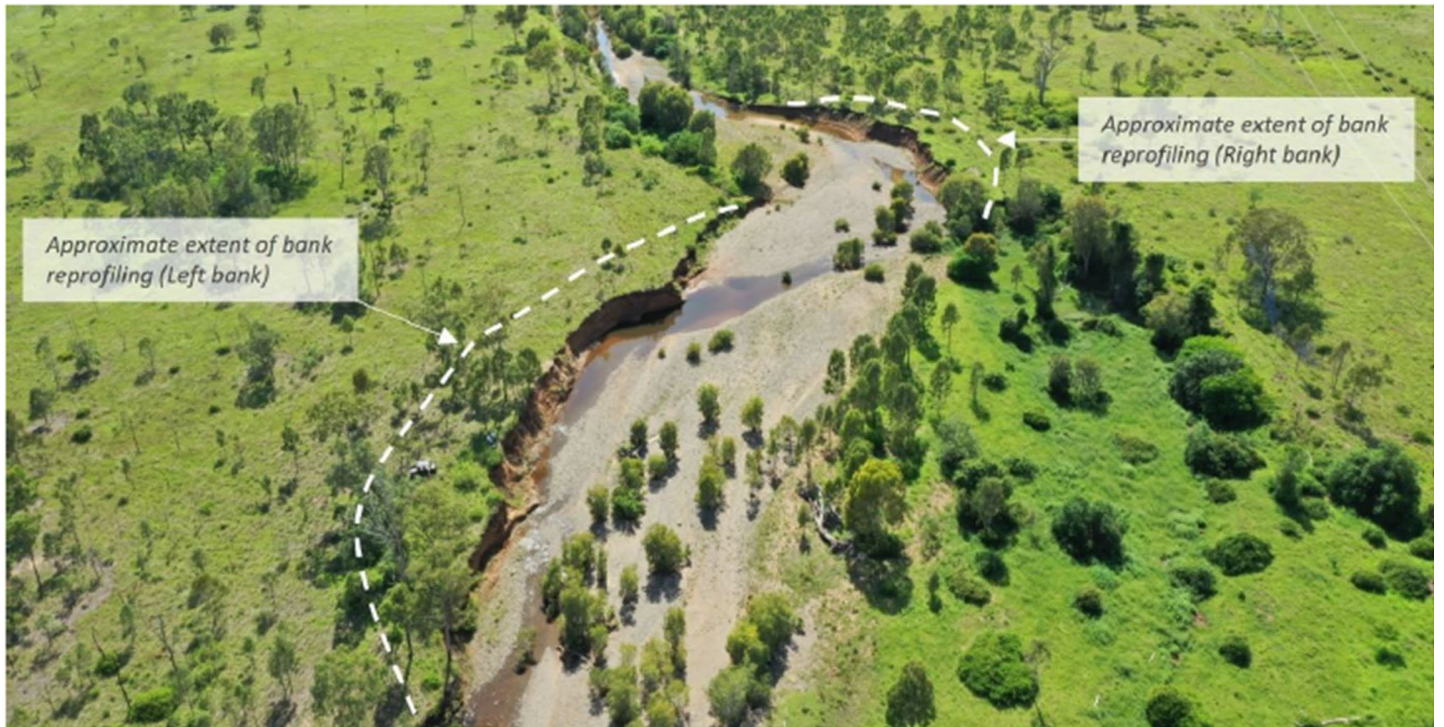
Figure 1. Aerial Imagery of the sites, illustrating the extent of the proposed works.

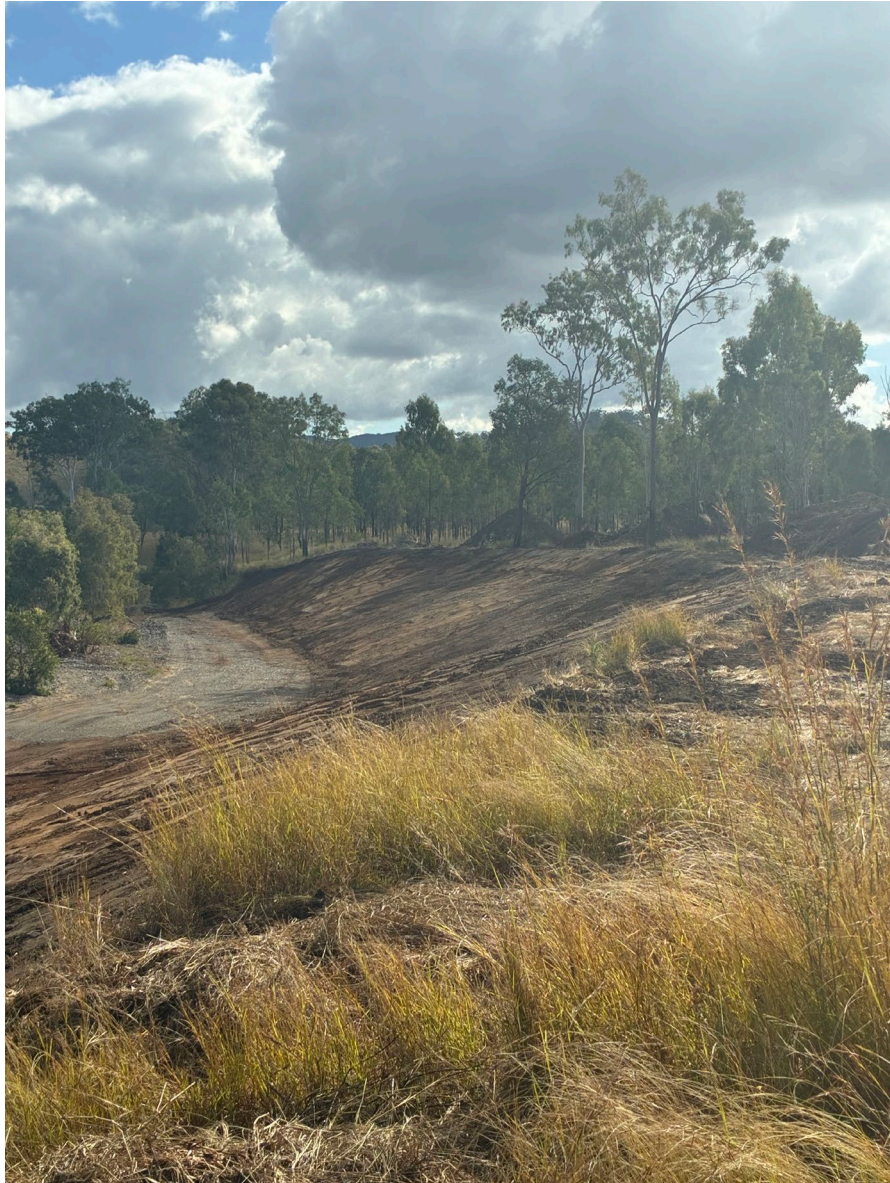
Figure 2. Progress image of site one. Reprofiling works have been completed as per designs. Image captured: 9 July 2025

Images 2 and 3 illustrate the implementation progress, which is ahead of schedule and demonstrates a significant improvement in land condition compared with Image 1.

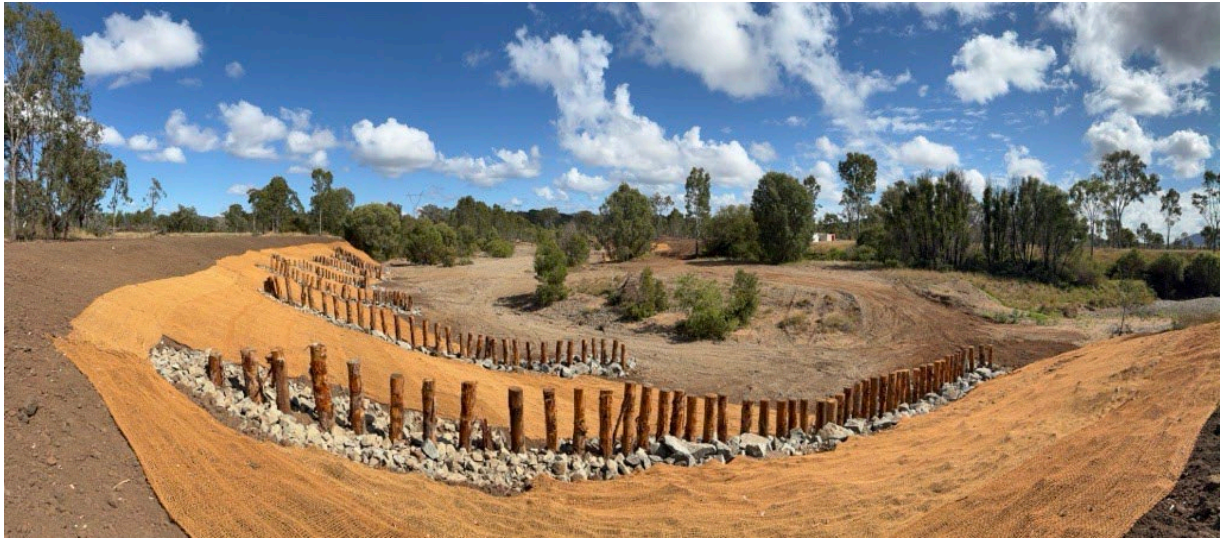
Figure 3. Progress image of site two upon completion of civil works. Works undertaken included pile driving, rock benching and topsoil replacement. Image captured: 4<sup>th</sup> September 2025

During this stage, site preparation activities were undertaken, including light grading of the access road, mobilisation of construction equipment, and vegetation clearing of 0.4 hectares in line with the Environmental Management Plan. The remainder of the civil works included bank reprofiling, pile field installation, rock benching, and topsoil replacement.

Challenges were encountered with pile field installation, as piles were driven only to the minimum required depth. To address this, the piles were trimmed to the specified height provided by Alluvium, and rock placement was adapted to include larger sized rock (D50 350) over a greater area of the pile field profile to provide additional support. To further safeguard soil integrity and promote natural regeneration, coir matting was installed, and seeding was undertaken across the site. A preliminary inspection has been carried out by Alluvium, and civil contractors have since demobilised from the site.

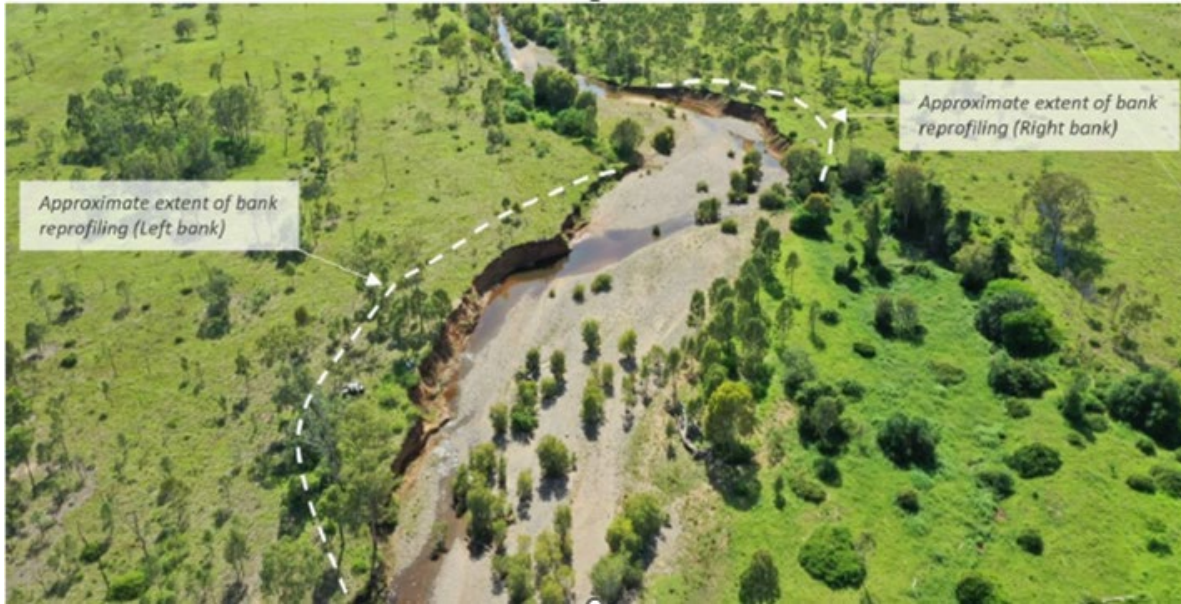
Image 1: Aerial imagery of the sites before construction commenced.

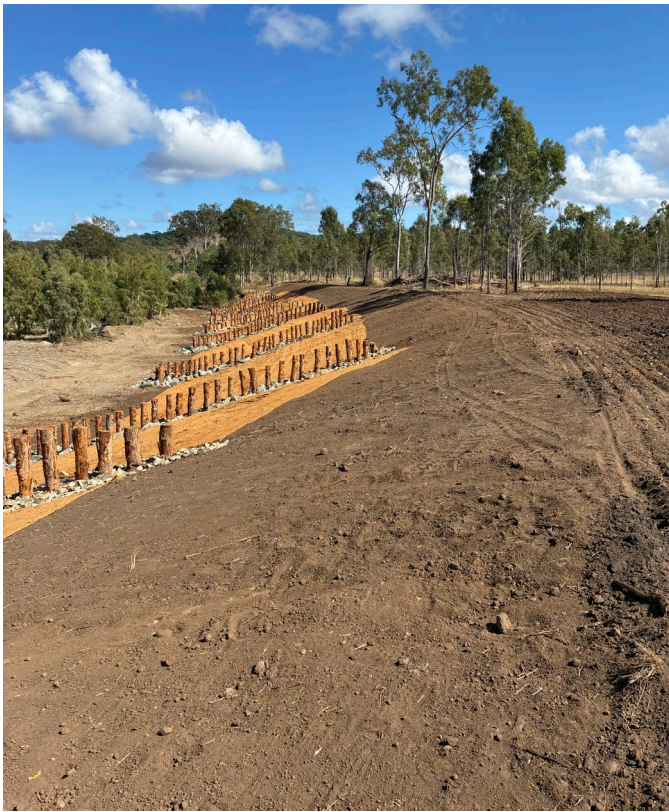
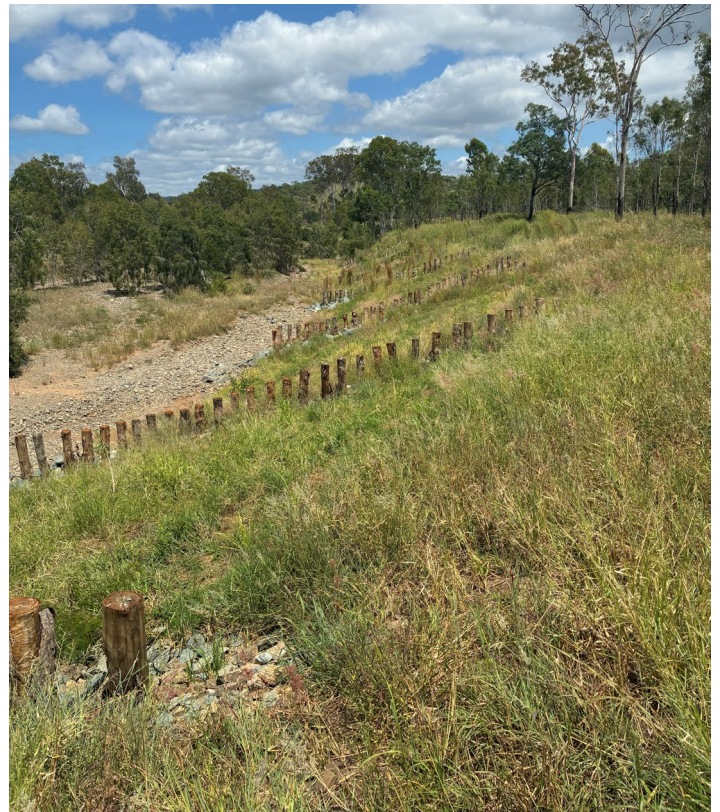
Image set 3. Progress of Pile Field One

Left: Completion of civil works (image captured 4 September 2025)

Right: Completion of irrigation and revegetation works (image captured 9 February 2026)

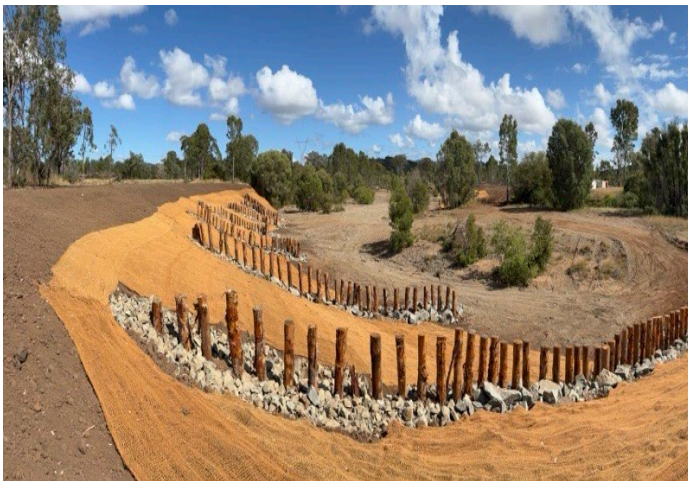
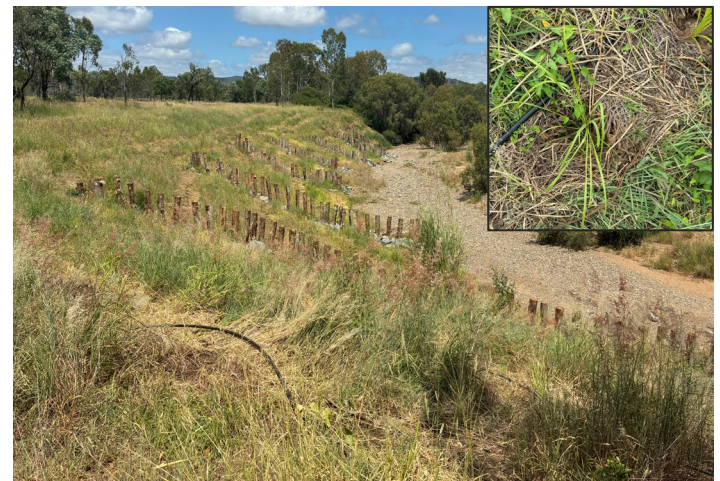
Image set 4. Progress of Pile Field Two

Left: Completion of civil works (image captured 4 September 2025)

Right: Completion of irrigation and revegetation works (images captured 9 February 2026)

Inset: *Lomandra hystrix* planted with ripper irrigation (6 L over 2.5 hours)

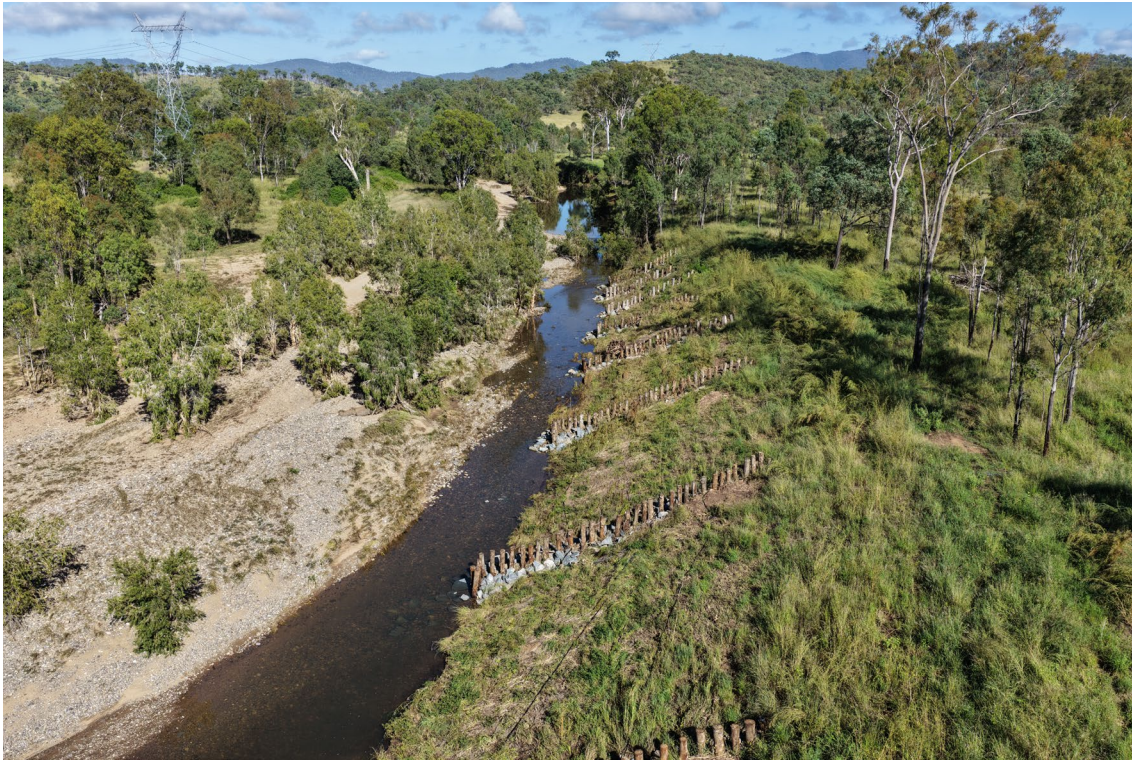
Image 2: Site 1 looking upstream (image captured 12 March 2026)

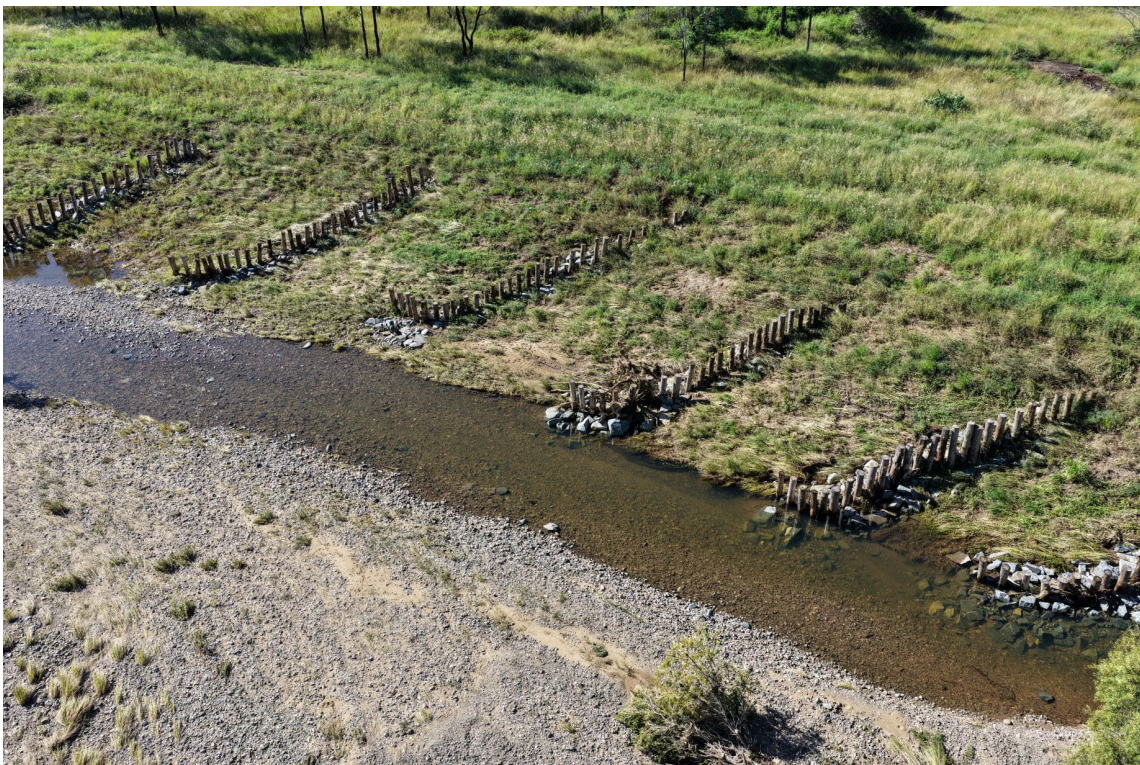
Image 3: Site 2 looking downstream (image captured 12 March 2026)

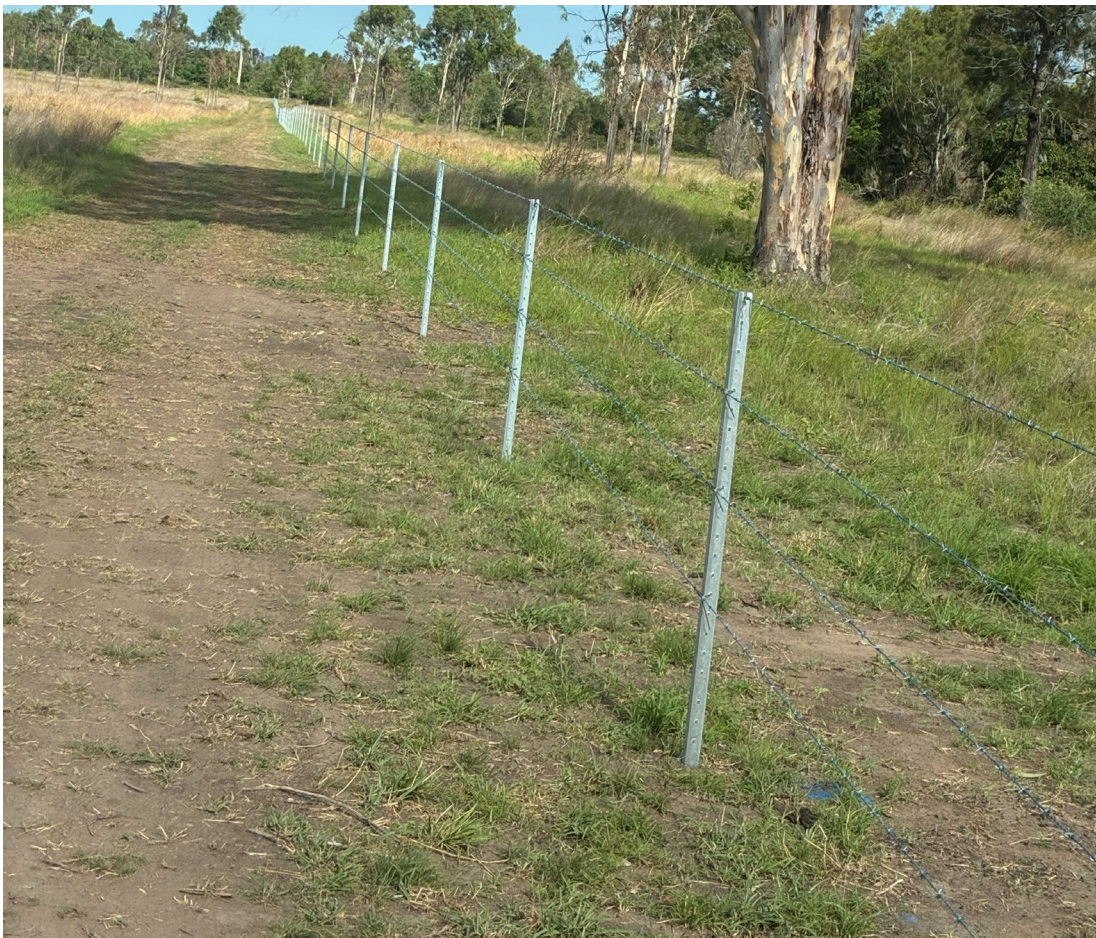
Fencing works were completed in December 2025, comprising the installation of approximately 3.15 km of new four-barb fencing.

Image 4. Section of completed fencing (image captured December 2025)

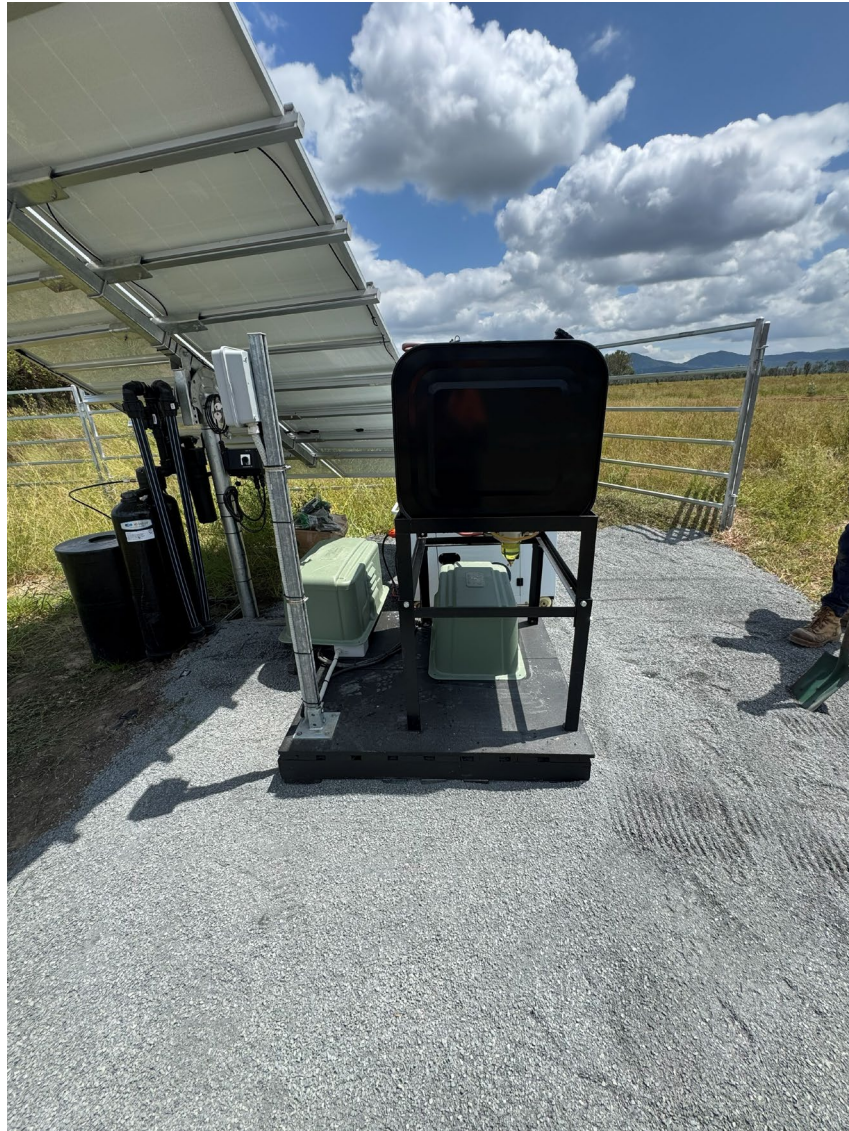
Water for the project is sourced from a bore located approximately 400 m from the site. The irrigation system, commissioned in late January by a contractor, includes pumps, a water conditioner, storage tanks, mainlines, lateral pipelines, and dripper emitters designed to ensure efficient water delivery.

Image 6: Irrigation pump installation

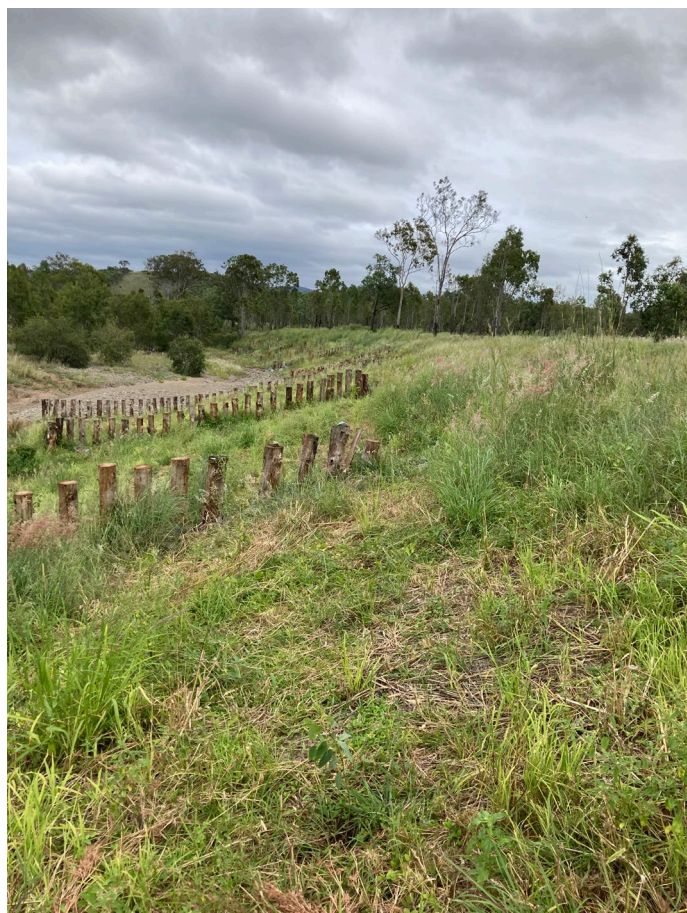
Image 9: Site I fully revegetated

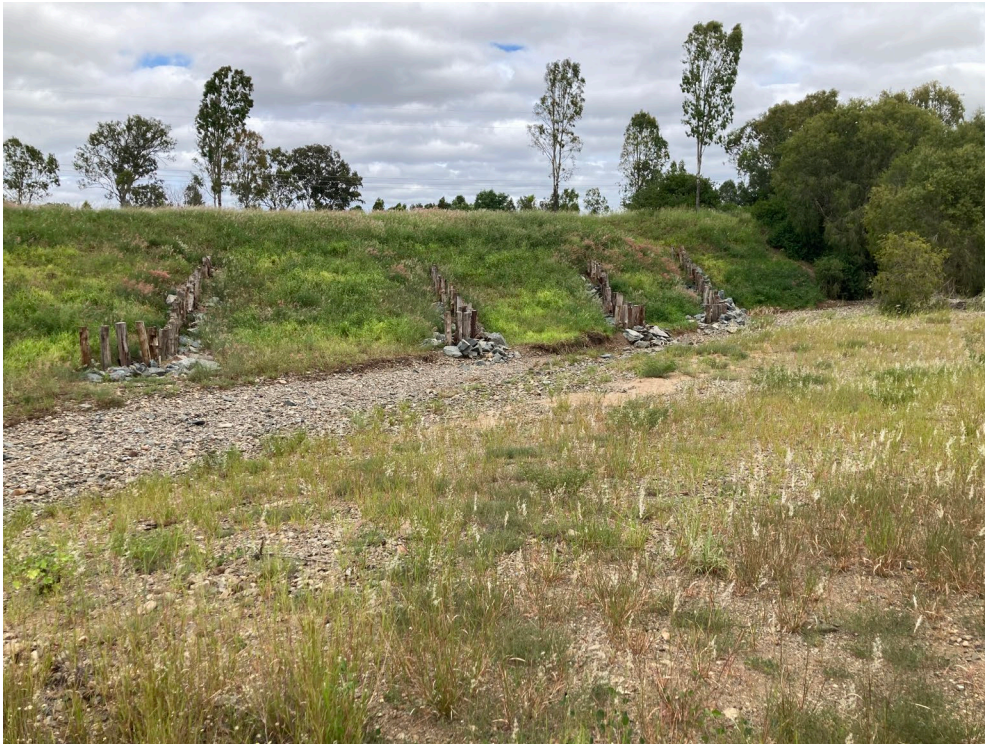
Image 10: Site 2 fully revegetated

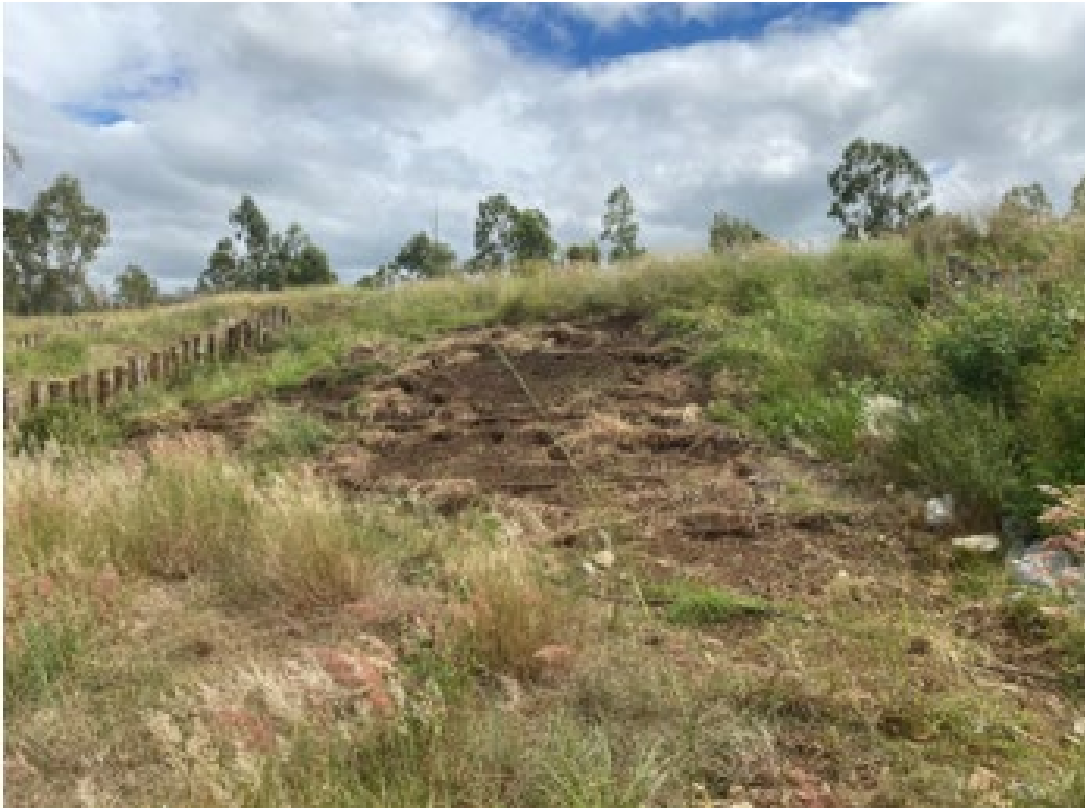
Environmental impacts were observed during the final three months of the reporting period. Evidence of feral pig activity was identified along the battered areas of the site from February onwards, resulting in localized disturbance to revegetation areas.

Fencing at both creek crossings has sustained damage and is currently awaiting repair. Portions of recently established revegetation areas have been uprooted due to feral pig activity and subsequent flooding. In addition, irrigation dripper lines have become tangled and displaced along the battered slopes.

Image 11: Evidence of pig damage at Site One. Photograph taken on 23 March 2026

- Replanting lost tubestock
- Reseeding areas affected by loss of topsoil and groundcover
- Repairing and re-tensioning damaged fence lines
- Reinstating and repositioning irrigation infrastructure

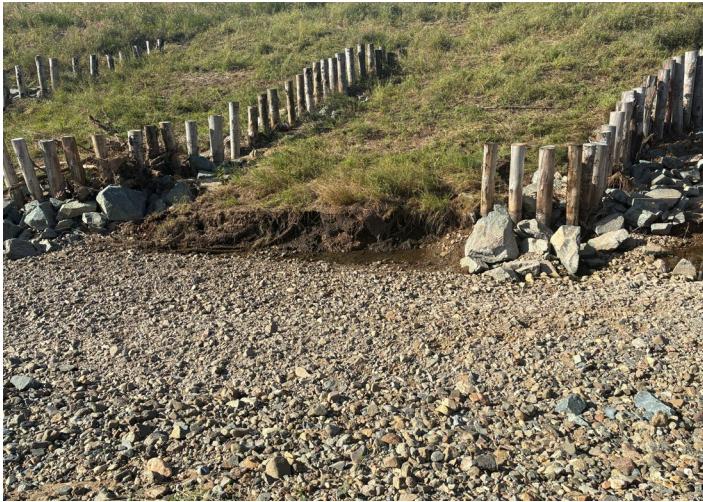
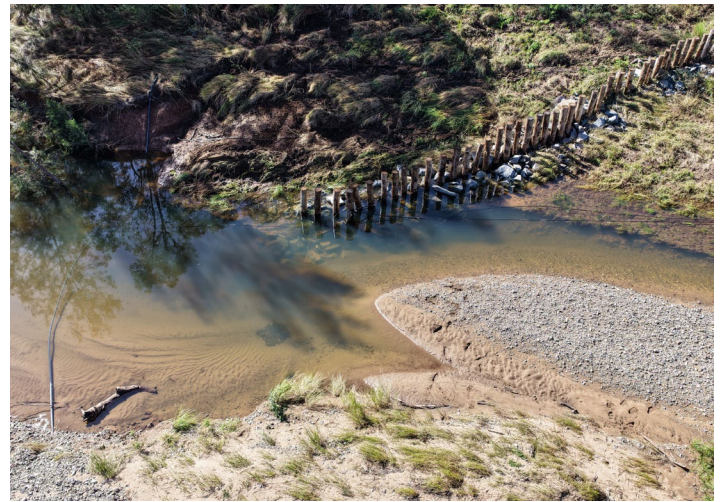
Image set 12. At Site Two, erosion affecting the second pile field following a high-flow event. Photographs taken on 23 March.

- Potential placement of additional rock armouring at the toe of the downstream pile field at Site Two

FBA intends to implement the precautionary measures outlined in Alluvium's design recommendations and will continue to monitor site conditions following significant weather events.

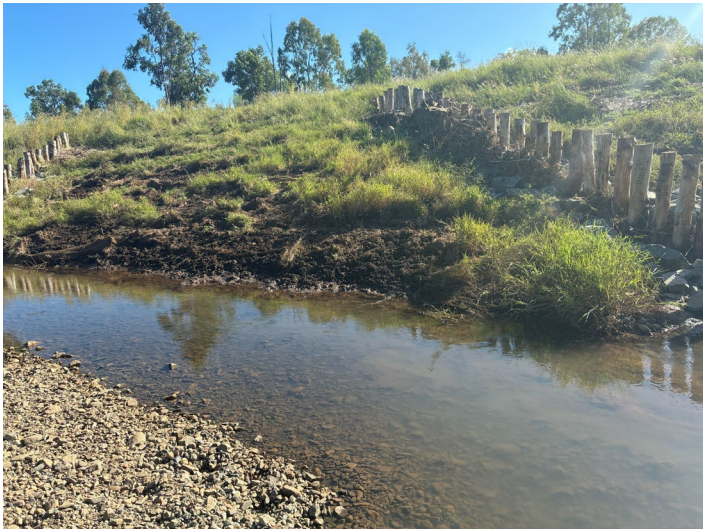
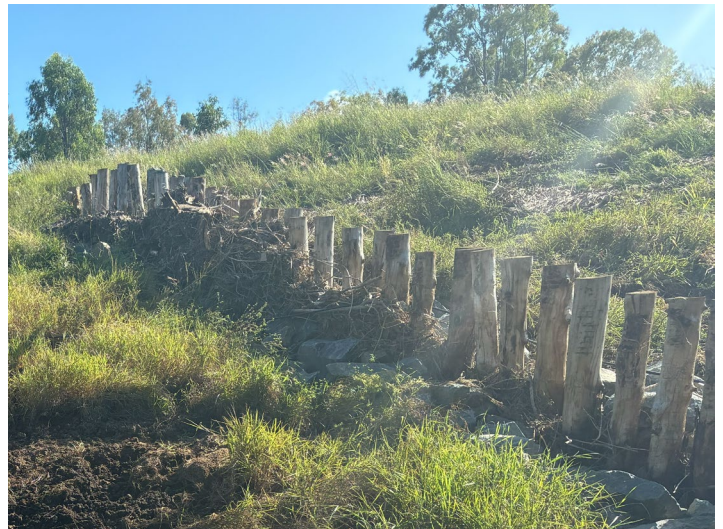
Image set 13. Pile Field One  
Left: Channel deepening at Site One (recovering)

Right: Debris accumulation on the pile fields
