Pancake Creek Moorings Program

Benthic Assessment, September 2019

Pancake Creek Moorings Program Benthic Assessment September 2019

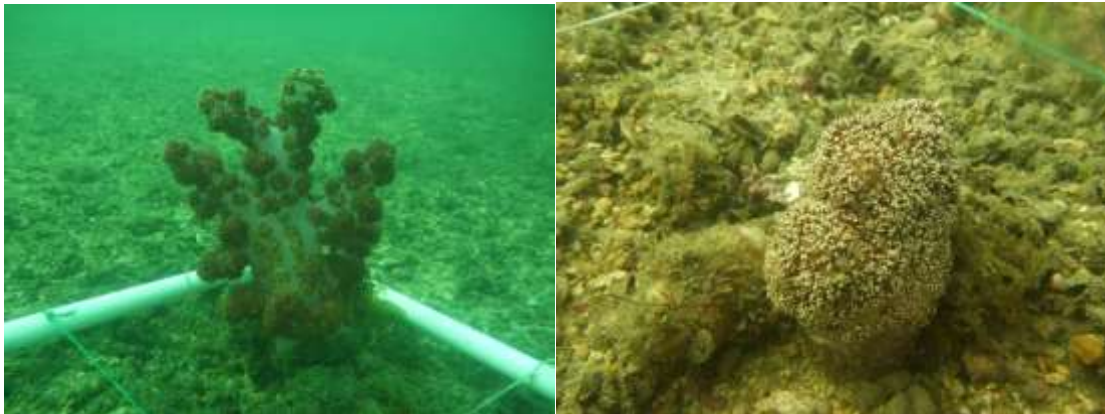
Figure 5 Images of coral species at site B3.

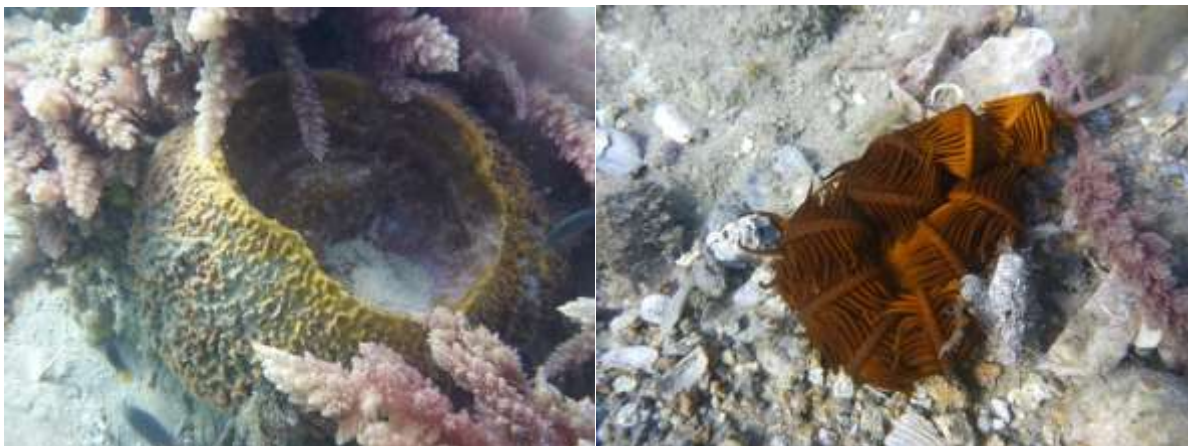
Figure 11 Image showing sponge and feather star near S2.

A large spawning aggregation of sea urchins was observed around the mooring block at S2 (Figure 10). The proximity of the urchins to the block would indicate a preference for the habitat it provides. Other invertebrate species were also observed at the site including sponges, starfish and ascidians (Figure 11).
